Brown Creek Tributaries Restoration Project FINAL Year 3 Monitoring Report

Anson County, North Carolina

DMS Project ID No. 95351, DEQ Contract No. 004641

Monitoring Year: 3 of 7

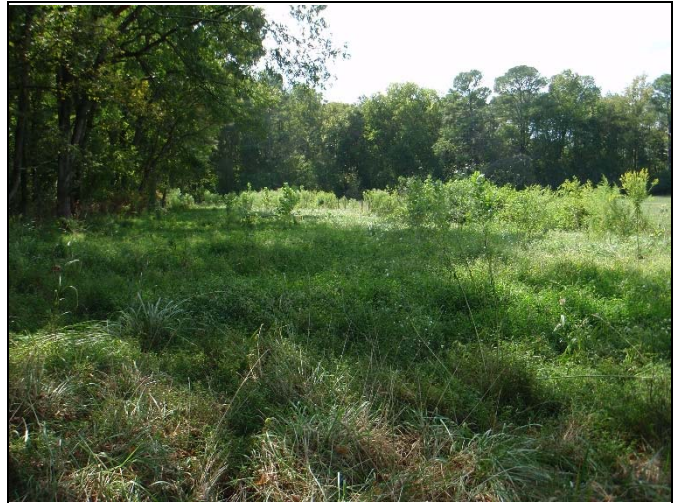
2) VPA: HC-R3, Low stem densities due to grass and shade pressure.

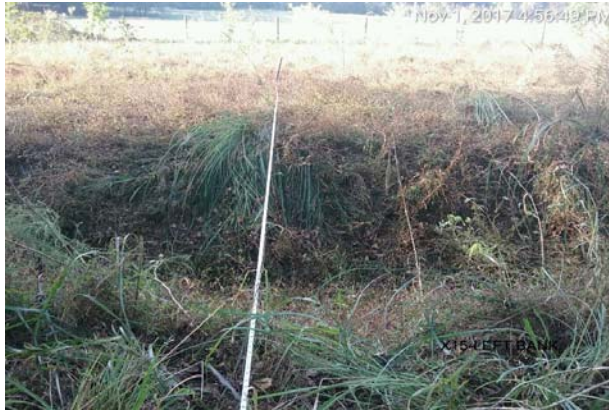
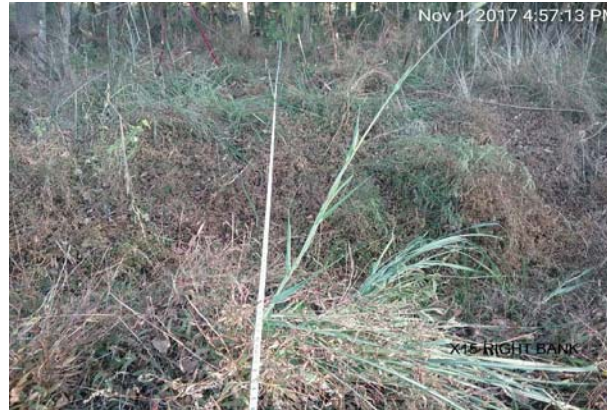
Permanent Cross-Section 15
Year 3 Data - Collected November 2017

Feature	Stream Type	BKF Area	BKF Width	BKF Depth	Max BKF Depth	W/D	BH Ratio	ER	BKF Elev	TOB Elev
Riffle	E	17.05	10.77	1.58	2.58	6.82	1.1	4.95	213.77	213.95
