# Brown Creek Tributaries Restoration Project Final Year 4 Monitoring Report

Anson County, North Carolina

DMS Project ID No. 95351, DEQ Contract No. 004641

Submission Date: December 2018

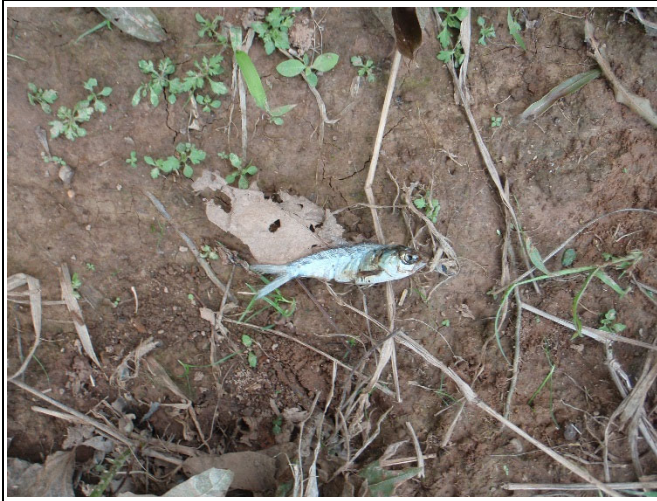
Reach UT4-R2: Fish found in floodplain

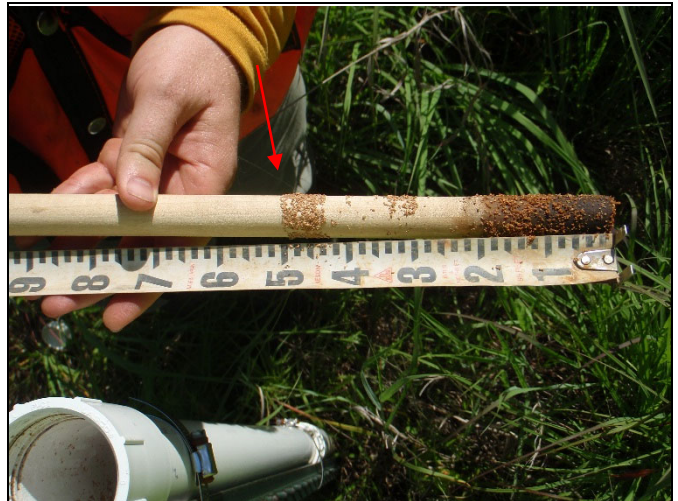
Reach UT4-R2 Crest Gauge: Overbank event of 0.50 ft recorded from 6/3/2018

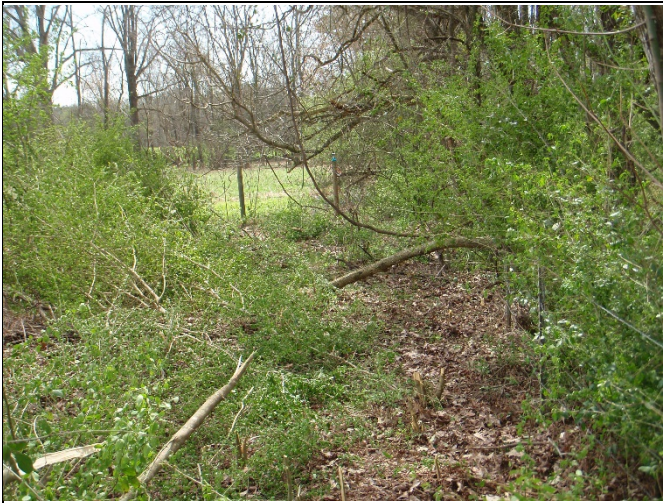
Reach HC-R1: Privet cut/sprayed, right floodplain at Station 10+00 (March 2018)

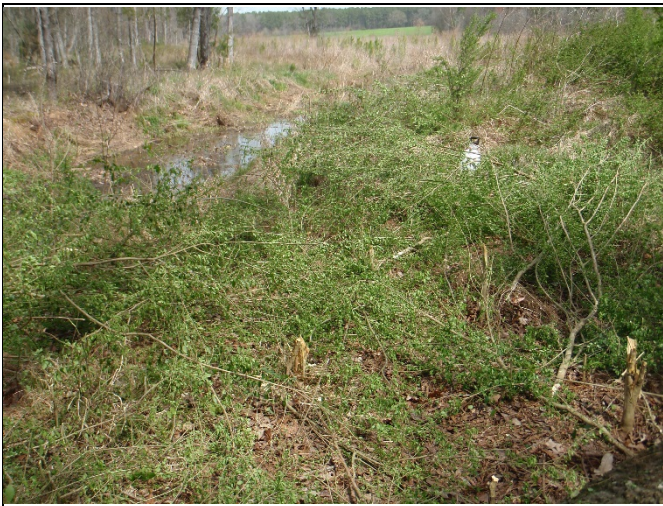
Reach HC-R1: Privet cut/sprayed, right floodplain at Station 10+00 (March 2018)

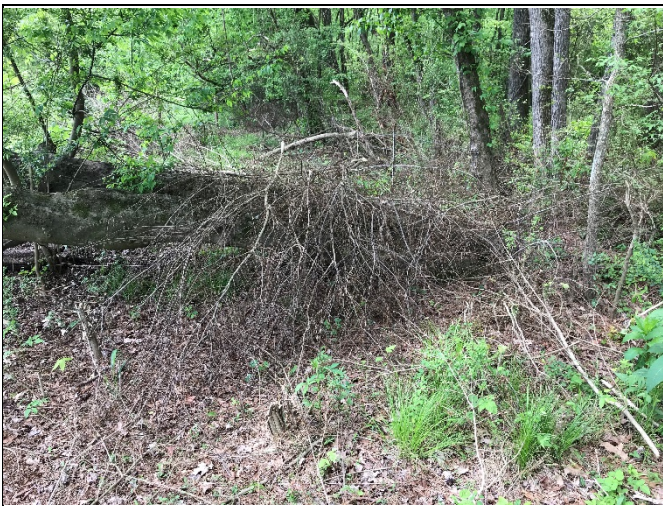
Reach HC-R1: Dead privet, Station 10+00 (Oct. 2018)
