**MONITORING YEAR 2  
ANNUAL REPORT  
FINAL**

**BUCKWATER MITIGATION SITE**

Orange County, NC  
NCDEQ Contract No. 006829  
DMS Project Number 97084  
USACE Action ID Number 2016-00873  
NCDWR Project Number 2016-0406

Data Collection Period: January – October 2020  
Draft Submission Date: November 19, 2020  
Final Submission Date: December 18, 2020

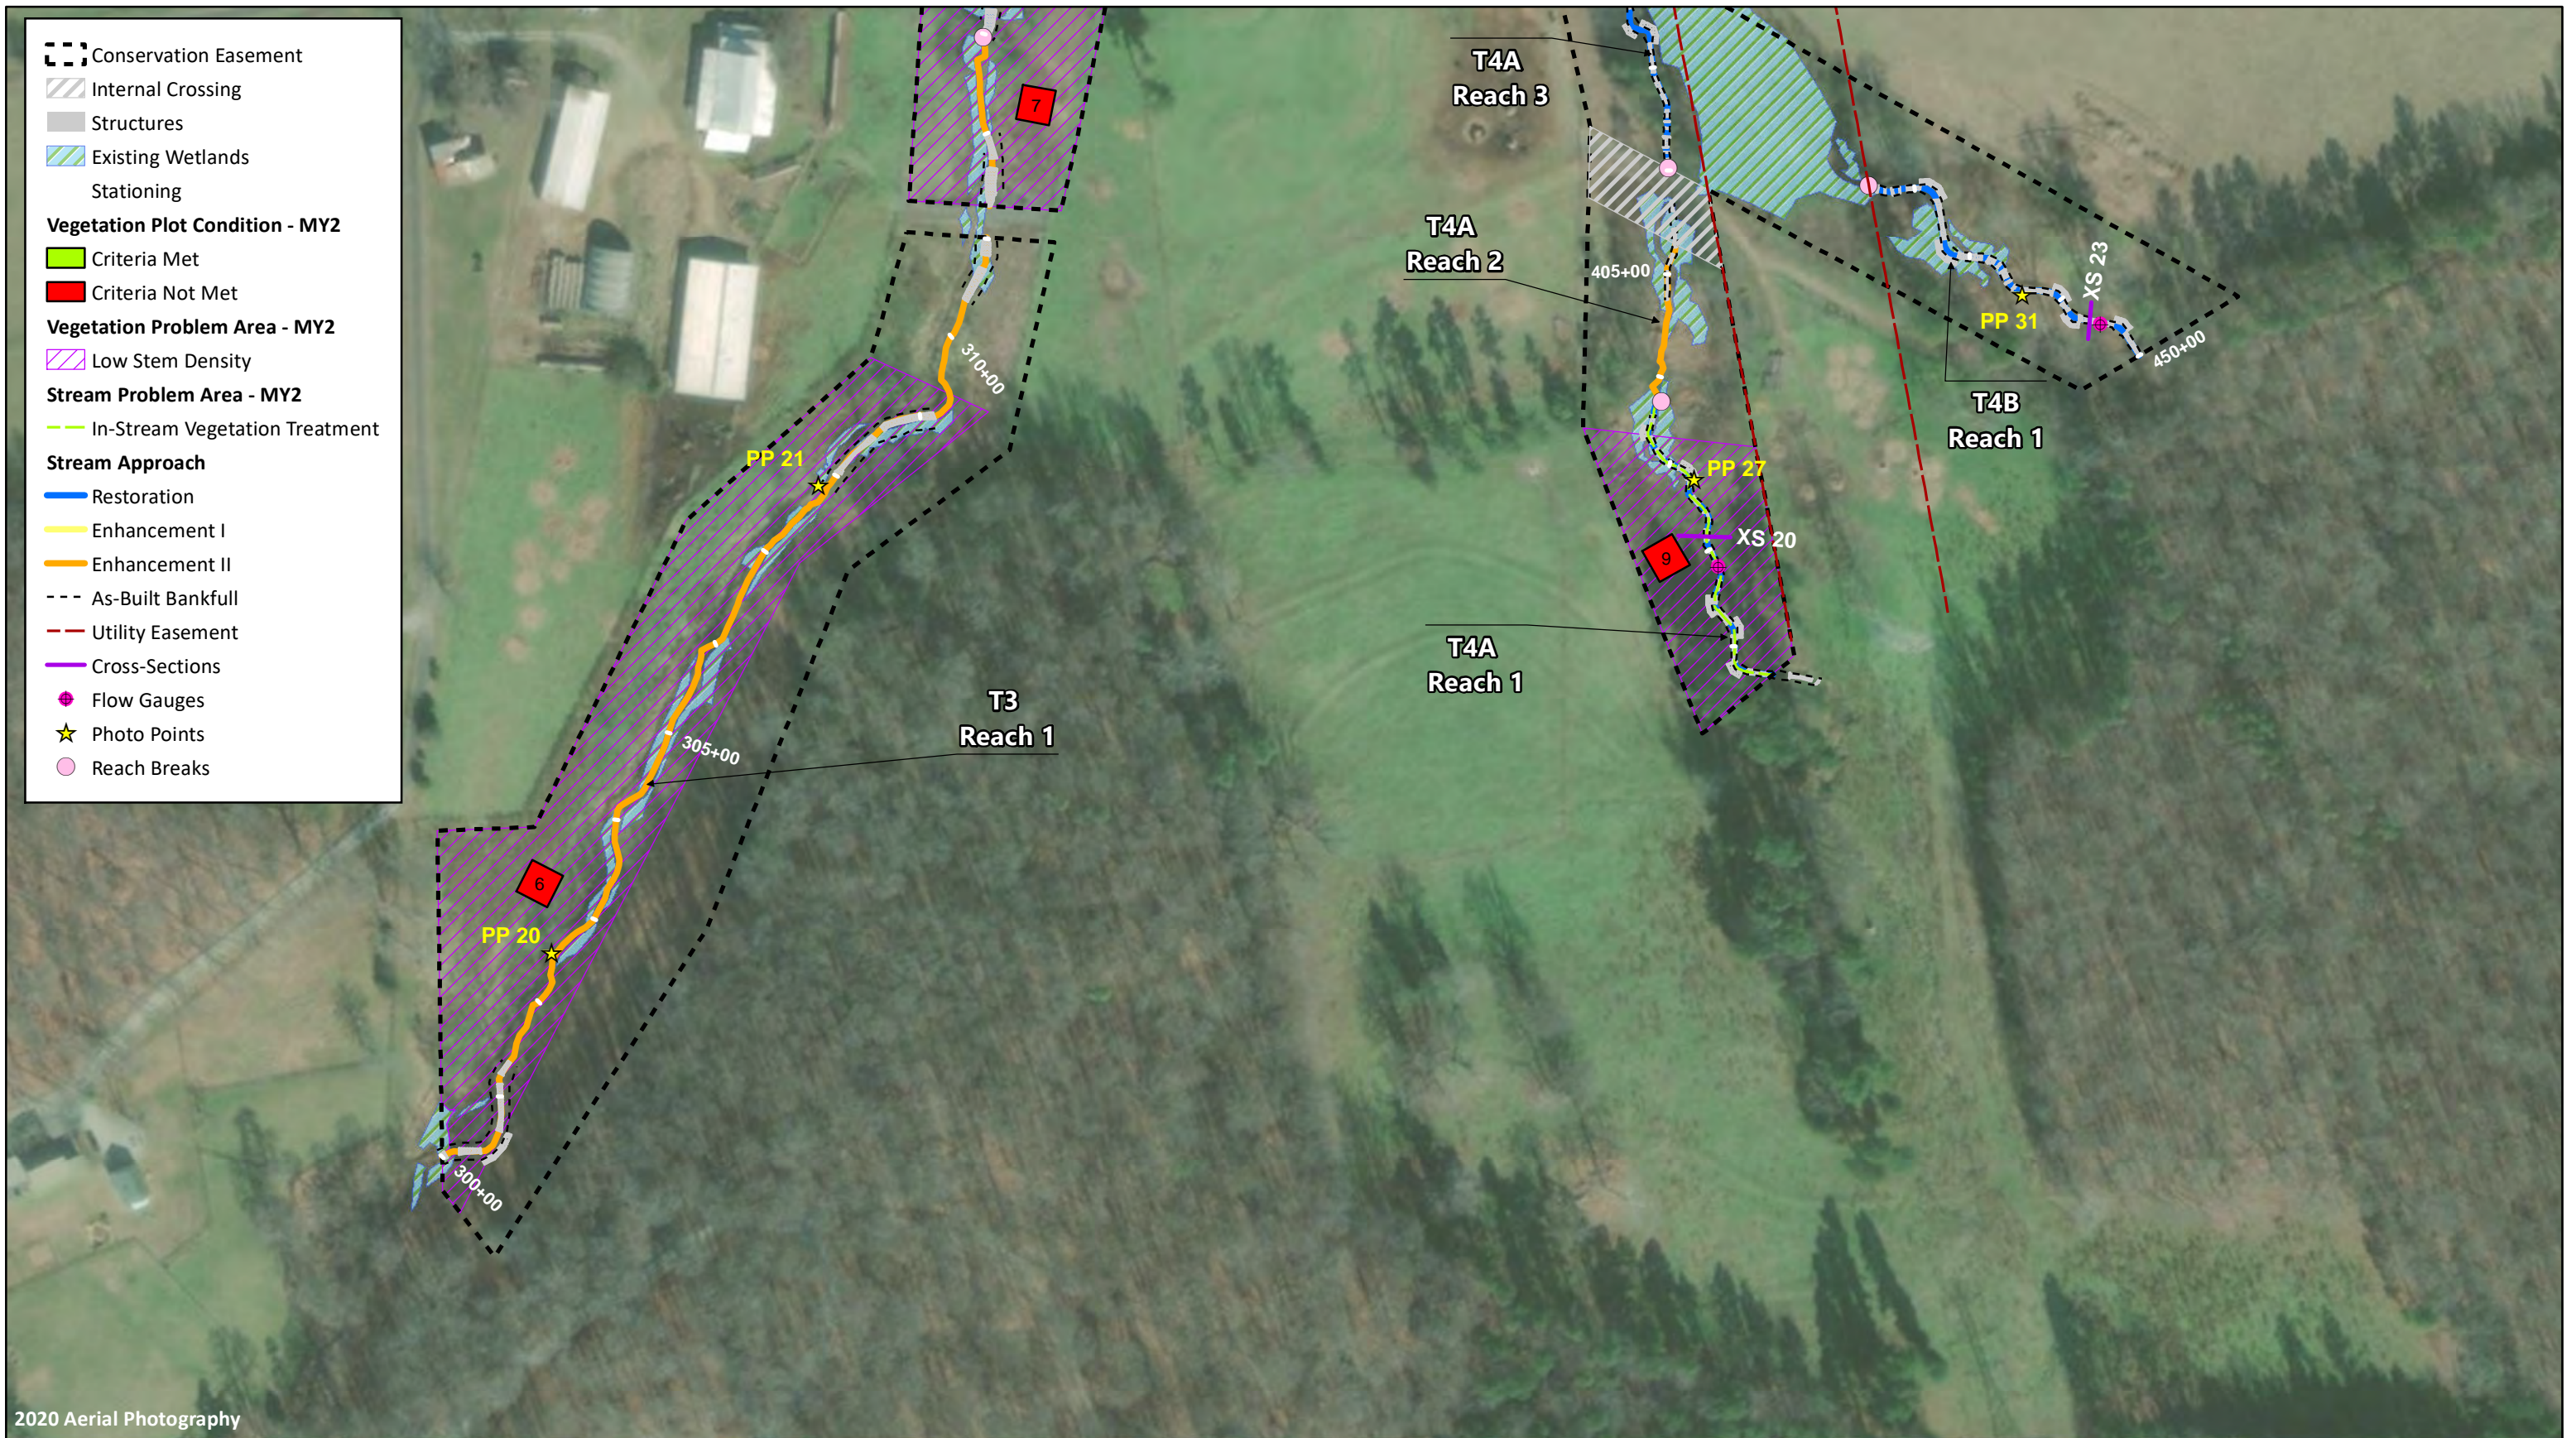
Figure 3e. Integrated Current Condition Plan View  
 Buckwater Mitigation Site  
 DMS Project No. 97084  
 Monitoring Year 2 - 2020

A 1.4-acre area of low vegetative growth was noted along T5 (upstream of St. Mary's Rd) and T6 (Figure 3e CCPV and Table 6, Appendix 2). Grading during construction exposed rocky poor-quality subsoil near the surface. Soil amendments including a mixture of dolomitic lime, fertilizer, and humic acid, and a seed mix of herbaceous vegetation were applied to this area in August 2020. Amendments will continue to be applied throughout subsequent monitoring years, as necessary.
