**MONITORING YEAR 4
ANNUAL REPORT**
Final

BUCKWATER MITIGATION SITE

Orange County, NC
Neuse River Basin
HUC 03020201

DMS Project No. 97084
NCDEQ Contract No. 006829
USACE Action ID No. 2016-00873
DWR Project No. 2016-0406 v2

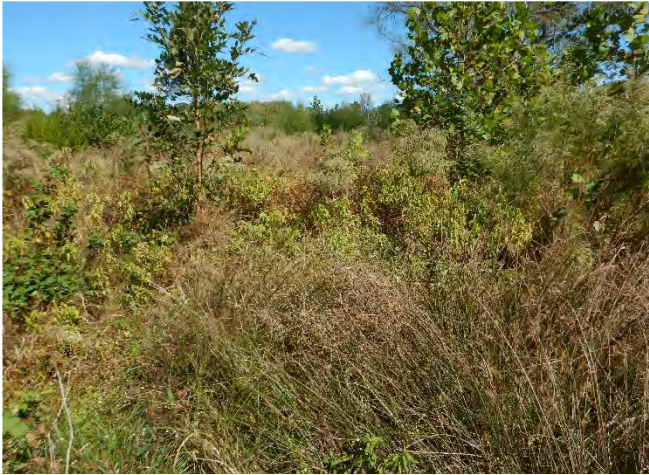
Buckwater Reach 4 – Additional wetland area. (10/6/2022)

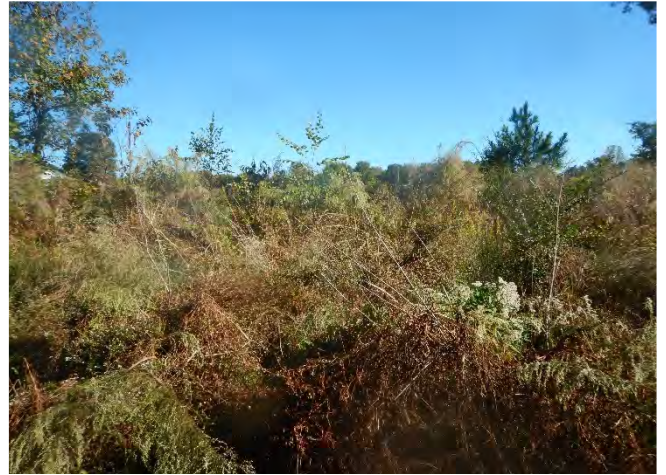
Buckwater Reach 4 – Area transitioning to wetland (10/6/2022)

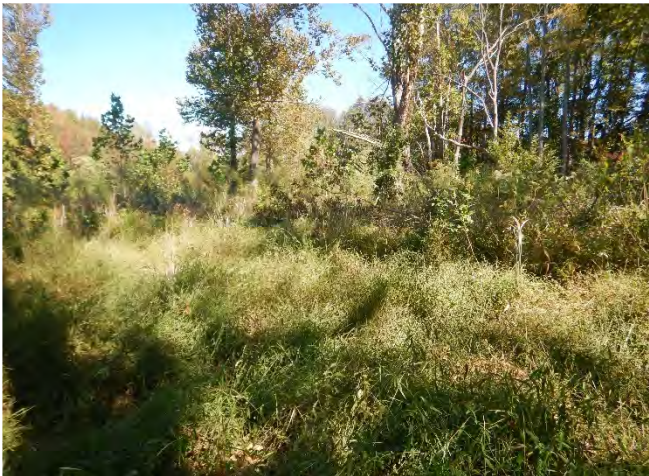
Buckwater Reaches 5 and 6 – Additional wetland areas (10/6/2022)

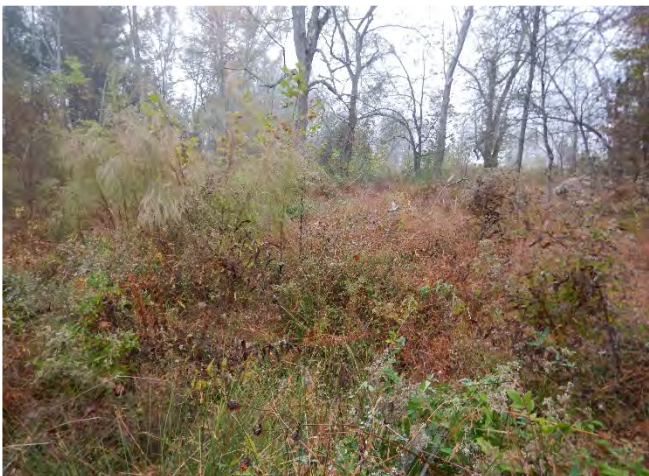
Buckwater Reach 7 – Existing and additional wetland areas (10/26/2022)

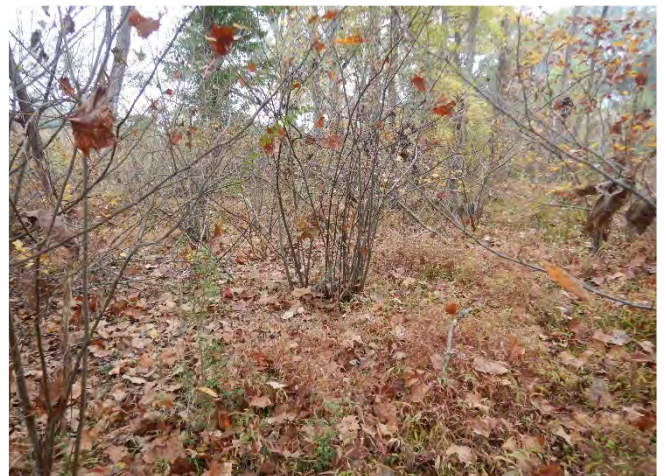
T1 Reach 1 – Area transitioned to upland (10/26/2022)

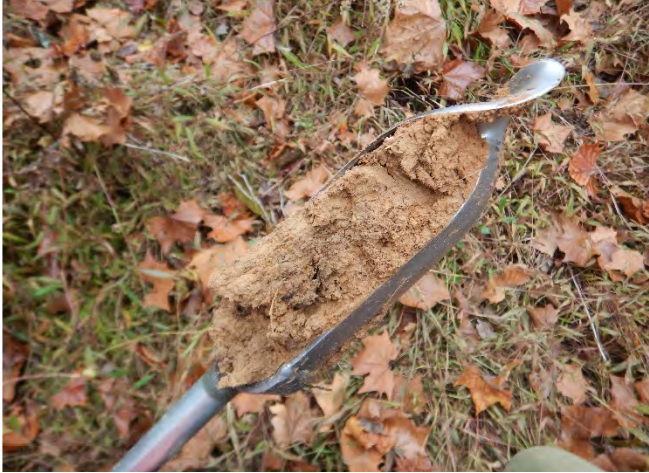
T1 Reach 1 – Representative soil profile of area transitioning to upland (10/26/2022)

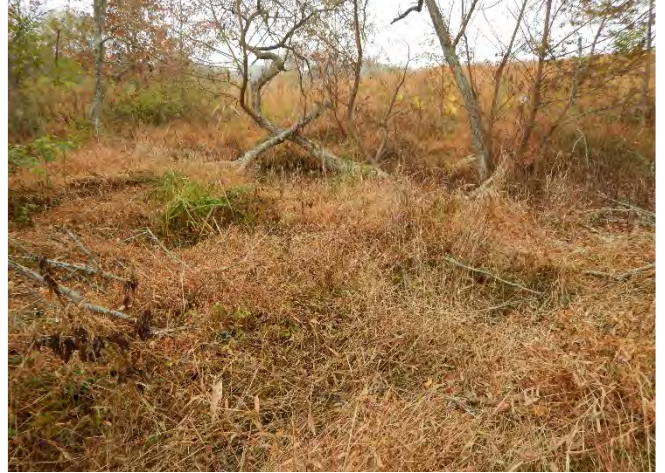
T1 Reach 2 – Existing wetland and area transitioning to wetland (10/26/2022)

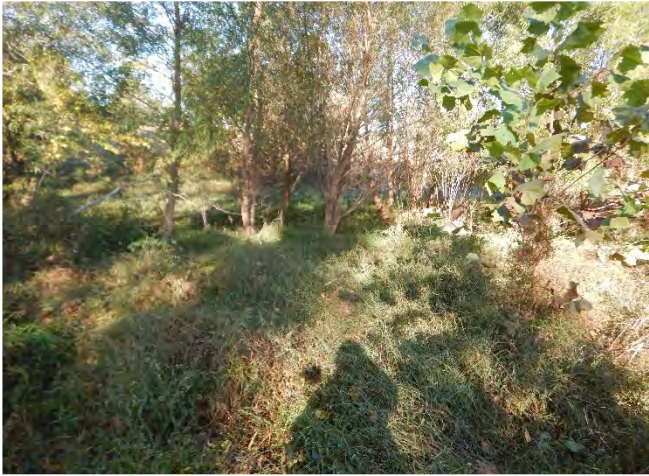
T3 Reach 2 – Additional wetland area (10/20/2022)

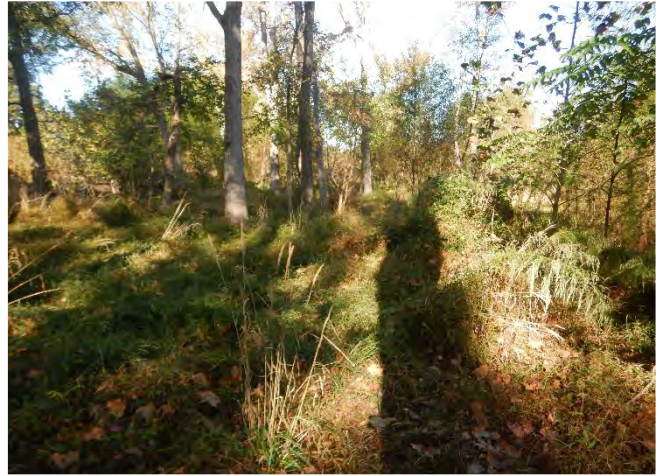
T4 Reach 1 – Additional and existing wetland areas (10/20/2022)

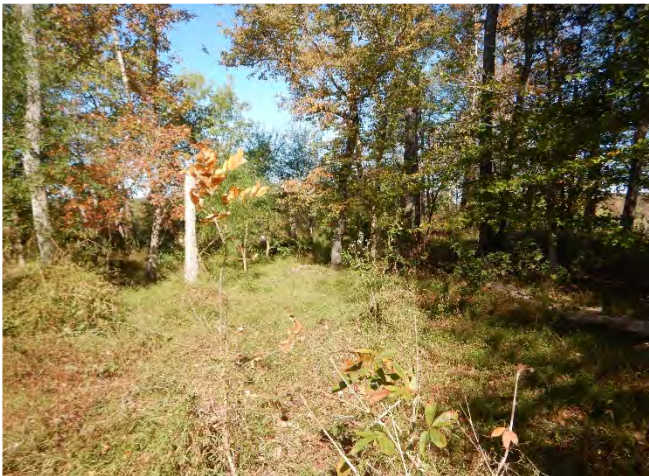
T4 Reach 2 – Additional and existing wetland areas (10/20/2022)

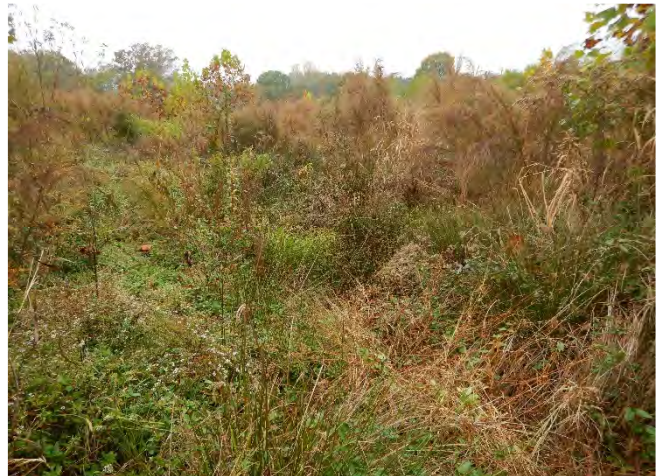
T2 – Additional wetland area (10/20/2022)

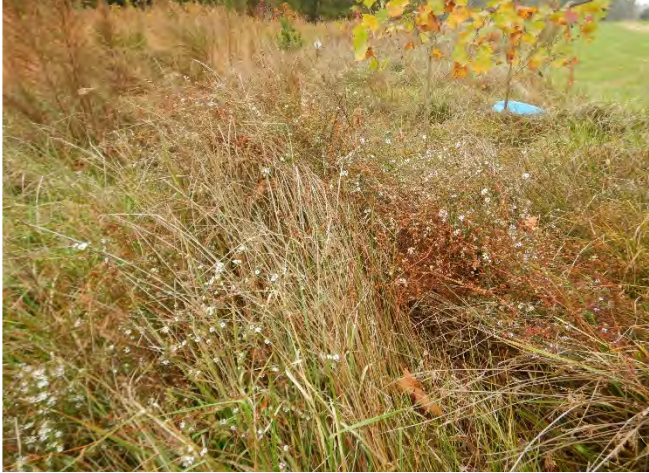
T5 – Existing wetland area (10/26/2022)

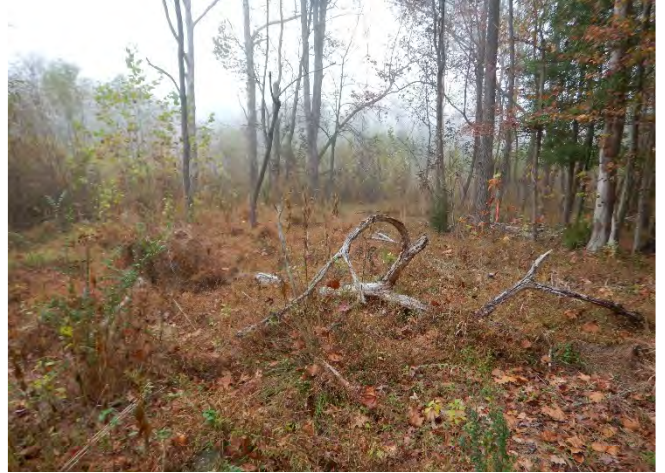
T7 Reach 2 and T7A – Additional and existing wetland areas (10/26/2022)
