MONITORING YEAR 5 ANNUAL REPORT

BUCKWATER MITIGATION SITE

Orange County, NC
Neuse River Basin
HUC 03020201
DMS Project No. 97084
NCDEQ Contract No. 006829
USACE Action ID No. 2016-00873
DWR Project No. 2016-0406v2

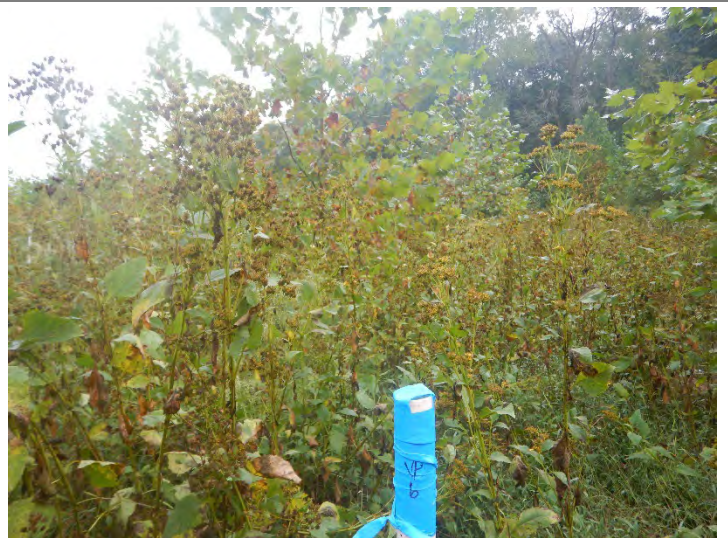
VEG PLOT 6 (10/03/2023)

*Vegetation Plots 6 and 7 only failed to meet criteria by less than 10%.

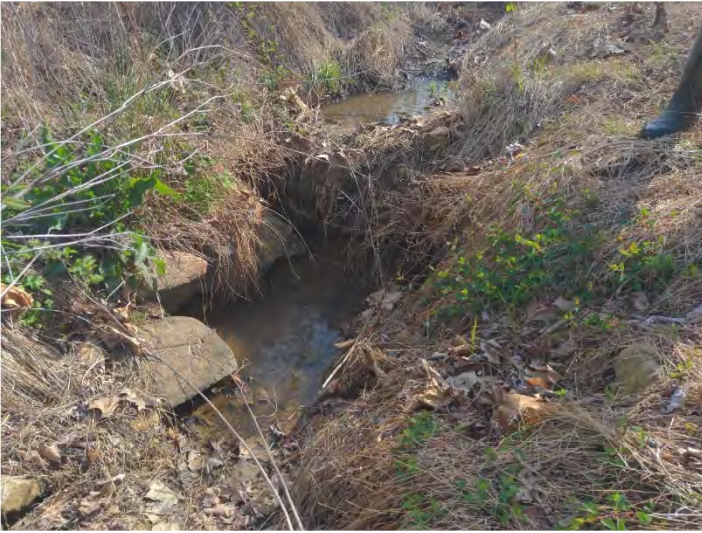
T4B R1 STA 451+40 – 451+70 – Piping Rock Sills (3/24/2023)
