MY3 FINAL MONITORING REPORT  
Buffalo Creek Tributaries Mitigation Project  
Johnston County  
Neuse River Basin  
CU 03020201

DMS Project # 100042  
DMS Contract # 7422  
DMS RFP # 16-007279  
USACE Action ID Number: SAW-2018-00425  
DWR Project # 2018-0199 V2  
Calendar Year of Data Collection: 2023

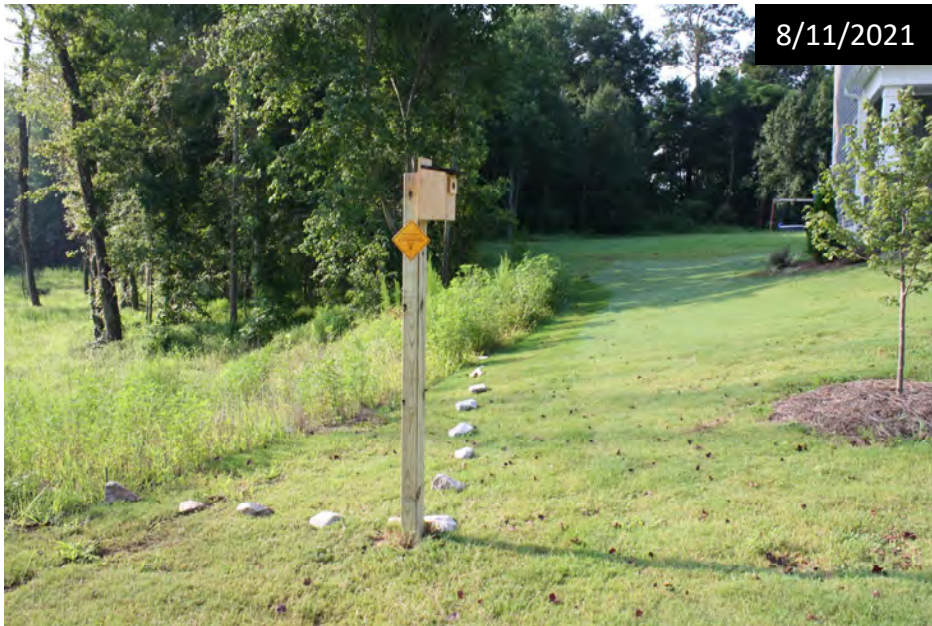
Encroachment Area 1, MS-R2, Upstream of Culvert (MY-03)

During MY1, there were two encroachments (~0.014 acres) observed near the southernmost culvert crossing on MS-R2. Both were sodded/planted grassy areas adjacent to new home construction. To prevent further encroachment, the homeowners were contacted, and the easement line was more clearly marked. Encroachment planting occurred on January 6<sup>th</sup>, 2022. During MY3, no further encroachments have occurred in these areas, and herbaceous and tree cover are doing well. These encroachments are resolved and WLS will continue to monitor the easement in these areas in MY4. No additional encroachments were noted during MY3.

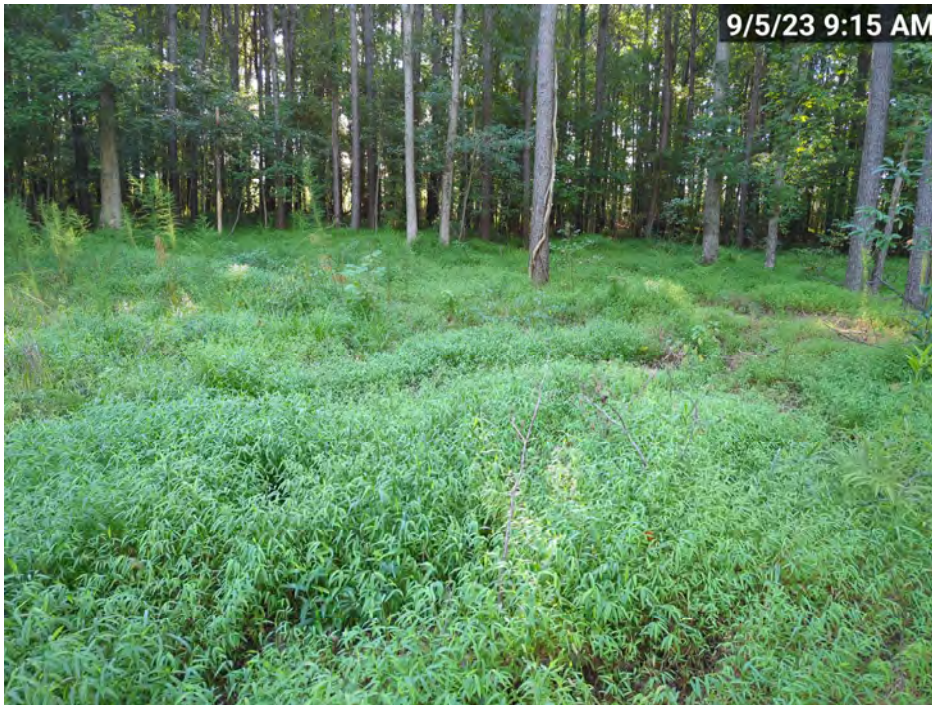
MS-R1, STA 15+00, BMP Overflow, Right Floodplain (MY-03)

An area of concern was noted during a DMS site visit on July 2<sup>nd</sup>, 2021, of overland flow occurring along MS-R1 from an offsite BMP. This area is stable with dense herbaceous vegetation preventing soil erosion, and there are no impacts to the floodplain or the stream (see photos in Appendix A).

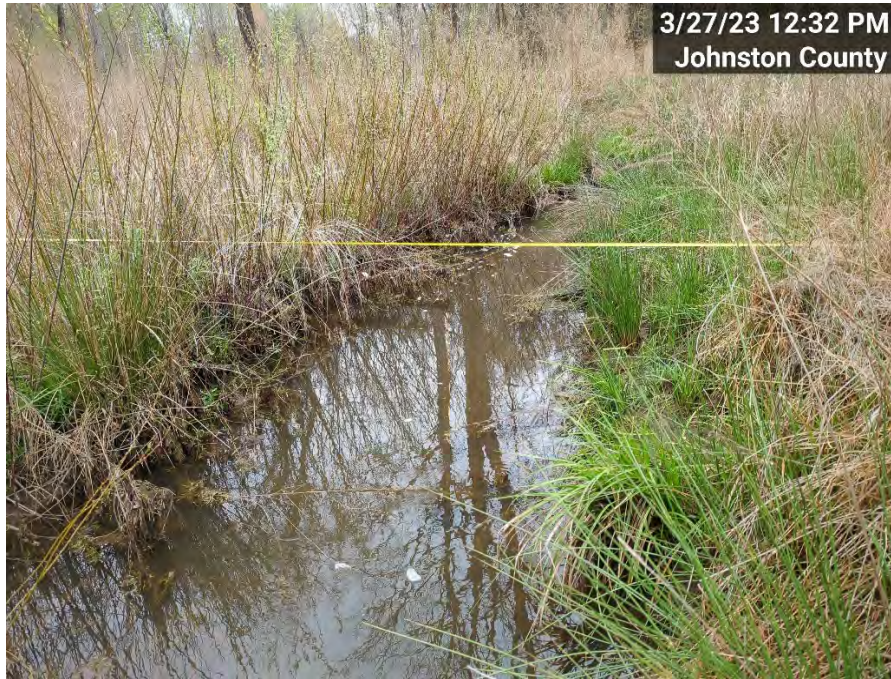
MS-R2 - Buffalo Creek Mitigation Site			
Monitoring Year	MY0	MY3	
Biotic Index Score	6.83	8.00	
Water Quality Level	Fair	Poor

MY3 - View Upstream

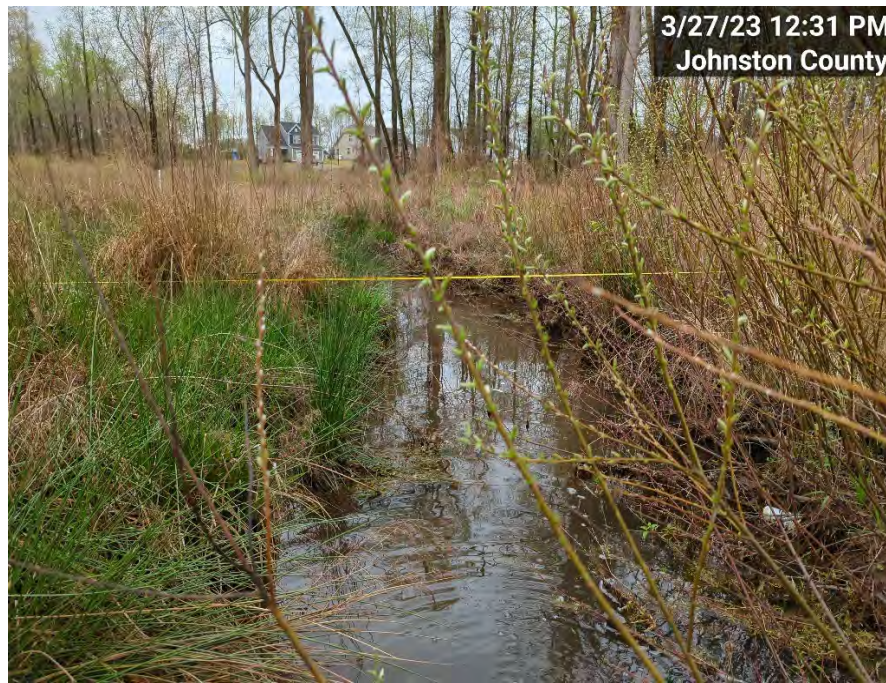
MY3 - View Downstream
