**Little Bugaboo Creek Stream Restoration
2006 Monitoring Report
Monitoring Year Two**

Ecosystem Enhancement Program Project Number 00056

Submitted: January 19, 2007

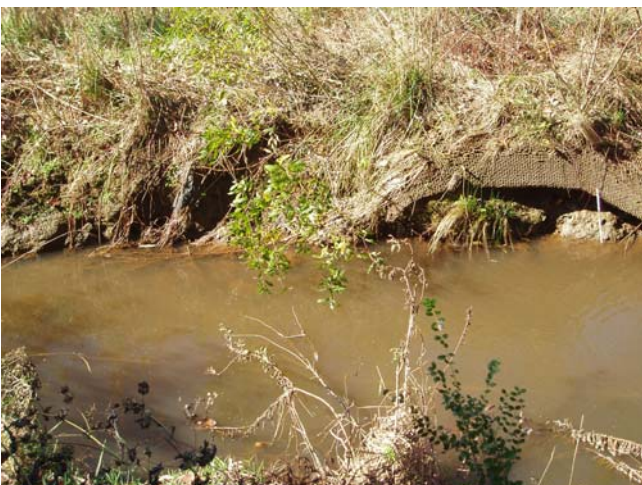
UTPA11 facing right bank

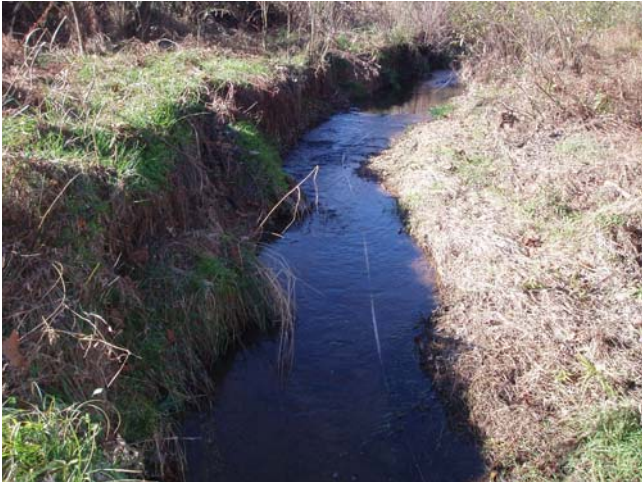
UTPA13 facing downstream

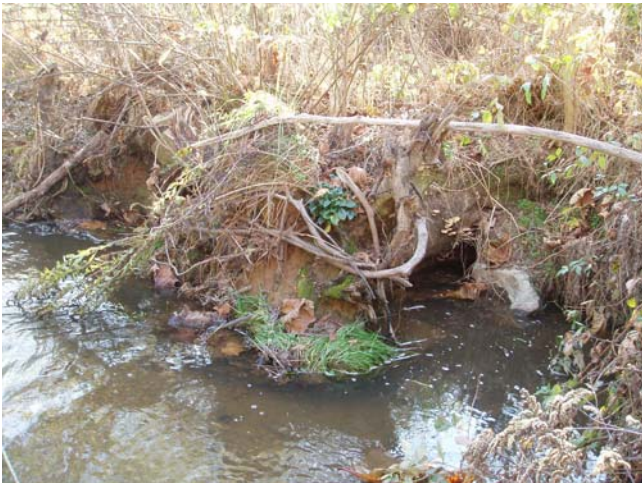
UTPA15 facing right bank

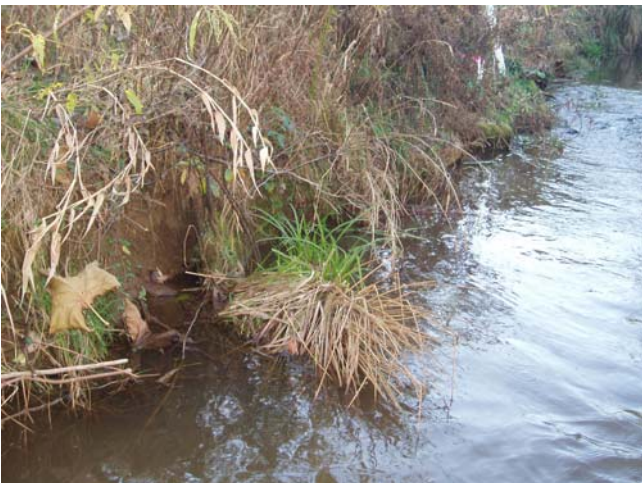
UTPA17 facing downstream

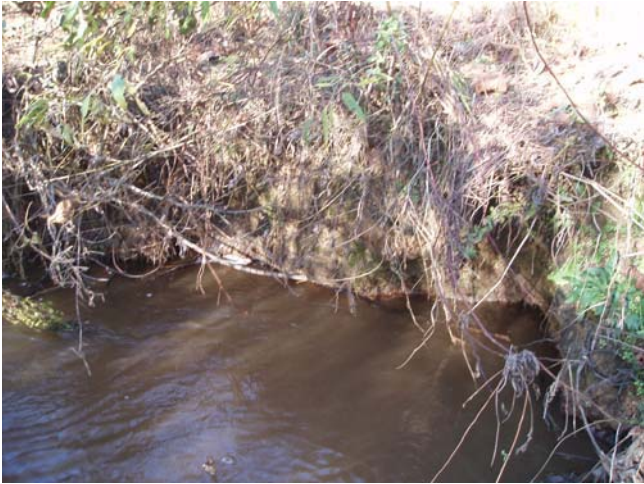
UTPA19 facing left bank

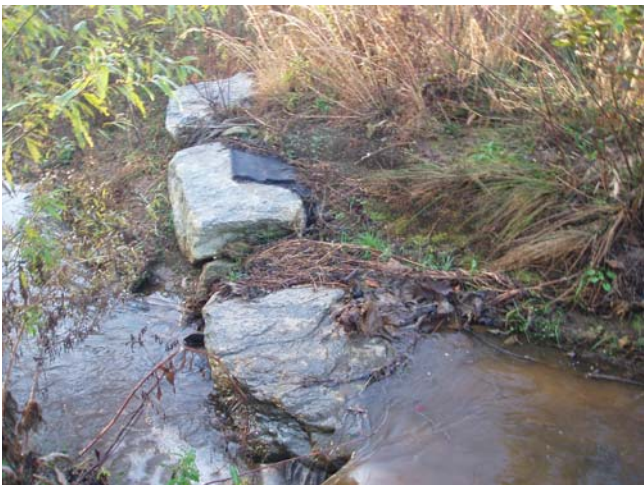
UTPA21 facing downstream, right bank

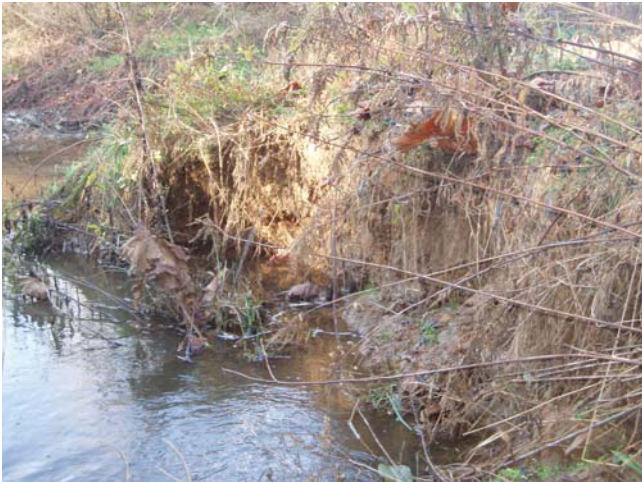
UTPA25	Bank erosion/scour	19+20	Improper design and/or construction	UTPA25

UTPA25 facing downstream

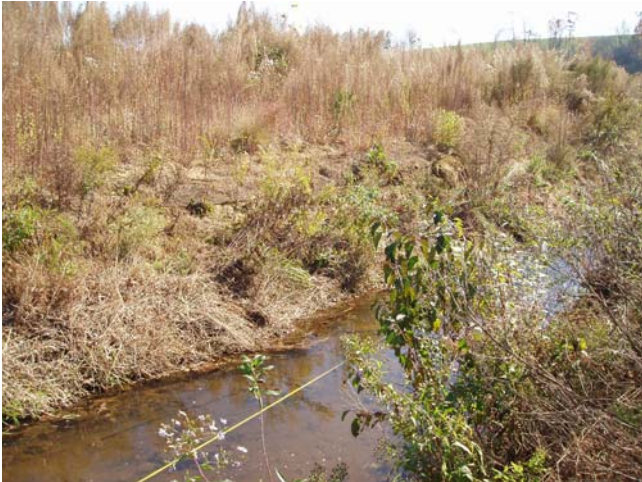
PA5 facing downstream

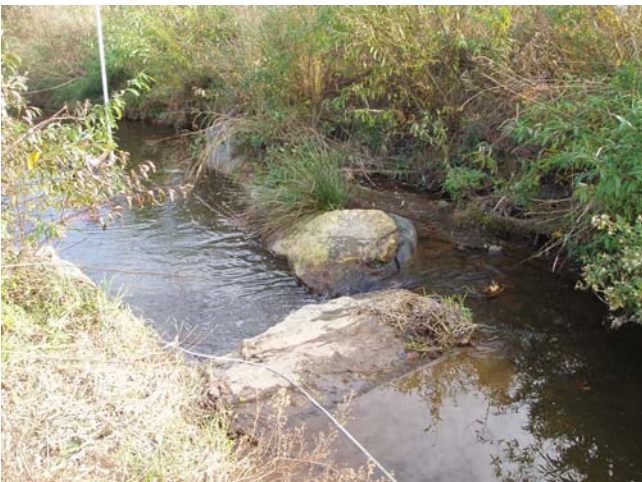
PA9 facing downstream

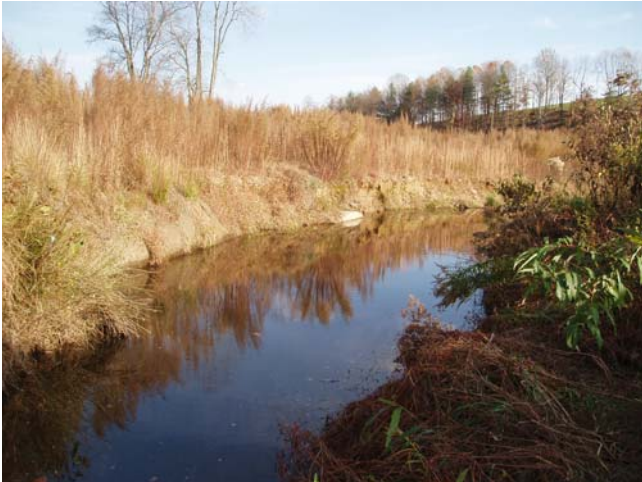
PA11 facing downstream

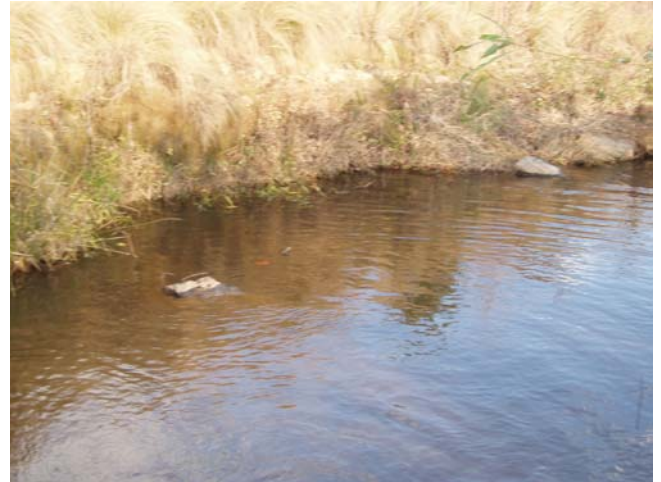
PA12 facing downstream

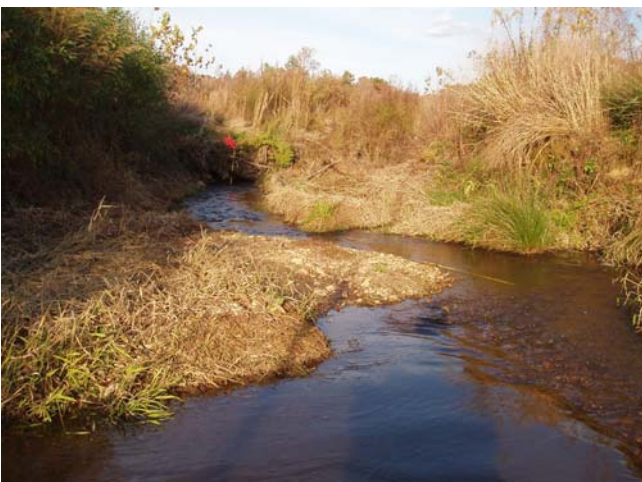
PA15 facing downstream

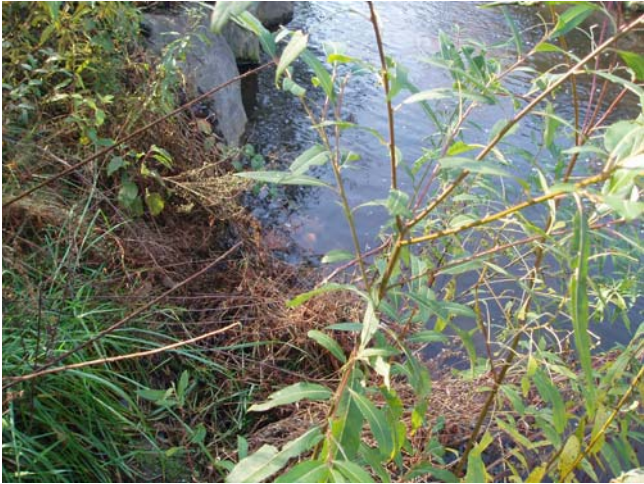
PA23 facing downstream from left bank

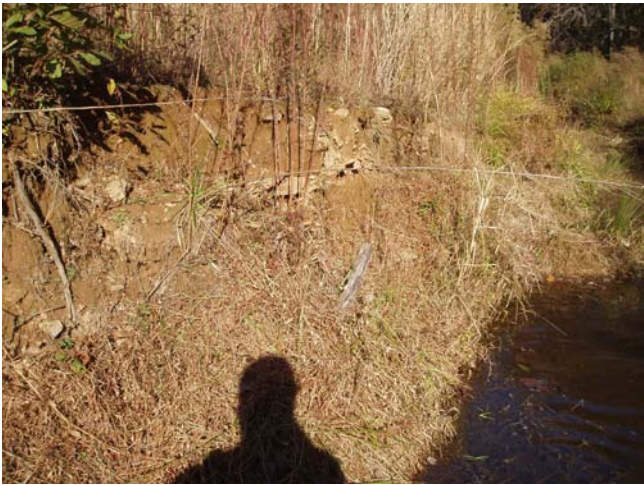
PA25 facing left bank

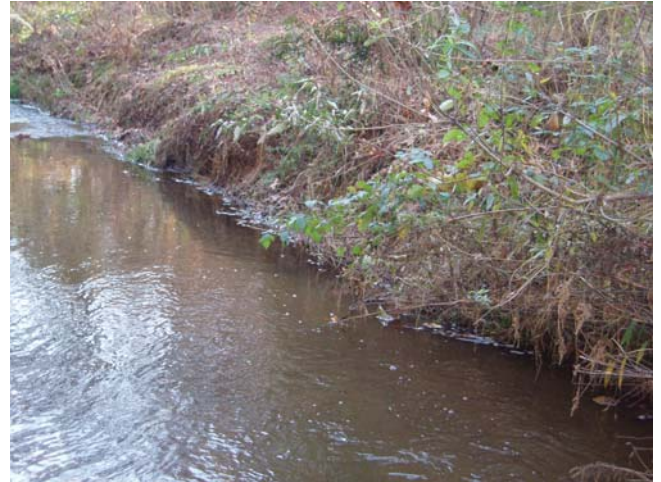
PA29	Bank erosion/scour	28+20	Improper design and/or construction	PA29
PA30	Bank erosion/scour	31+10	Improper design and/or construction	PA30
PA31	Bank erosion/scour	35+00	Improper design and/or construction	PA31
PA32	Bank erosion/scour	35+10	Improper design and/or construction	PA32
PA33	Bank erosion/scour	37+30	Improper design and/or construction	PA33
PA34	Bank erosion/scour	39+90	Structure placement	PA34
PA35	Bank erosion/scour	41+00	Improper design and/or construction	PA35
PA36	Bank erosion/scour	41+30	Improper design and/or construction	PA36
PA37	Structure degradation	41+60	Improper design and/or construction	PA37
PA38	Bank erosion/scour	42+00	Improper design and/or construction	PA38
PA39	Bank erosion/scour	42+30	Improper design and/or construction	PA39
PA40	Structure degradation	42+76	Improper design and/or construction	PA40

PA30 facing downstream

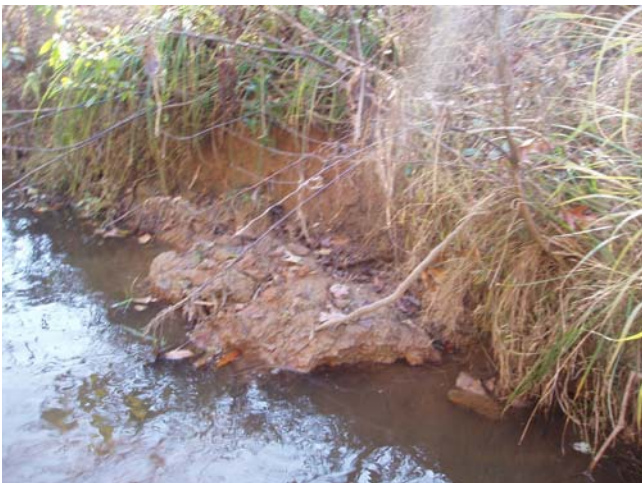
PA31 facing left bank

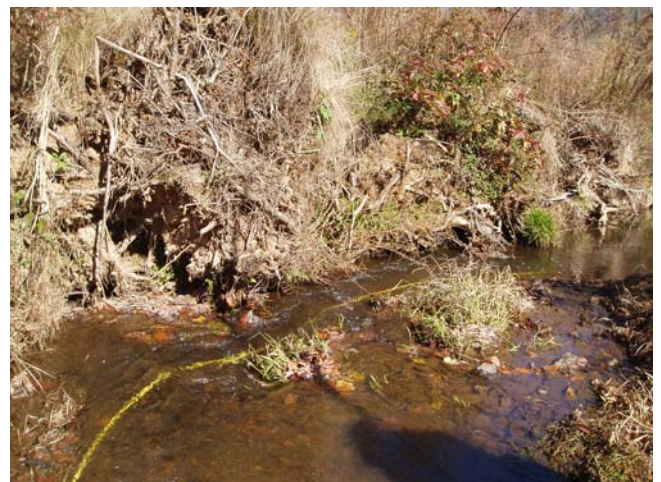
PA34 facing downstream

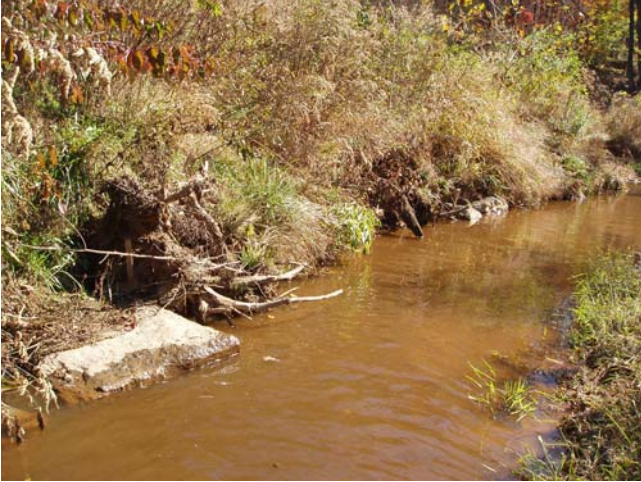
PA35 facing downstream

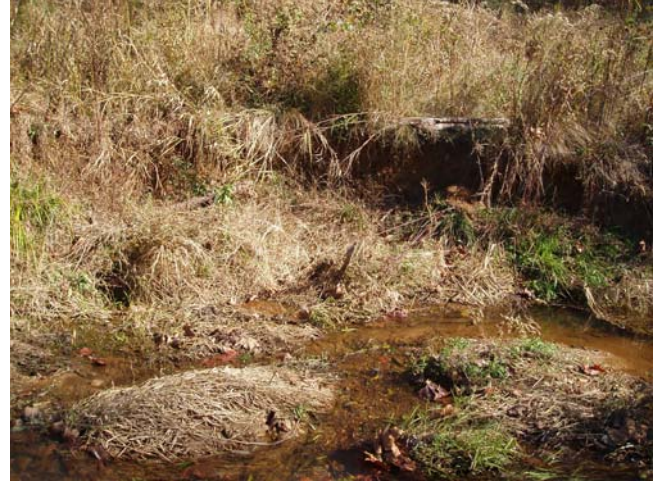
PA36 facing junction with UT

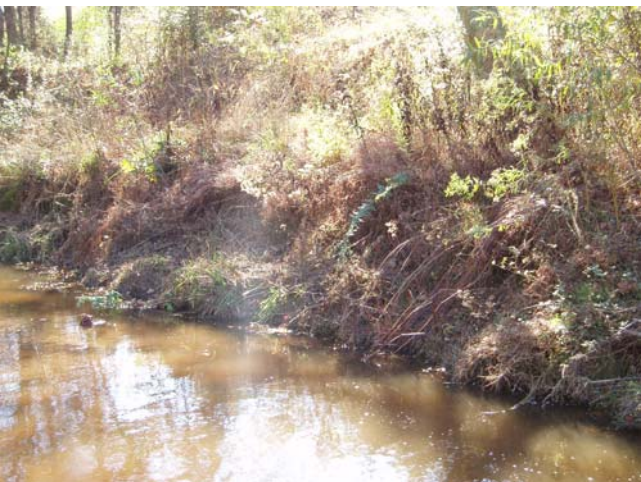
PA39 facing downstream
