**Little Bugaboo Creek Stream Restoration  
2007 Final Monitoring Report  
Monitoring Year Three**

**Ecosystem Enhancement Program Project Number 00056**

Submitted: February 26, 2008

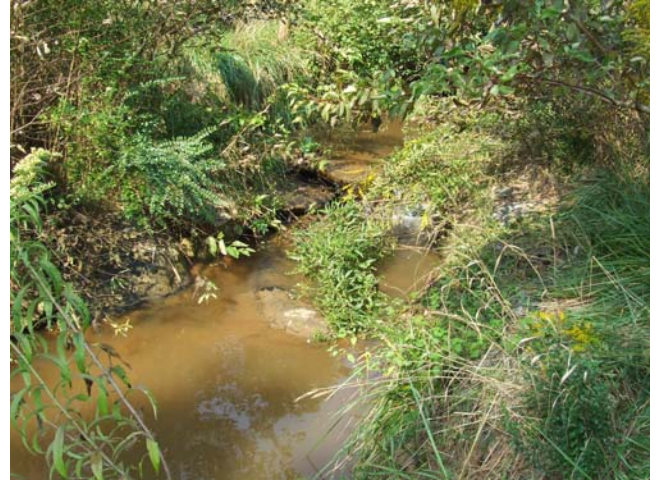
UTPA10 facing upstream

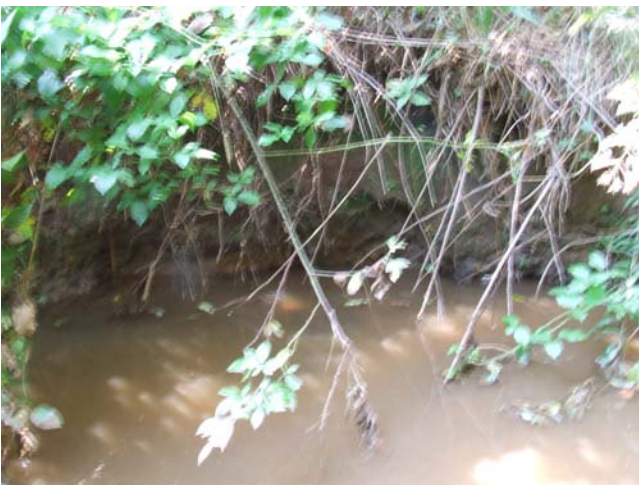
UTPA21 facing upstream

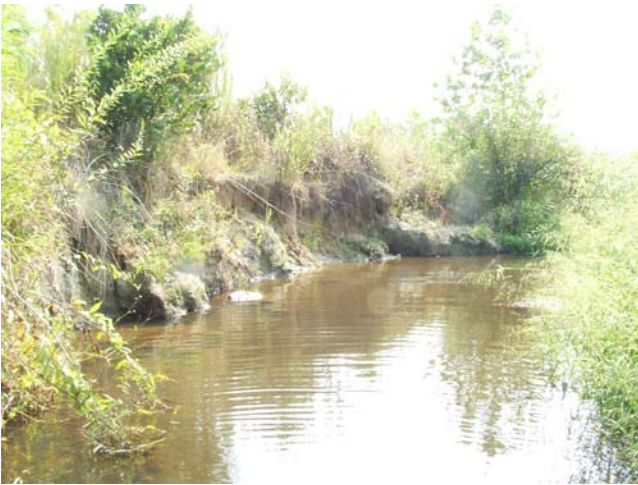
Stream Problem Areas – Little Bugaboo Creek			
Little Bugaboo Creek			
Feature #	Feature/Issue	Station #/Range	Probable Cause
PA1	Bank erosion	3+10	Root wad failure
PA2	Bank erosion/scour	3+70	Improper design and/or construction
PA3	Beaver dam	4+20	Beaver
PA4	Structure degradation	6+80	Scour behind rootwad
PA5	Beaver dam	7+40	Beaver
PA6	Bank erosion/scour	7+50	Improper design and/or construction
PA7	Structure degradation	8+45	Improper design and/or construction
PA8	Structure failure	9+20	Erosion behind arm
PA9	Beaver dam	11+00	Beaver
PA10	Channel failure	10+60 to	Improper design and/or construction
PA11	Bank erosion/scour	14+00	Improper design and/or construction
PA12	Structure degradation	15+10	Scour behind rootwad
PA13	Bar formation	16+15	Aggradation
PA14	Bank erosion/scour	16+50	Improper design and/or construction
PA15	Structure degradation	17+80	Mass wasting
PA16	Structure failure	19+90	Bank erosion
PA17	Bank erosion/scour	21+10	Improper design and/or construction

PA1 facing left bank

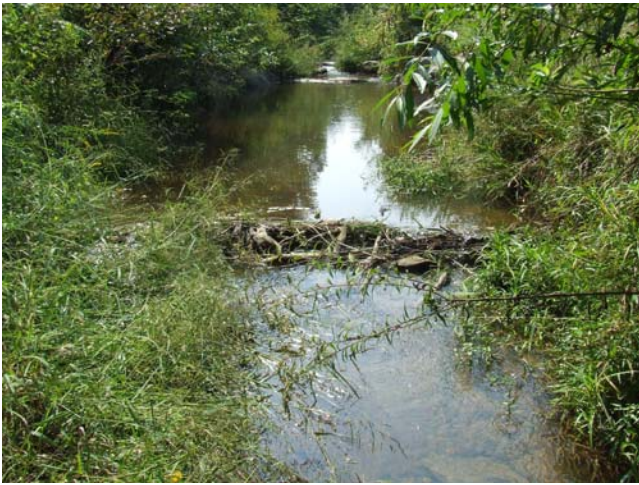
PA5 facing upstream

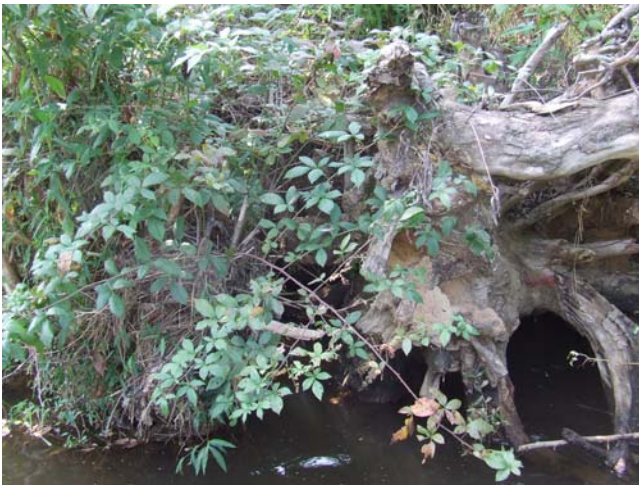
PA7 facing right bank

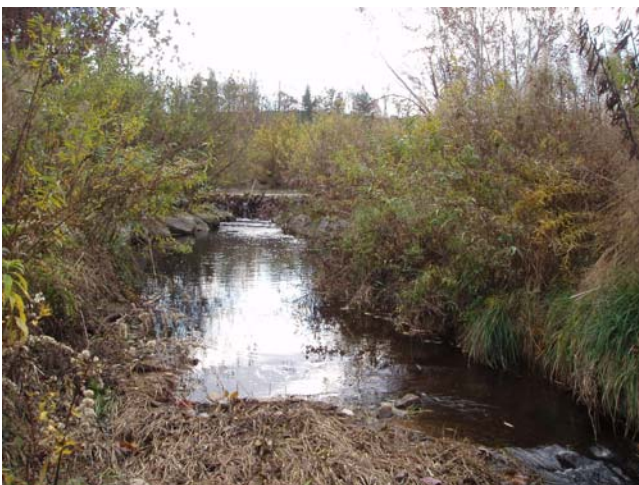
PA9 facing upstream (11/15/07)

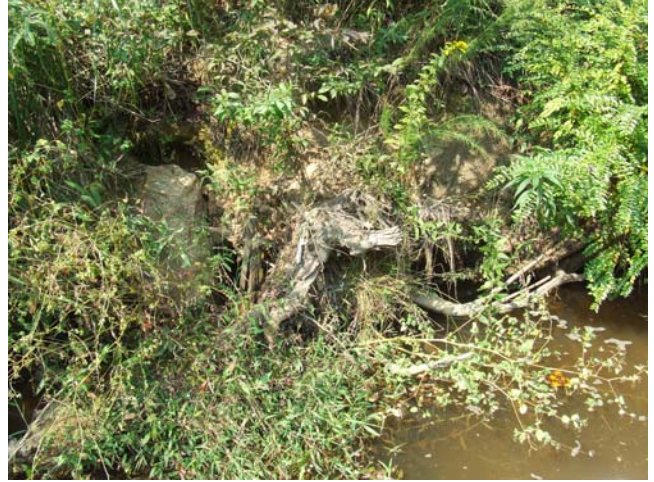
PA12 facing right bank

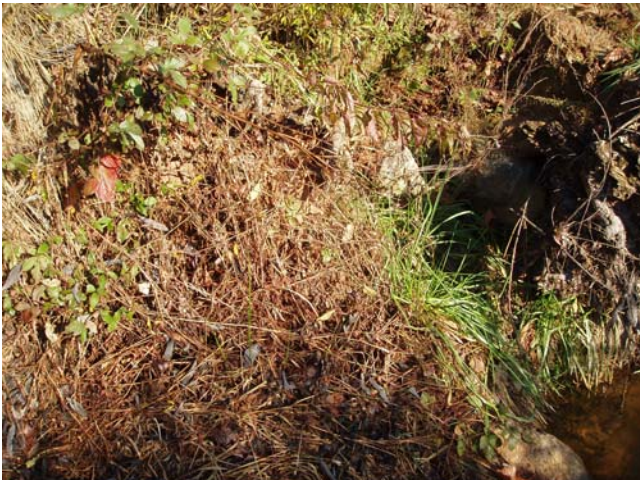
PA14	Bank erosion/scour	16+50	Improper design and/or construction	PA14
PA15	Structure degradation	17+80	Mass wasting	PA15
PA16	Structure failure	19+90	Bank erosion	PA16
PA17	Bank erosion/scour	21+10	Improper design and/or construction	PA17
PA18	Bank erosion/scour	24+00	Improper design and/or construction	PA18
PA19	Structure degradation	24+50	Bank erosion	PA19
PA20	Structure degradation	24+90	Piping behind wads	PA20
PA21	Bank erosion/scour	25+00	Improper design and/or construction	PA21
PA22	Bank erosion/scour	25+10	Improper design and/or construction	PA22
PA23	Beaver dam	27+00	Beaver	PA23
PA24	Bank erosion/scour	27+20	Improper design and/or construction	PA24
PA25	Bank failure	30+00	Improper design and/or construction	PA25
PA26	Bank erosion/scour	32+30	Wildlife crossing	PA26
PA27	Bank erosion/scour	34+90	Scour behind rootwad	PA27
PA28	Bank erosion/scour	39+90	Structure placement	PA28
PA29	Bank erosion/scour	40+05	Improper design and/or construction	PA29

PA15 facing left bank

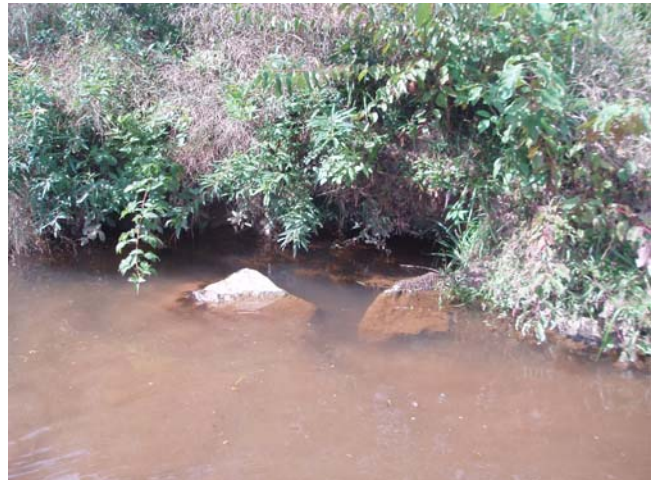
PA16 facing left bank

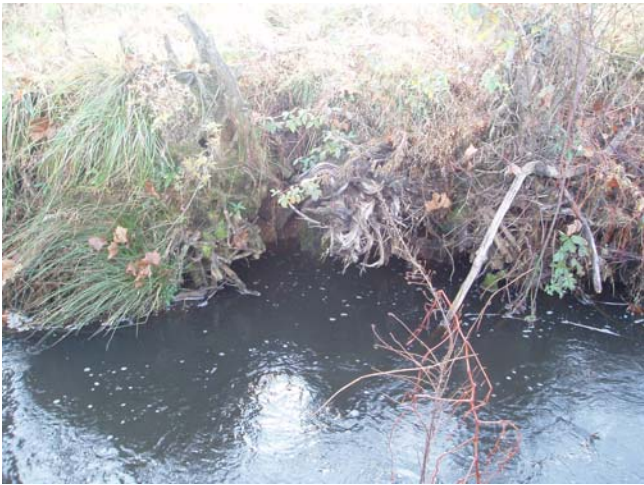
PA17 facing right bank

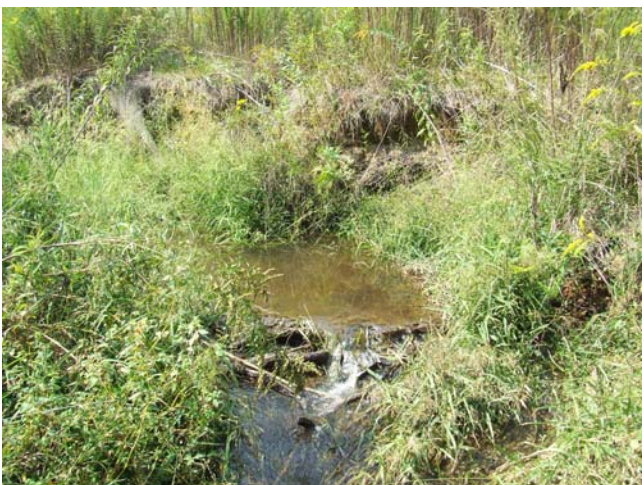
PA18	Bank erosion/scour	24+00	Improper design and/or construction
PA19	Structure degradation	24+50	Bank erosion
PA20	Structure degradation	24+90	Piping behind wads
PA21	Bank erosion/scour	25+00	Improper design and/or construction
PA22	Bank erosion/scour	25+10	Improper design and/or construction
PA23	Beaver dam	27+00	Beaver
PA24	Bank erosion/scour	27+20	Improper design and/or construction
PA25	Bank failure	30+00	Improper design and/or construction
PA26	Bank erosion/scour	32+30	Wildlife crossing
PA27	Bank erosion/scour	34+90	Scour behind rootwad
PA28	Bank erosion/scour	39+90	Structure placement
PA29	Bank erosion/scour	40+05	Improper design and/or construction
PA30	Bank erosion/scour	41+00	Improper design and/or construction
PA31	Beaver dam	41+20	Beaver
PA32	Bank erosion/scour	41+30	Improper design and/or construction
PA33	Structure degradation	41+60	Improper design and/or construction
PA34	Structure degradation	42+76	Improper design and/or construction

PA21 facing upstream

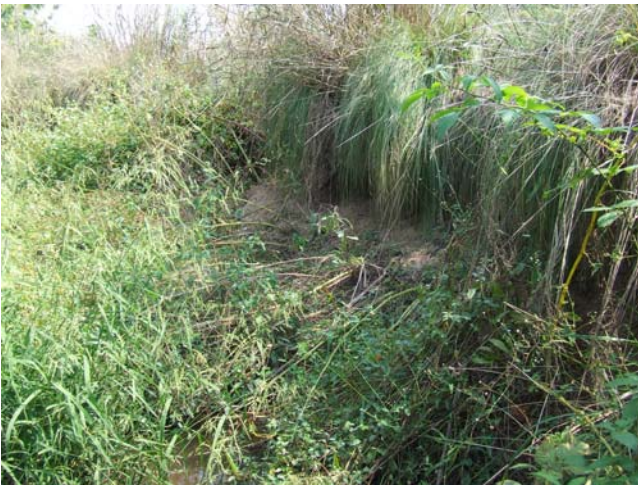
PA25 facing right bank

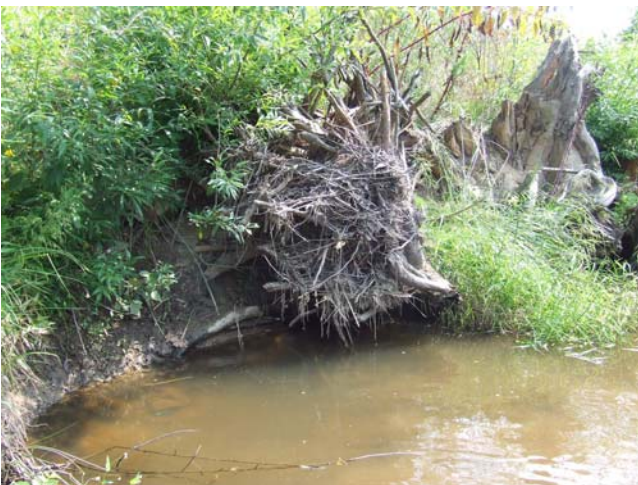
PA27 facing left bank

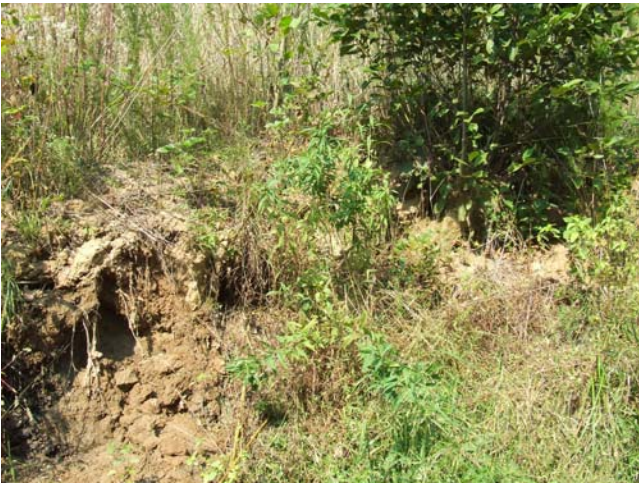
PA29 facing left bank

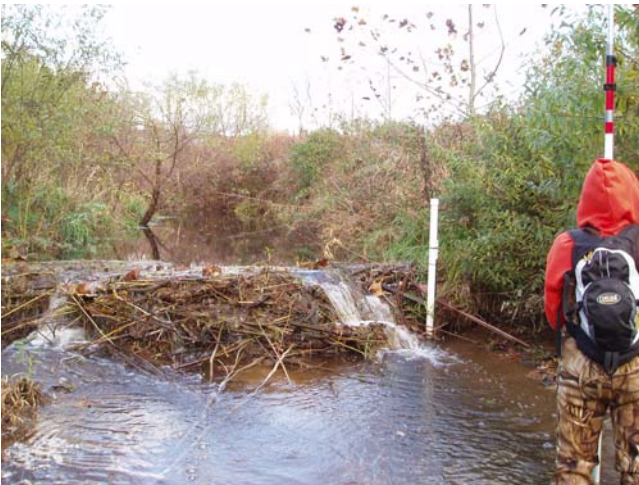
PA30	Bank erosion/scour	41+00	Improper design and/or construction	PA30
PA31	Beaver dam	41+20	Beaver	PA31
PA32	Bank erosion/scour	41+30	Improper design and/or construction	PA32
PA33	Structure degradation	41+60	Improper design and/or construction	PA33
PA34	Structure degradation	42+76	Improper design and/or construction	PA34

PA31 facing upstream (11/15/07)

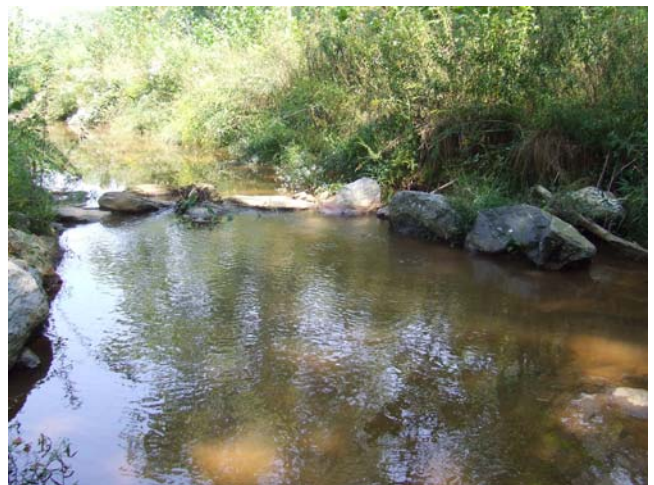
PA34 facing upstream
