MONITORING YEAR 2 ANNUAL REPORT

BUG HEADWATERS MITIGATION SITE

Wilkes County, NC
Yadkin River Basin
HUC 03040101

DMS Project No. 100084
DMS RFP No. 16-007406 / Date of Issue: December 17,
2017
NCDEQ Contract No. 7617
USACE Action ID No. 2018-01788
DWR Project No. 2018-1273

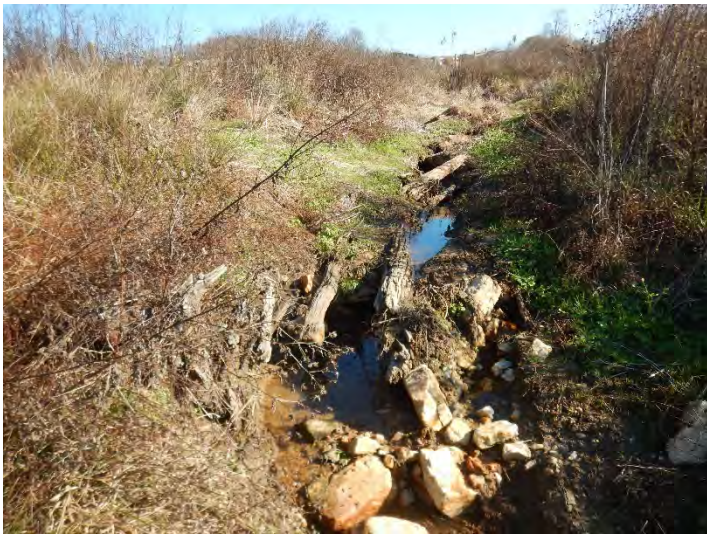
Stream Area of Concern Photographs
UT2A Reach 1
Station 400+91 - 401+419

Before – Localized Incision (11/17/2022)

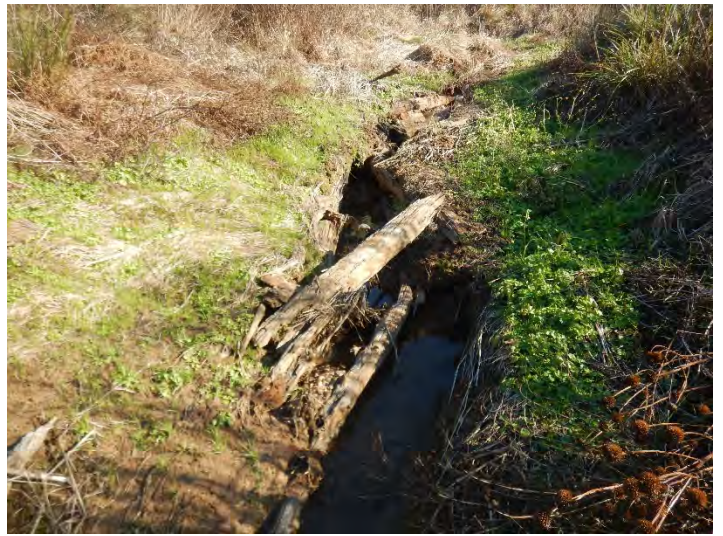
Before – Localized Incision (11/17/2022)

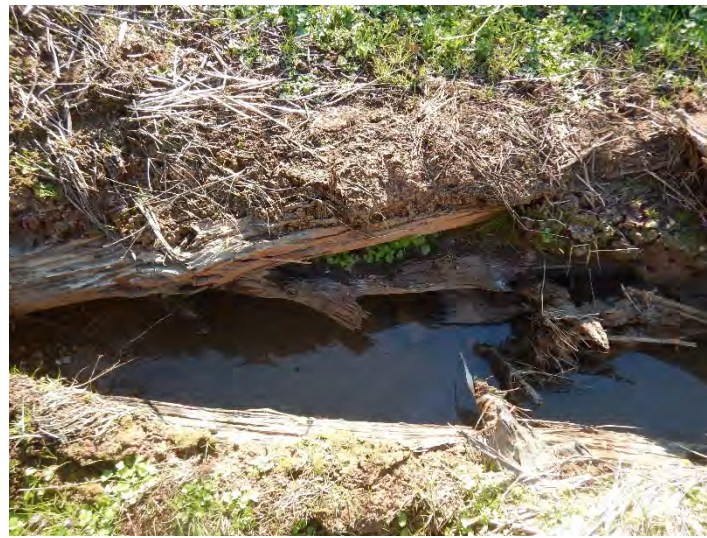
Before – Localized Incision (11/17/2022)
