**CANDIFF CREEK RESTORATION PROJECT**  
**ANNUAL MONITORING REPORT FOR 2012 (YEAR 1)**

**EEP Project Number: 92767**

**January 2013**  
**FINAL**

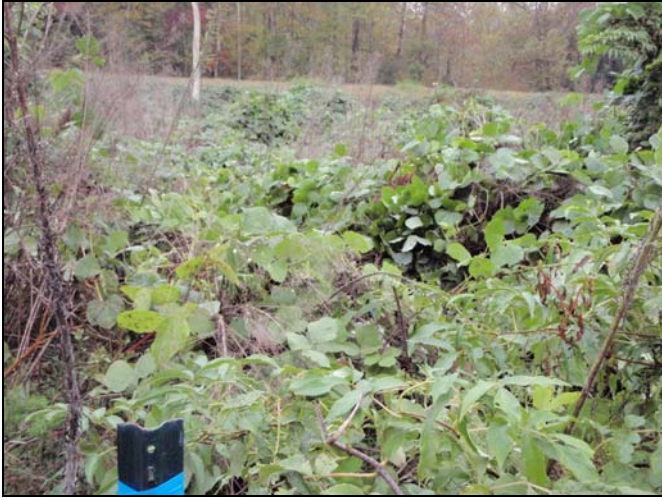
Vegetation Plot 13

During Year 1 monitoring, kudzu (*Pueraria montana*) was observed on the Site in the vicinity of vegetation Plot 13. This concentration of kudzu is located on the upstream portion of Reach M1, downstream of River-Siloam road. This area of kudzu was previously treated during construction. This area of kudzu is scheduled to be treated again during the appropriate time(s) in 2013.

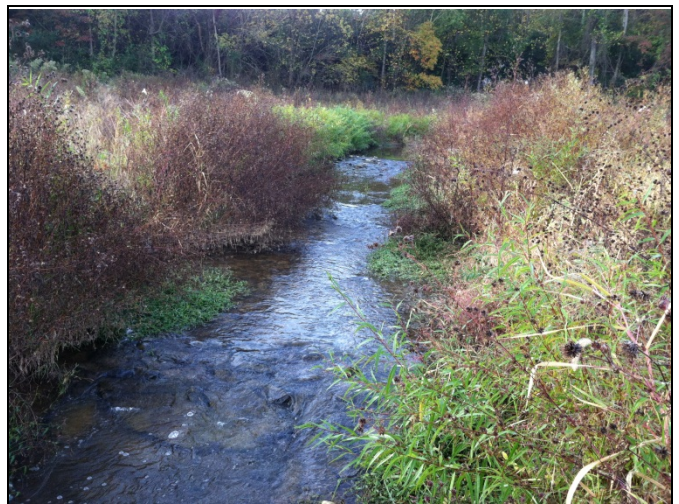
PP 6 STA 58+85, Constructed Riffle

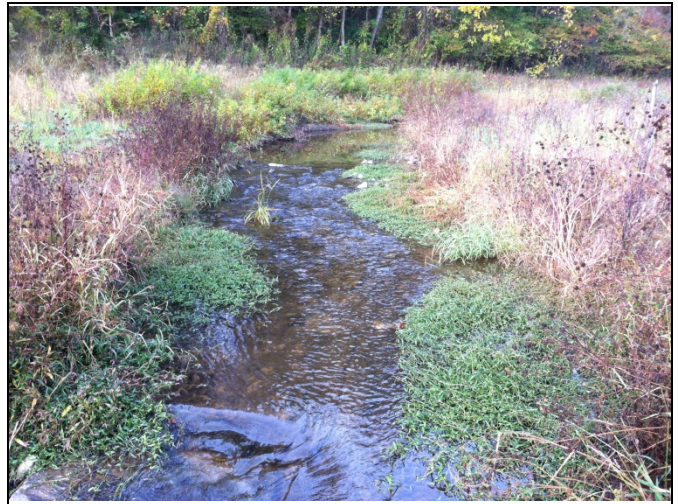
PP 10 STA 56+50, Constructed Riffle

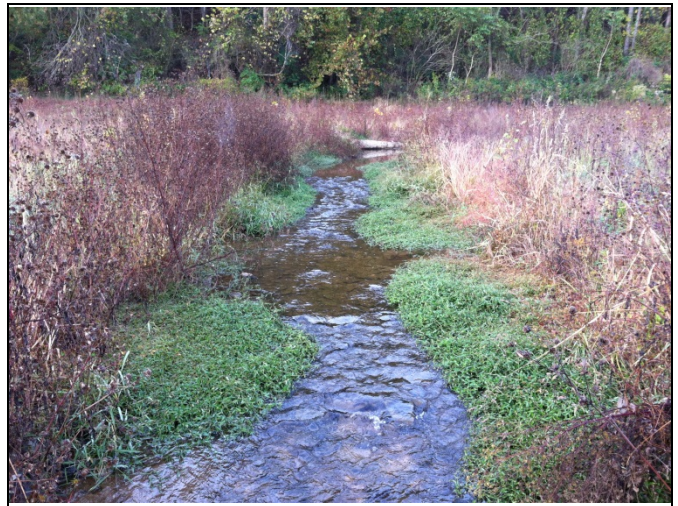
PP 18 STA 50+40, Constructed Riffle

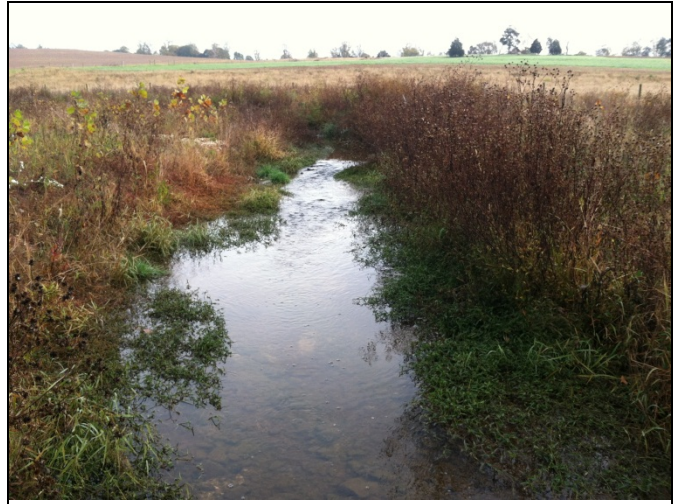
PP 20 STA 48+75, Constructed Riffle

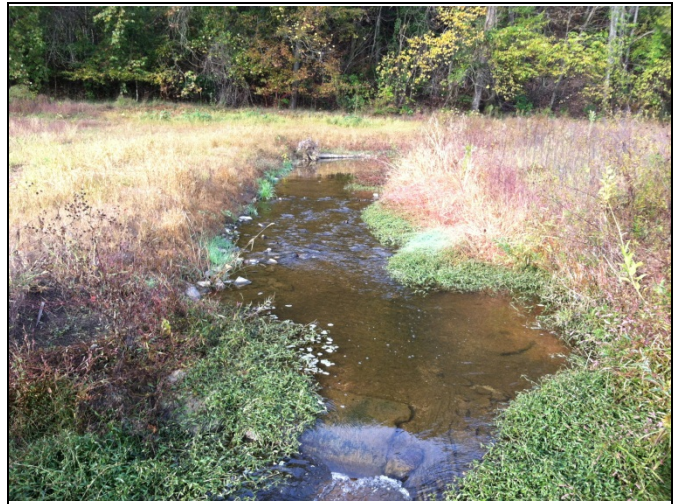
PP 22 STA 47+25, Constructed Riffle
