CANDIFF CREEK RESTORATION PROJECT
ANNUAL MONITORING REPORT FOR 2014 (YEAR 3)

EEP Project Number: 92767

Prepared by: Michael Baker International

January 2015
FINAL

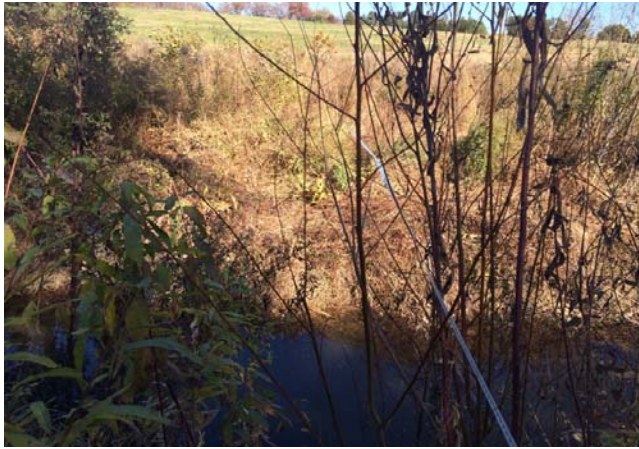
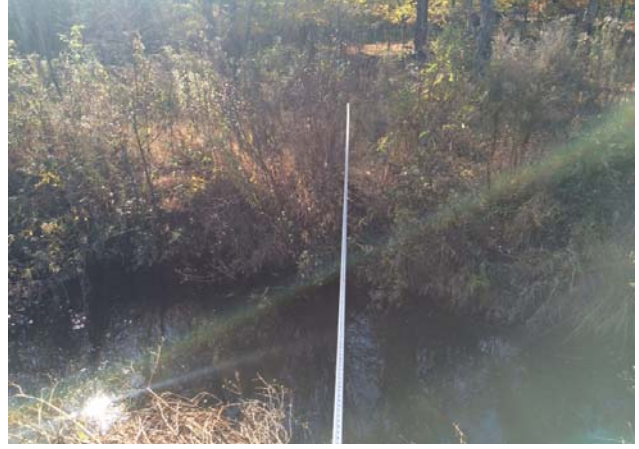
Permanent Cross-section 2

Feature	Stream Type	BKF Area	BKF Width	BKF Depth	Max BKF Depth	W/D	BH Ratio	ER	BKF Elev	TOB Elev
Pool		31.9	13.49	2.37	3.63	5.7	1.1	11.4	816.08	816.26

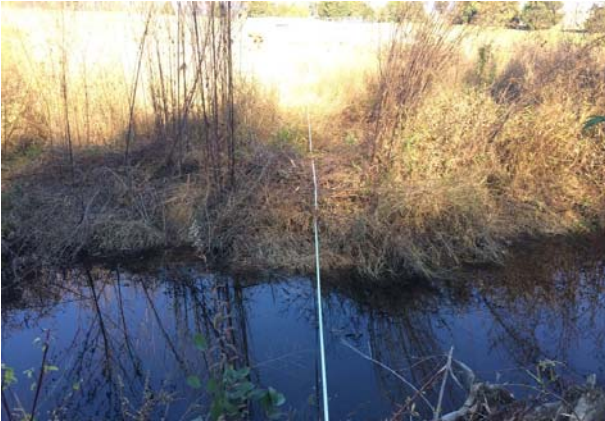
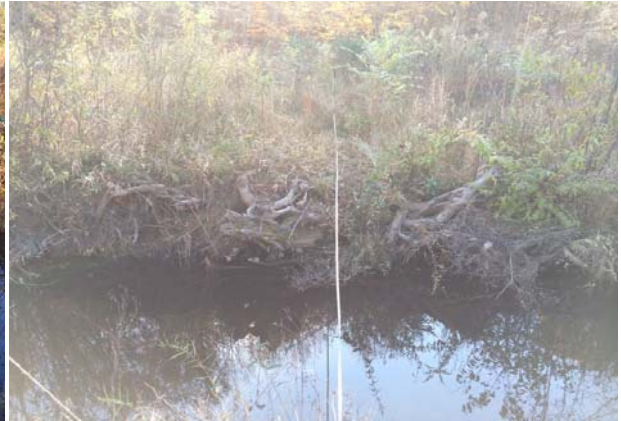
Permanent Cross-section 3

Feature	Stream Type	BKF Area	BKF Width	BKF Depth	Max BKF Depth	W/D	BH Ratio	ER	BKF Elev	TOB Elev
Pool		50.1	18.03	2.78	4.42	6.48	1.0	6.9	813.37	813.45

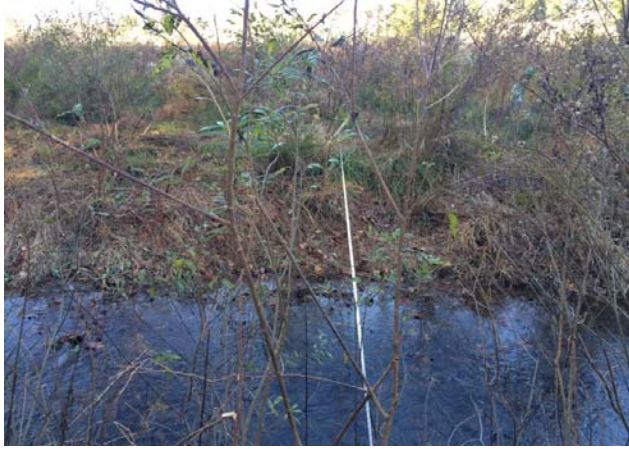
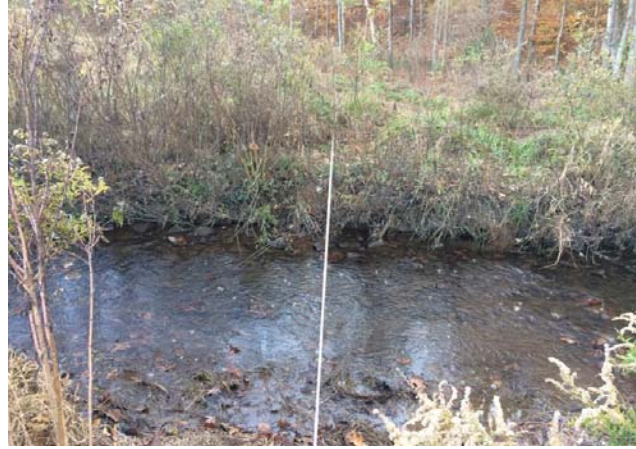
Permanent Cross-section 4

Feature	Stream Type	BKF Area	BKF Width	BKF Depth	Max BKF Depth	W/D	BH Ratio	ER	BKF Elev	TOB Elev
Riffle	C	30.2	25.62	1.18	2.21	21.77	1	4.7	810.63	810.58

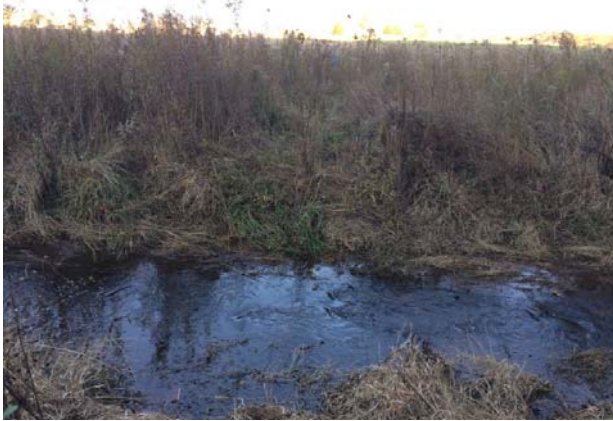
Permanent Cross-section 6

Looking at the Left Bank

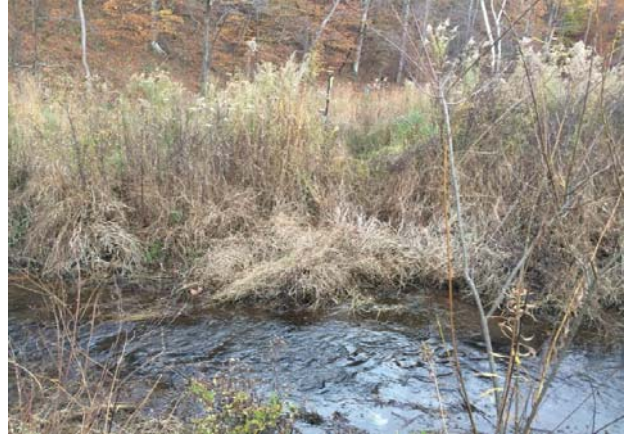
Looking at the Right Bank

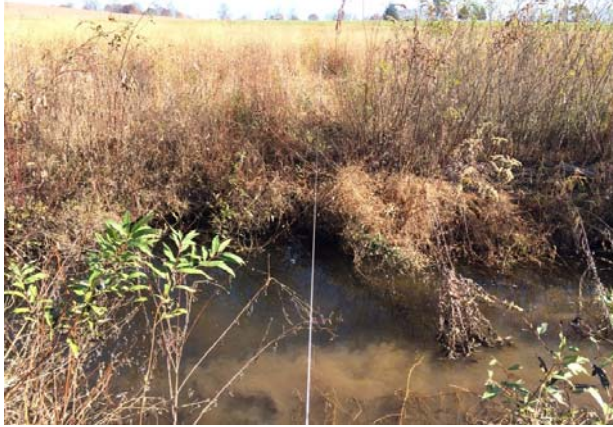
Permanent Cross-section 7

Looking at the Left Bank

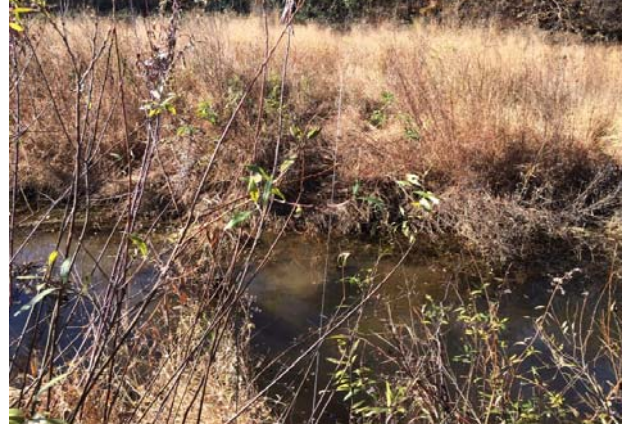
Looking at the Right Bank

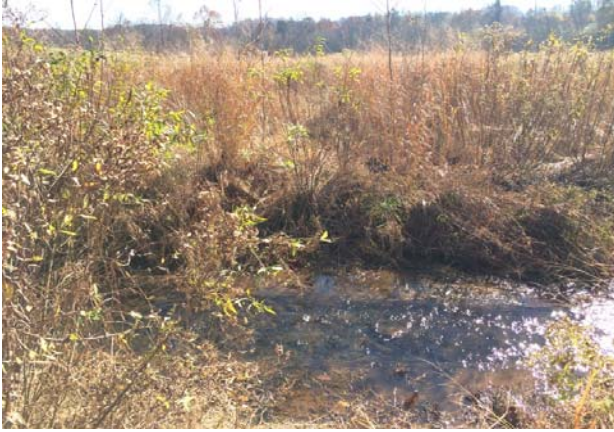
Permanent Cross-section 8

Looking at the Left Bank

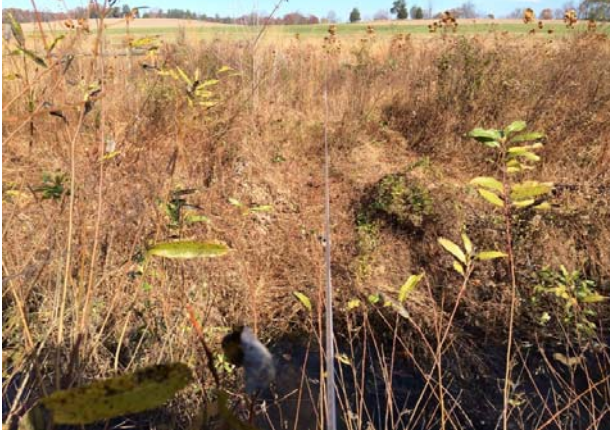
Permanent Cross-section 9

Looking at the Left Bank

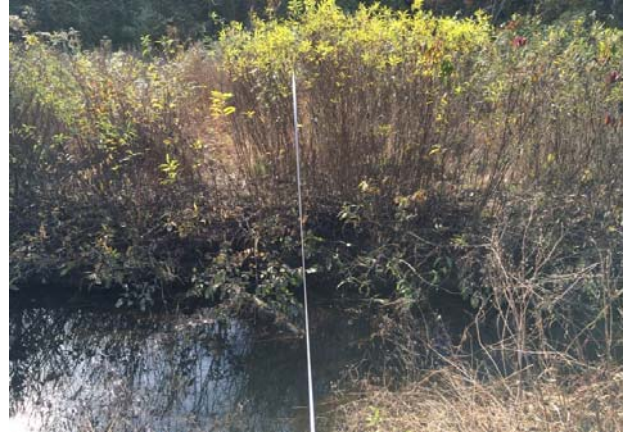
Looking at the Right Bank

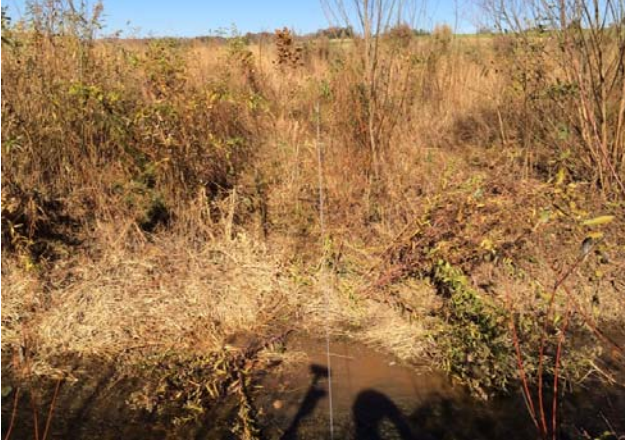
Permanent Cross-section 10

Looking at the Left Bank

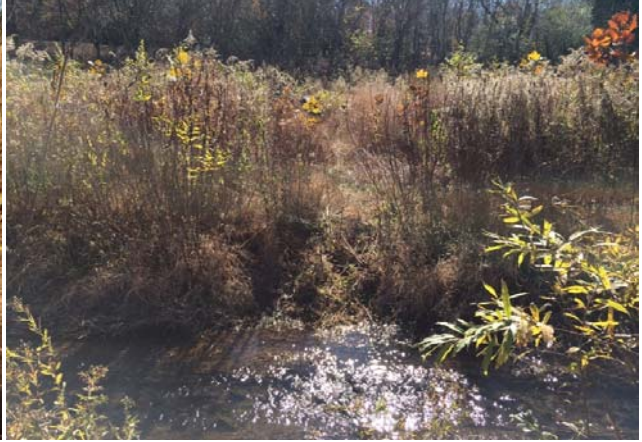
Looking at the Right Bank

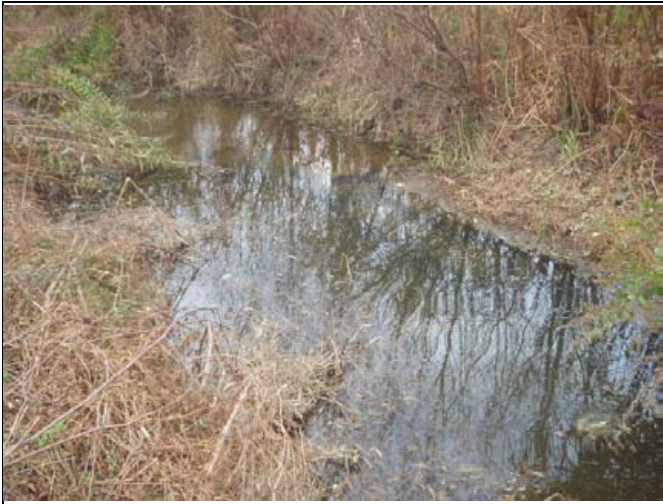
PP 3 STA 60+25, Rock J-Hook

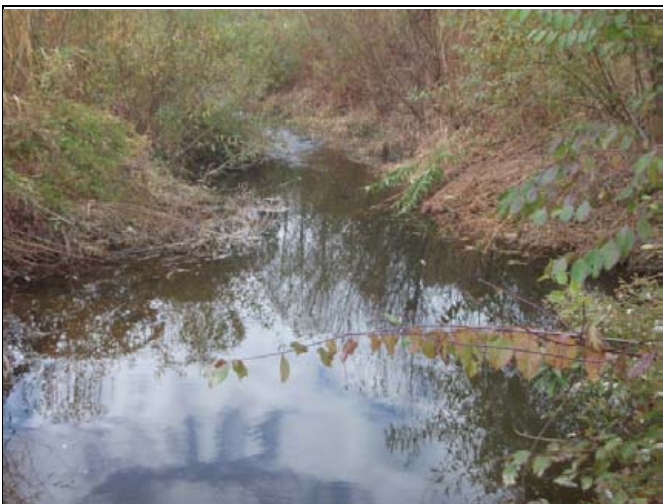
PP 5 STA 59+10, Log J-Hook

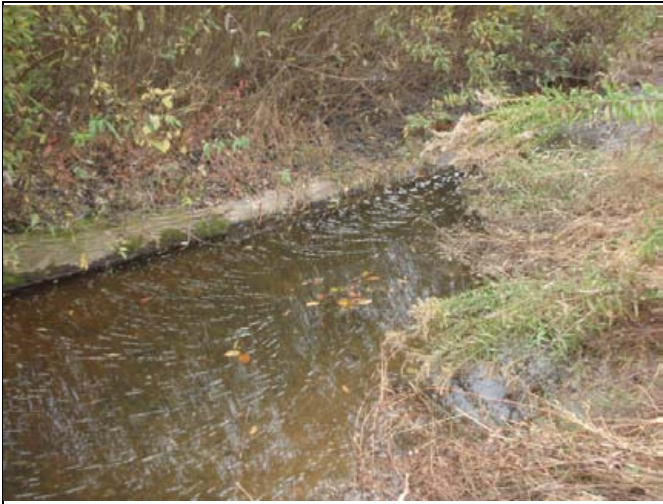
PP 7 STA 57+65, Log J-Hook

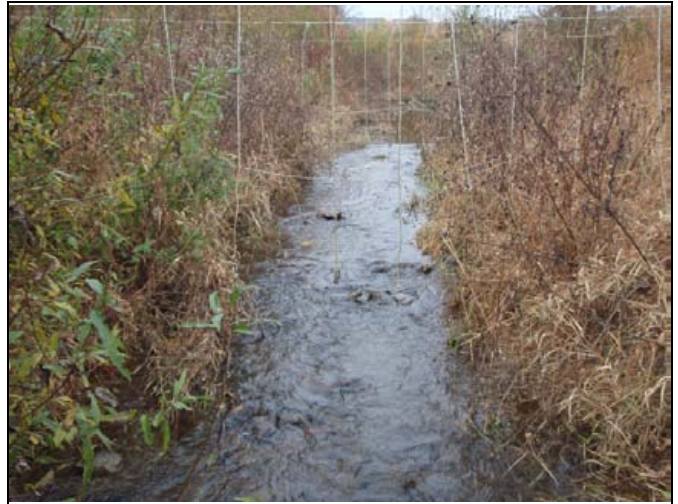
PP 8 STA 57+50, Stream Crossing

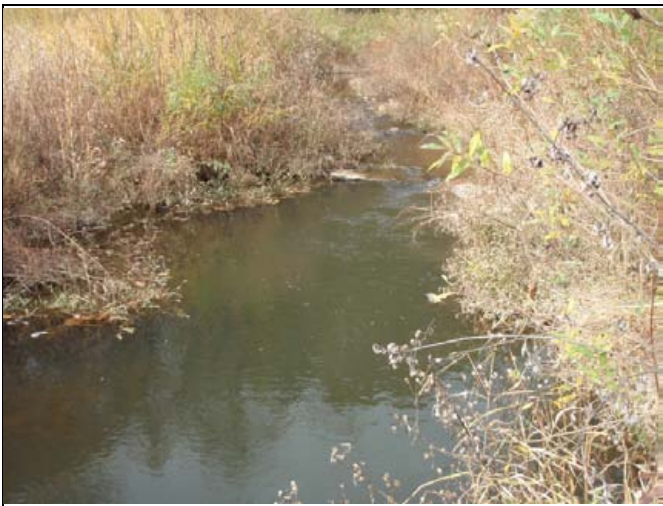
PP 9 STA 56+70, Log J-Hook

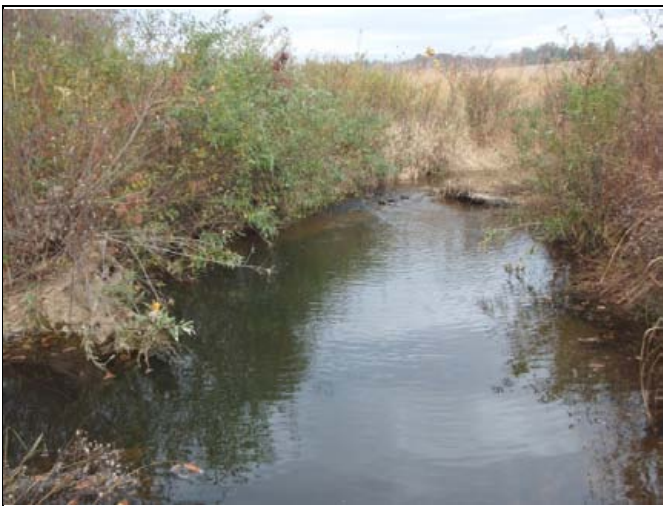
PP 11 STA 55+40, Log J-Hook

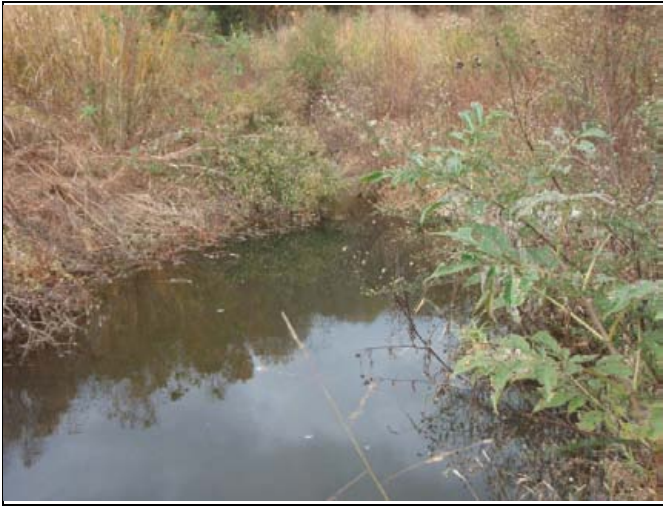
PP 13 STA 53+95, Rock J-Hook

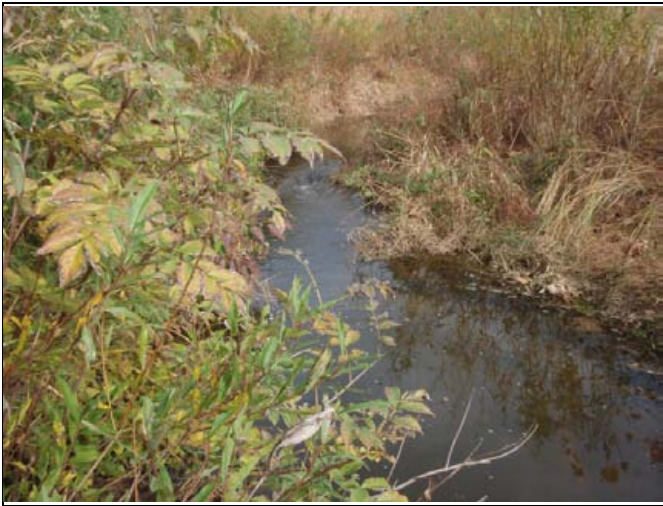
PP 15 STA 52+35, Log J-Hook

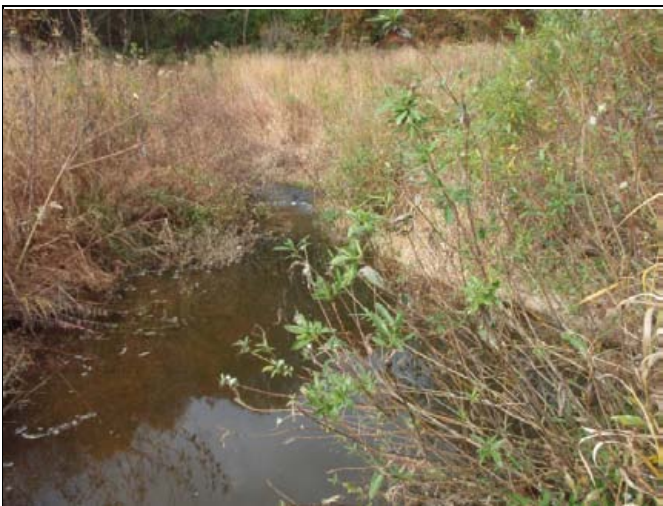
PP 17 STA 50+75, Log J-Hook

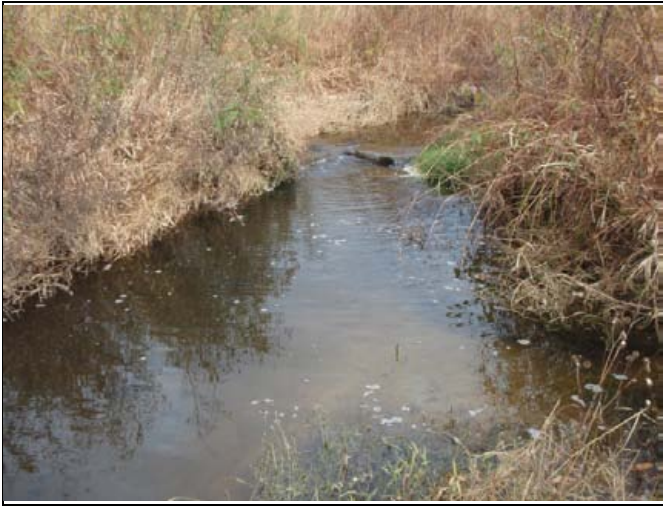
PP 19 STA 49+15, Log J-Hook

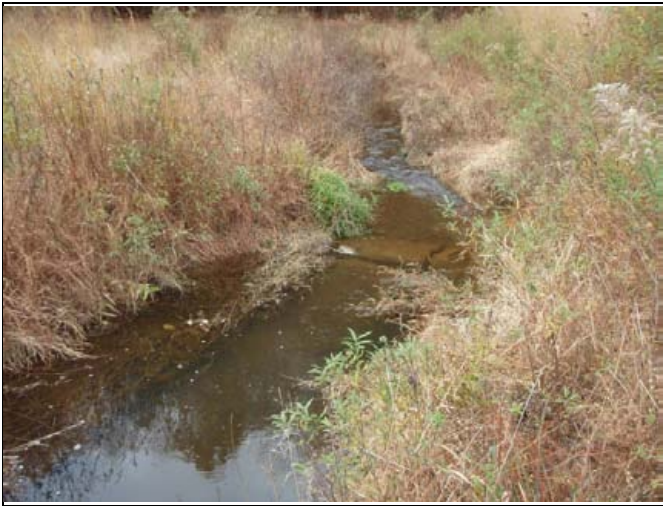
PP 21 STA 47+50, Log J-Hook

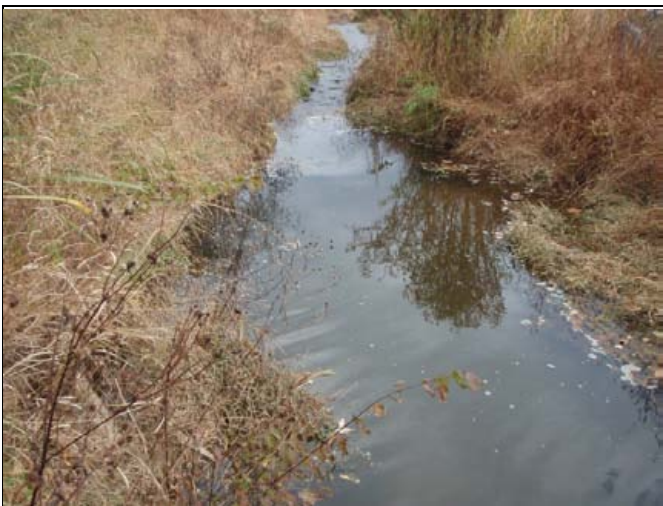
PP 23 STA 46+15, Log J-Hook
