CANDIFF CREEK RESTORATION PROJECT
ANNUAL MONITORING REPORT FOR 2016 (YEAR 5)

NCDEQ-DMS Project Number: 92767

November 2016
FINAL

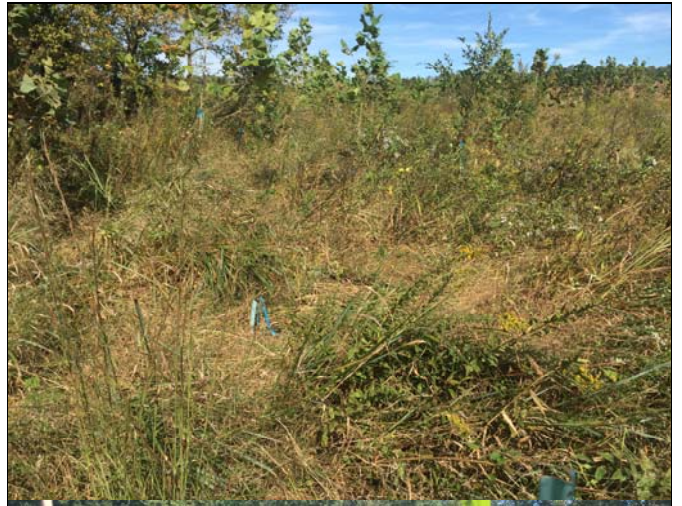
Vegetation Plot 4

During Year 5 monitoring, volunteer species including tulip poplar (*Liriodendron tulipifera*) and redbud (*Cercus canadensis*) were noted in plots 8 and 4, respectively.

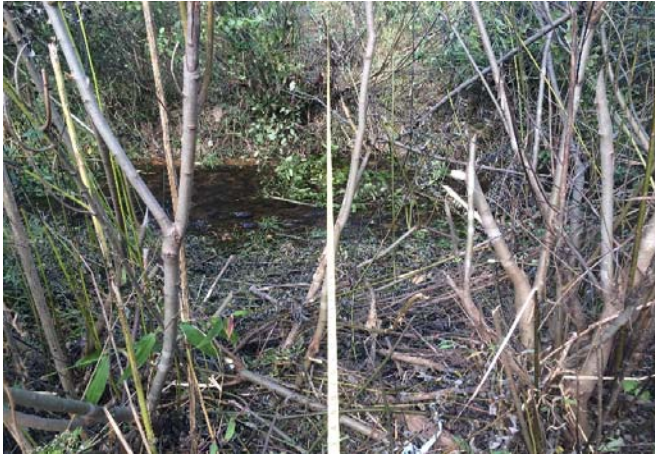
Permanent Cross-section 1

Looking at the Left Bank

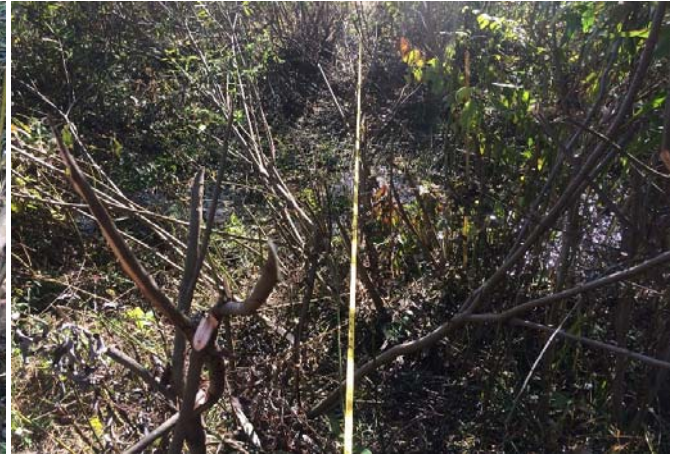
Looking at the Right Bank
