# MONITORING YEAR 6 ANNUAL REPORT

## CANDY CREEK MITIGATION SITE

Guilford County, NC  
NCDEQ Contract 5794  
NCDMS Project Number 96315  
USACE Action ID Number 2015-01209  
DWR Project Number 14-0334  
RFP Number 16-005568

Data Collection Period: February - October 2022  
Draft Submission Date: November 2022  
Final Submission Date: February 2023

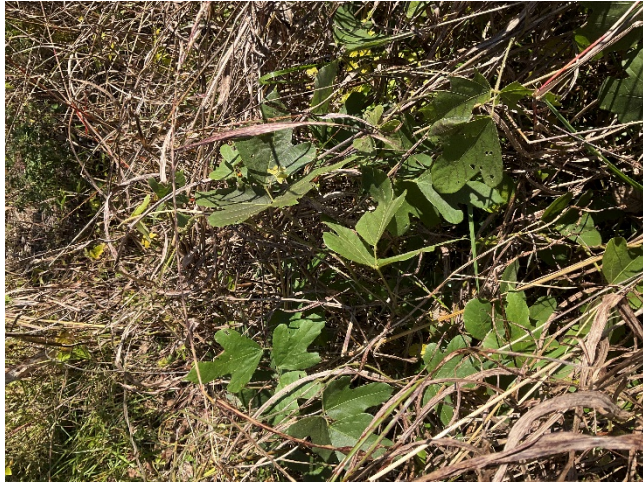
Candy Creek Reach 4 - Kudzu (Sta. 201+50) (10/18/2022)

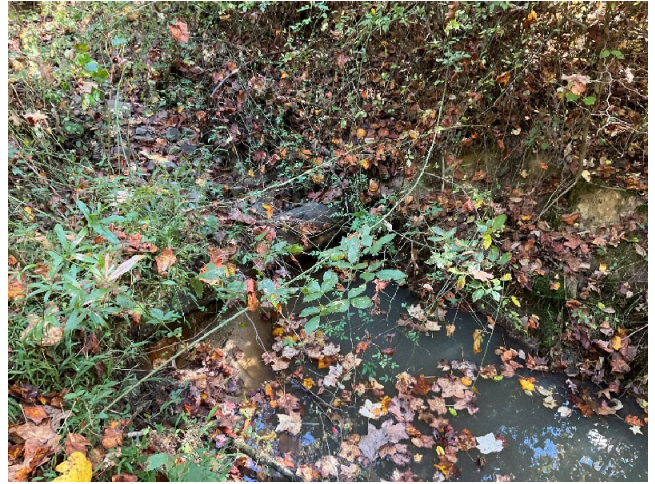
UT1C - Structure issue, piping (Sta. 206+04) (10/21/2022)

1. As discussed in the field, failing structures on EII reaches that meet the reporting threshold need to be discussed and included in the report/CCPV/tables.
2. Section 1.2.2: Repairs on UT1C have not been completed, please update the narrative and include future repair plan.

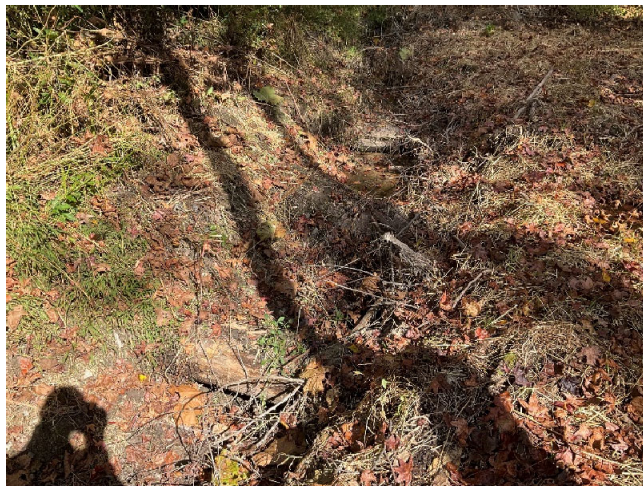
UT1D - Structure issue, piping (Sta.253+00) (10/21/2022)

5. Walked to UT1D where there are a series of failed structures that are piping underneath
  - a. Piping structures (~STA~253+00); repair work is also planned for the same period of the fall/winter of 2021.

- i. Suspected cause is the increased elevation change where the flatter headwaters ties into the lower elevation of the main channel. The steeper grade likely undercut the structures.

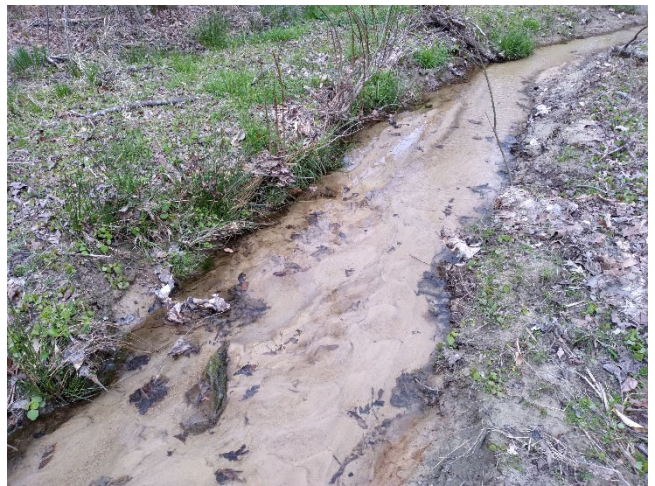
UT5 - Aggradation (Sta. 600+75) (03/30/2022)

10. Drove upstream to Candy R1 and UT5.
11. Walked part of UT5 (~STA604+00-608+00).
  - a. The aggradation on this channel and how to report it was discussed in detail. The main take away is that the aggradation and sedimentation in the channel that was observed was not negatively impacting the overall structure or function of the stream.

- b. The sedimentation was mostly within the banks, but some was also on the floodplain. Its structure was coarse sand. The source is suspected to have come from off-site as no erosive areas have been observed within the easement. There are several farm ponds upstream of the project (above UT5-preservation) that drain a large agricultural tract and could have provided the sediment load, as could have an overflowing or breached pond dam (although no direct source has been confirmed).

- c. For the effects on the stream, it was noted that while the pools are filling with some sand, the stream is functioning more like a sand-bed stream. The pools are present but shallow, and the sediment is not collecting or burying the riffles as noted by the macroinvertebrates present today on the riffle substrate.

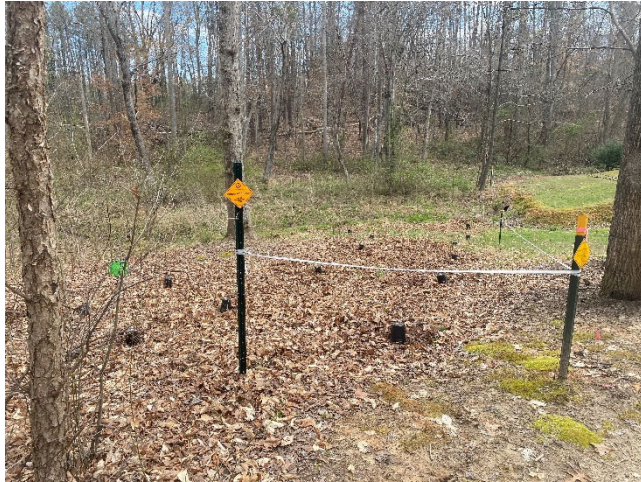
Candy Creek Reach 1 - Easement encroachment replanting  
(Sta. 100+00) (03/31/2022)

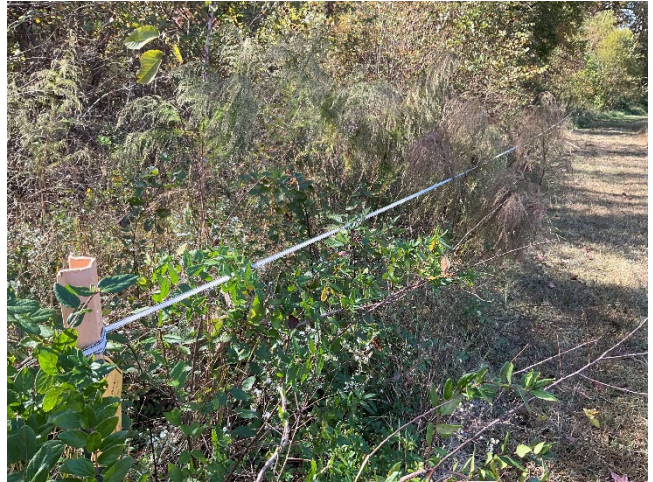
Candy Creek Reach 1 - Easement encroachment replanting,  
RB (Sta. 111+00-113+00) (10/21/2022)

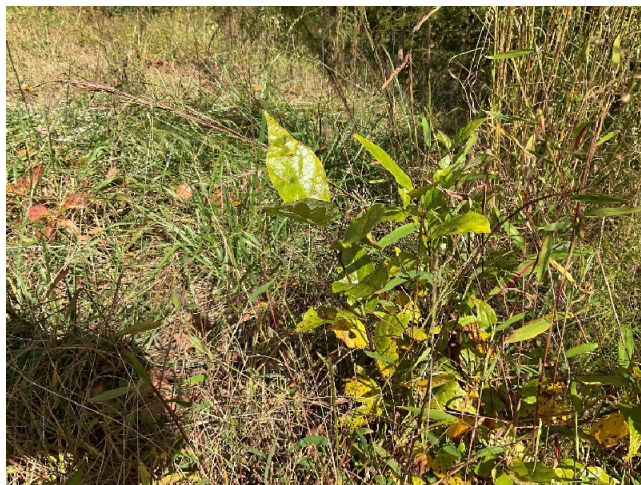
Candy Creek Reach 3 - Easement encroachment replanting  
at Hopkins Road,  
LB (Sta. 149+00-150+00) (10/19/2021)
