MONITORING YEAR 1 ANNUAL REPORT FINAL

CARPENTER BOTTOM MITIGATION SITE

Gaston County, NC
Catawba River Basin
HUC 03050102
(03050103 Expanded Service Area)

DMS Project No. 100090
NC DEQ Contract No. 7731
DMS RFQ No. 16-007133-CT03
Date of Issue: April 24, 2017
USACE Action ID No. SAW-2018-02062
DWR Project No. 2019-0049
Data Collection Dates: March – November 2022

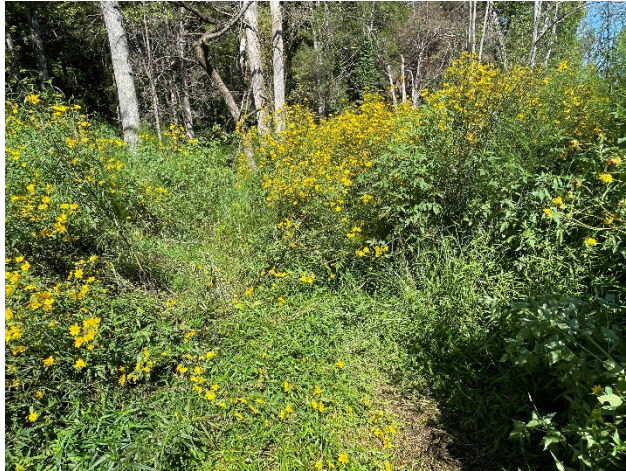
approximately 27-feet, they are small enough that the targeted forest community can easily provide a closed canopy over these areas. Additionally, floodplain pools 3 and 4 were delineated as Wetlands D and B, respectively, and were protected during construction; the vegetative and hydrologic conditions of these two pools should not pose a concern—even if they were to have some surface water—as their hydrologic functionality and their vegetation communities are assumed to be comparable to the existing conditions. Refer to the CCPV figures for the locations of the floodplain pools. A photo log is included in Appendix A to show the conditions of each of these pools, but because they do not pose a concern, the photo log will not be included in subsequent monitoring years.

PHOTO POINT 3 - Carpenter Bottom R1 - Floodplain Pool (8/31/2022)

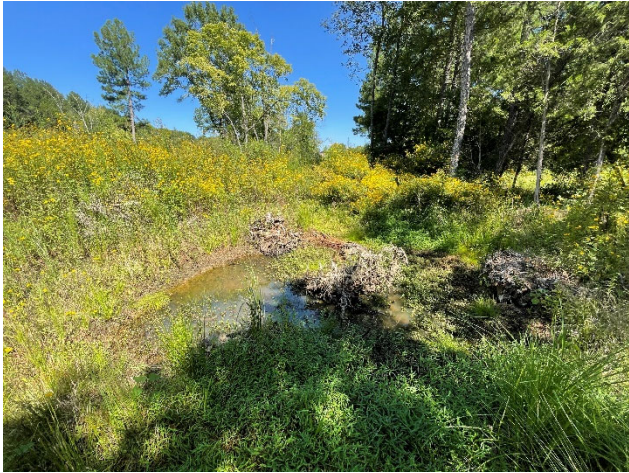
FLOODPLAIN POOL 1 (FP1):
Maximum water depth: 0.50 feet.
(8/31/2022)

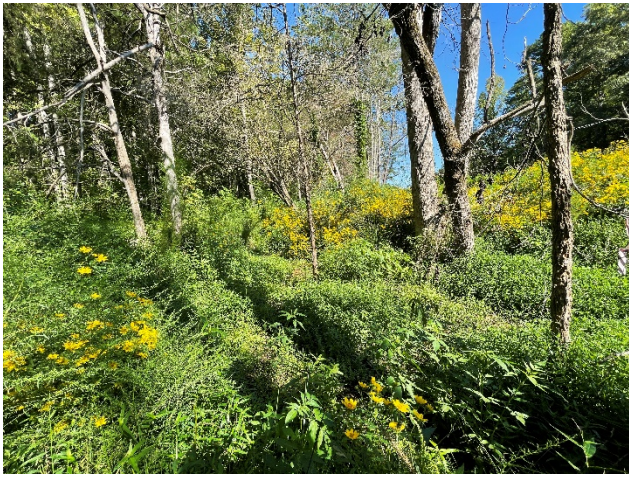
FLOODPLAIN POOL 3 (FP3):
Maximum water depth: 0.00 feet (i.e., dry).
(8/31/2022)
