MONITORING YEAR 2 ANNUAL REPORT FINAL

CARPENTER BOTTOM MITIGATION SITE

Gaston County, NC
Catawba River Basin
HUC 03050102
(03050103 Expanded Service Area)

DMS Project No. 100090
NC DEQ Contract No. 7731
DMS RFQ No. 16-007133-CT03
Date of Issue: April 24, 2017
USACE Action ID No. SAW-2018-02062
DWR Project No. 2019-0049
Data Collection Dates: January – November 2023

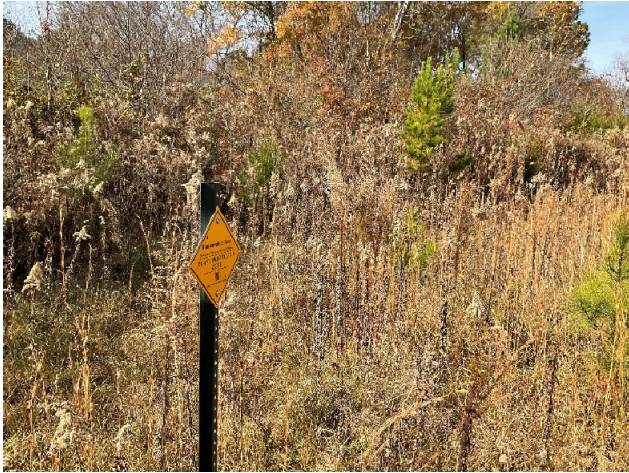
Encroachment 1 – Resolved mowing encroachment in upstream floodplain (11/14/2023)

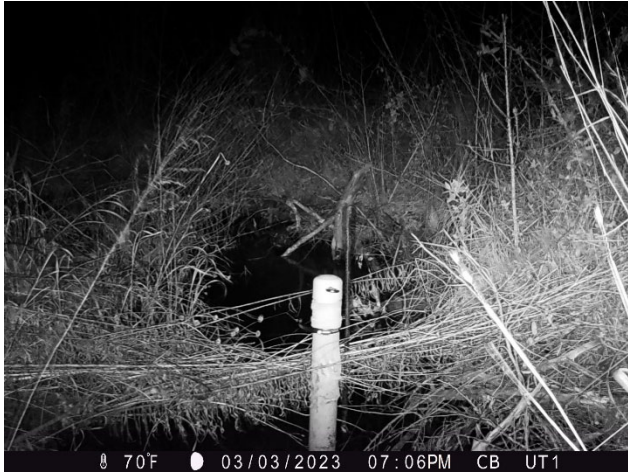
Photo 1 – UT1 – High flow, above thalweg but below bankfull (7PM) (03/03/2023)

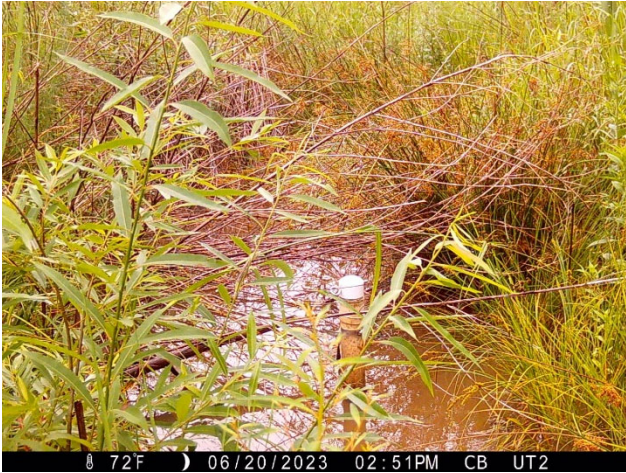
Photo 6 – UT2 – High flow, above thalweg but below bankfull (3PM) (06/20/2023)

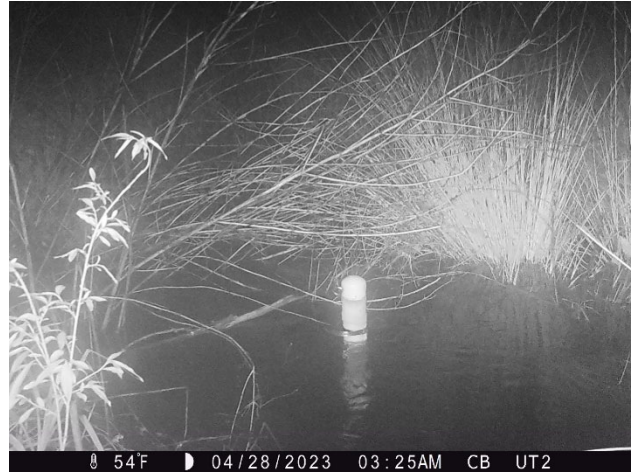
Photo 7 – UT2 – Bankfull event (3AM) (04/28/2023)

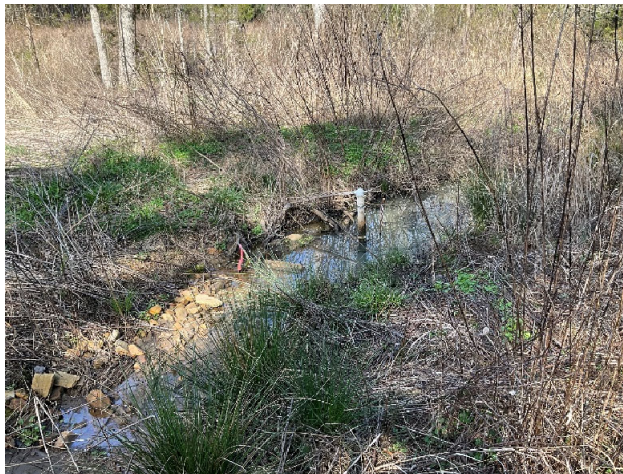
Photo 10 – UT2 – Photo point 10 confirming flow (03/06/2023)
