**CEDAR CREEK STREAM AND WETLAND RESTORATION  
PROJECT  
MONITORING REPORT  
MONITORING YEAR 3  
FINAL**

SAMPSON COUNTY, NORTH CAROLINA  
CONTRACT No. 005011 - PROJECT No. 95718  
USACE ACTION ID No. 2012-00389 – NCDWR PROJECT No. 2013-0186

RE: Cedar Creek Stream and Wetland Restoration Site: MY3 Monitoring Report  
(NCDMS ID 95718)

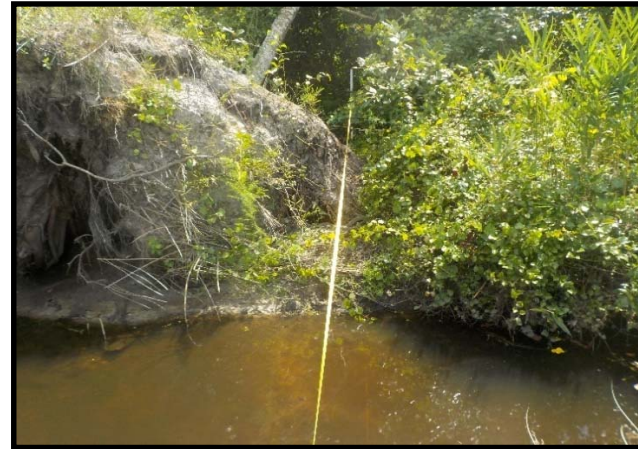
Left Bank \*Note Downed Tree
