MONITORING YEAR 1 ANNUAL REPORT

COOL SPRINGS MITIGATION SITE

Harnett County, NC
Cape Fear River Basin
HUC 03030004

DMS Project No. 100166
NCDEQ Contract No. 0302-02
DMS RFP No. 16-20190302/Issued: December 20, 2019
USACE Action ID No. SAW-2020-01400
DWR Project No. 2020-1279

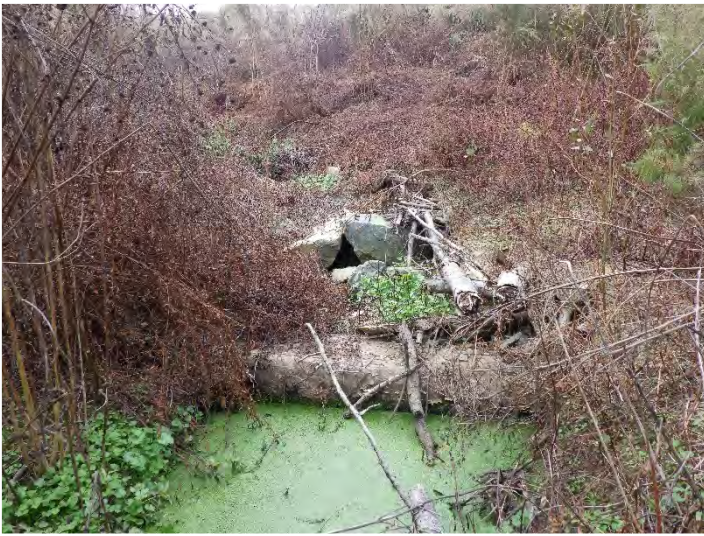
Photo Point 8 T2 – upstream (11/10/2023)

Within the bottom half of T2 adjacent to photo point 8, water is piping around a series of structures consisting of a rock sill and two log sills, resulting in scouring of the left bank and dislodging of associated brush toe (refer to Appendix A for Stream Area of Concern Photographs). The affected area is approximately 24 linear feet in length (see Figure 1a). Hand repairs are planned to take place during MY2 and mechanical repairs will then be utilized if necessary.

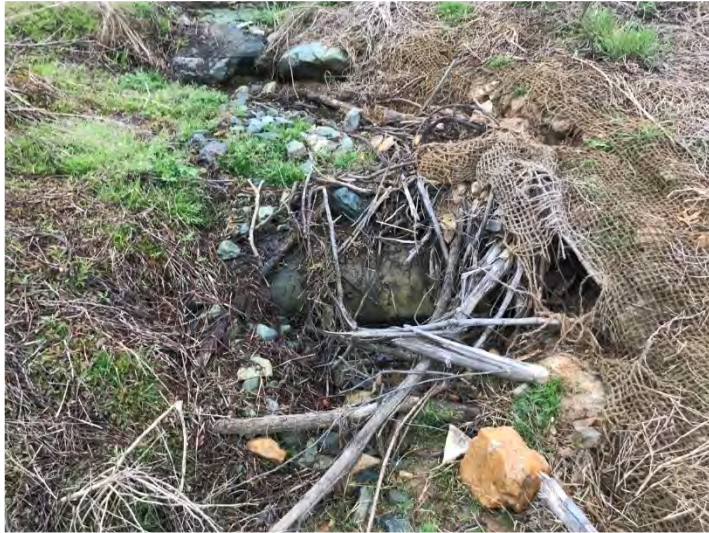
T2 STA 303+05-303+20: Before – Piping Log Sill Causing Dislodged Brush Toe and Scouring of the Left Bank (4/7/2023)

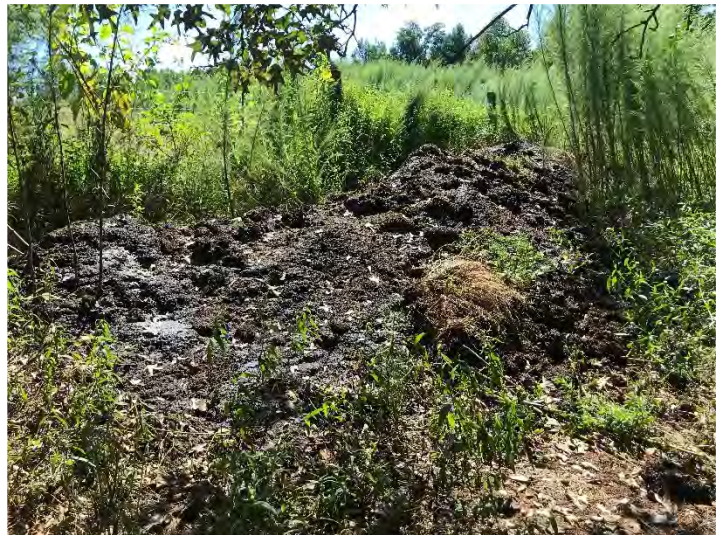
*Chicken littler has been dumped into approximately 560 square feet of the conservation easement. A landowner-prescribed fire burned approximately 1 acre of the conservation easement during April, 2023.

**Chicken Litter Pile Dumped at Fenceline Directly Perpendicular
to BMP 2 (9/1/2023)**
