MONITORING YEAR 0 ANNUAL REPORT

COOL SPRINGS MITIGATION SITE

Harnett County, NC
Cape Fear River Basin
HUC 03030004

DMS Project No. 100166
NCDEQ Contract No. 0302-02
DMS RFP No. 16-20190302/Issued: December 20, 2019
USACE Action ID No. SAW-2020-01400
DWR Project No. 2020-1279

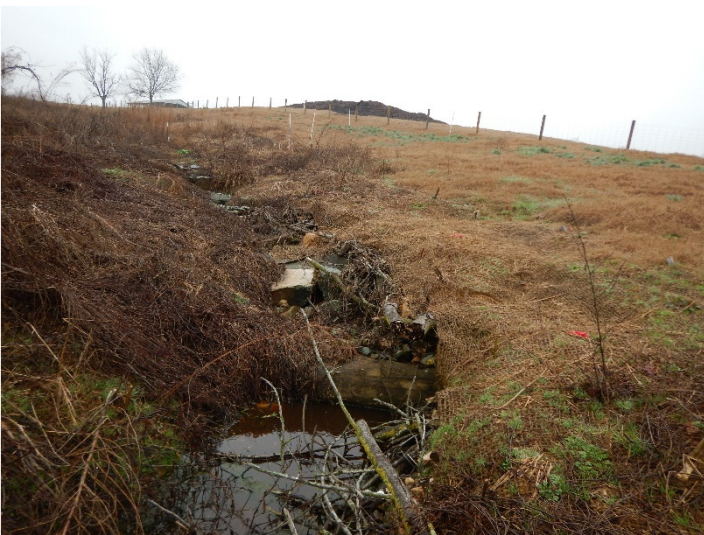
Photo Point 8 T2 – upstream (1/31/2023)

Within the bottom half of T2 adjacent to photo point 8, water is piping around a series of structures consisting of a rock sill and two log sills, resulting in scouring of the left bank and dislodging of associated brush toe (refer to Appendix A for Stream Area of Concern Photographs). The affected area is approximately 24 linear feet in length (see Figure 1a). Hand repairs are planned to take place during MY1 or MY2. If hand-repairs are unsuccessful, mechanical repairs may be utilized.

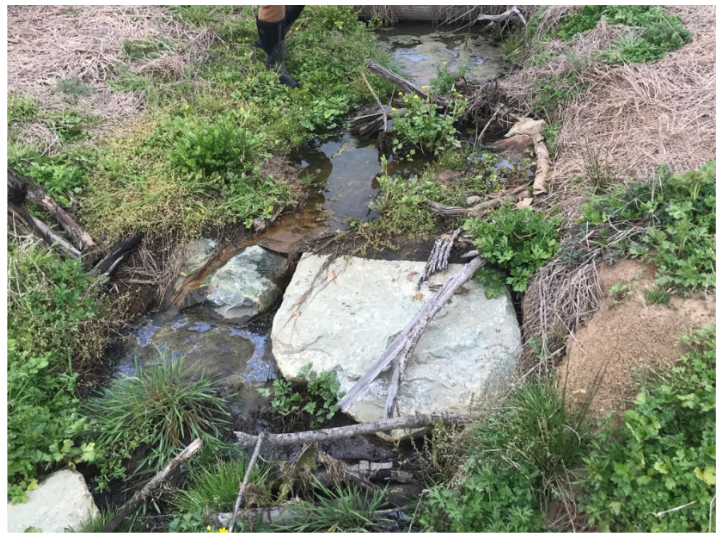
T8 STA 902+59: Before – Piping Rock Sill Causing Localized Scouring (4/7/2023)
