**Year 1 Monitoring Report**

**COWFORD PROJECT**

NCDMS Project #100095 (Contract #0007746)

**January 2023**

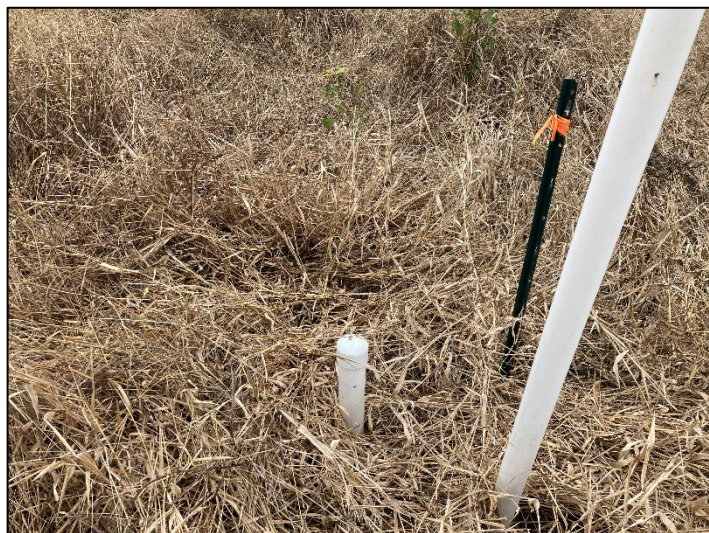
Wetland Gauge 1 (11/3/2022)

A total of five groundwater wells with automatic recording pressure transducers were installed throughout the wetland areas on November 2<sup>nd</sup>, 2021, and April 28<sup>th</sup>, 2022. All five groundwater wells failed to meet success of 12-16 percent of the growing season (GW1 0%, GW2 1%, GW3 7%, GW4 4%, and GW5 5%) **Appendix E**. It is important to note that GW5 is located outside of the wetland crediting area. Although all five groundwater wells did not meet success, it was noted that due to extensive draining efforts that it may take at least a year for the site to become completely saturated and reach the target hydroperiods. Onslow county has experienced drought conditions for more than 70% of 2022 and rainfall amounts in February and June were below normal limits which could have attributed to lower hydroperiods. Therefore, RES expects the hydroperiods to increase in subsequent years as the wetlands continue to establish.

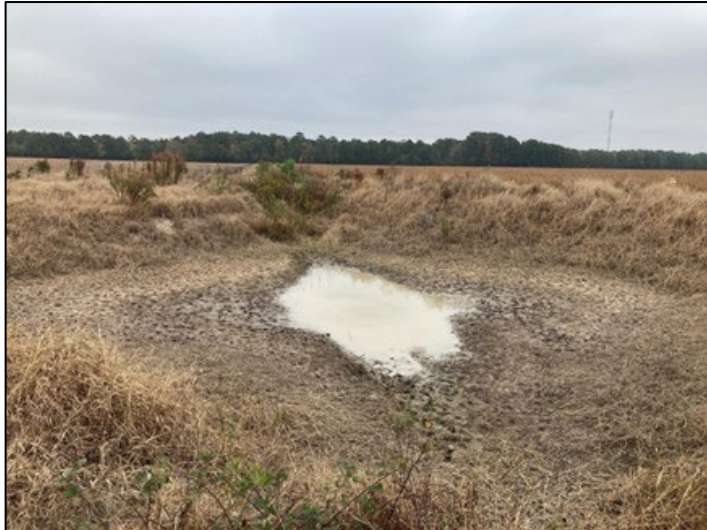
Photo Point 3: Treatment pool at edge of Wetland (11/3/2022)

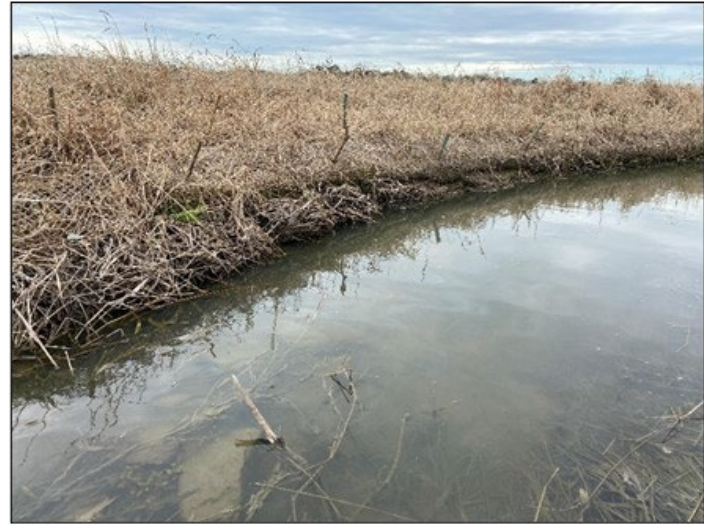
Haybale brush toe in BJ1-B (3/16/2022)

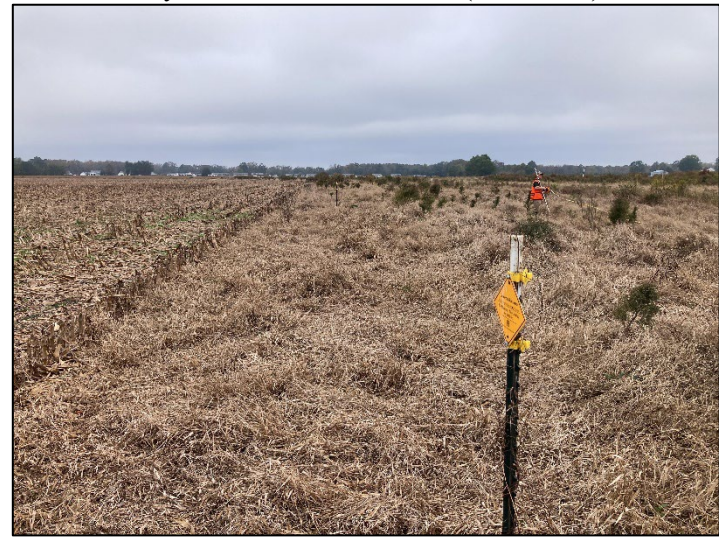
Easement marker (11/3/2022)
