Year 2 Monitoring Report

COWFORD PROJECT

NCDMS Project #100095 (Contract #0007746)
USACE Action ID: SAW-2019-00487
DWR Project #2019-0495

Onslow County, North Carolina
White Oak River Basin
HUC 03030001

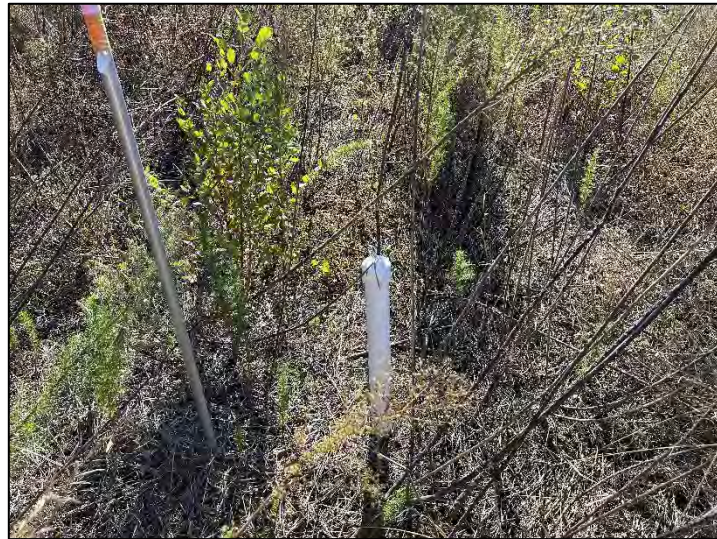
Wetland Gauge 2 (11/2/2023)

A total of five groundwater wells with automatic recording pressure transducers were installed throughout the wetland areas on November 2nd, 2021, and April 28th, 2022. All five groundwater wells failed to meet success of 12-16 percent of the growing season (GW1 2%, GW2 2%, GW3 6%, GW4 5%, and GW5 5%) **Appendix E**. It is important to note that GW5 is located outside of the wetland crediting area. Although all five groundwater wells did not meet success again in MY2, it was noted that due to historic draining efforts it may take more than a year for the site to become completely saturated and reach the target hydroperiods. Onslow county has experienced abnormally dry and moderate drought conditions in 2022 and 2023 (**Appendix E**). Rainfall amounts in December (2022), March, April, and October were below normal limits which could have attributed to lower hydroperiods. RES expects the hydroperiods to increase in subsequent years as the wetlands continue to establish. In addition, RES plans to install supplemental groundwater wells throughout the wetland crediting area to capture a more accurate representation of the wetland hydroperiod. These wells will be installed in the upcoming dormant season. RES has provided additional full calendar year hydroperiod data in **Appendix E**. Full calendar year hydroperiods are as follows: GW1 2%, GW2 2%, GW3 12%, GW4 9%, GW5 9%.

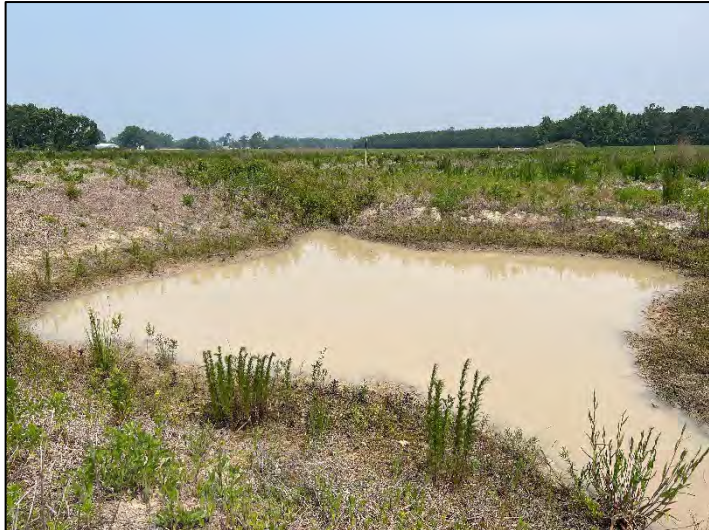
Photo Point 3: Treatment pool at edge of Wetland (6/7/2023)
