**Cox Mitigation Project
Johnston County, North Carolina**

FINAL Year 5 Monitoring Report

December 2010

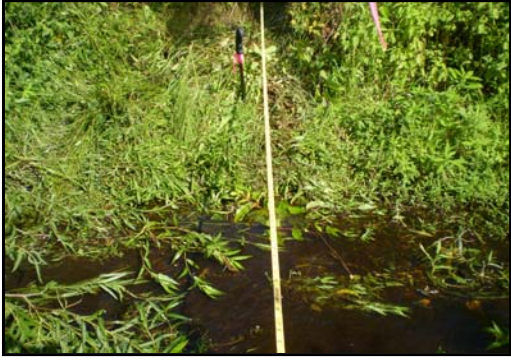
Looking at left bank.

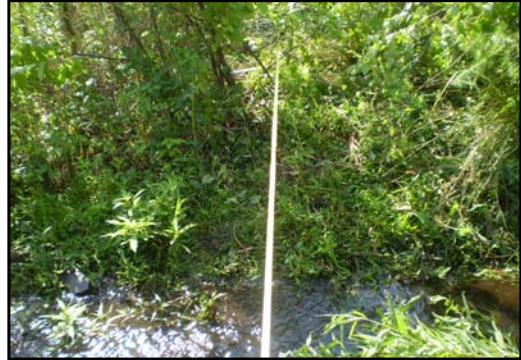
Looking at right bank.

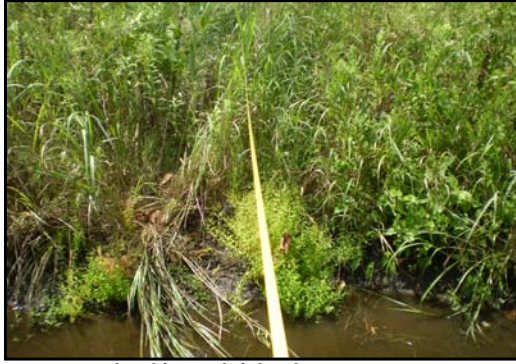
Looking at left bank.

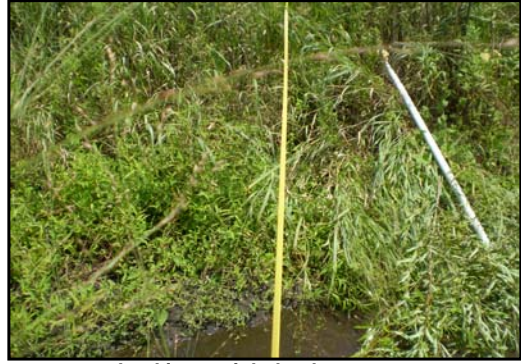
Looking at right bank.

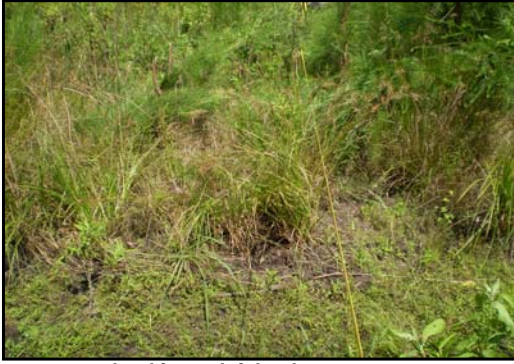
Looking at left bank.

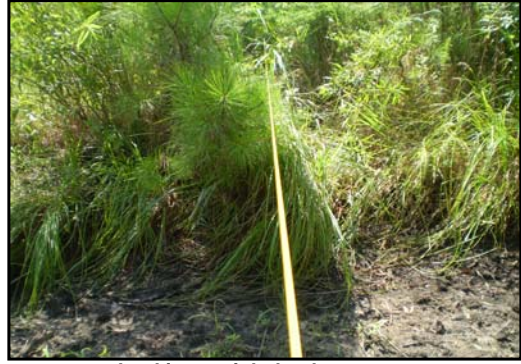
Looking at right bank.
