MY1 MONITORING REPORT

CRANE STREAM AND WETLAND MITIGATION SITE

Lee County, North Carolina
Cape Fear River Basin
Cataloging Unit 03030002

Data Collection: January 2023-November 2023
Submission: February 2024

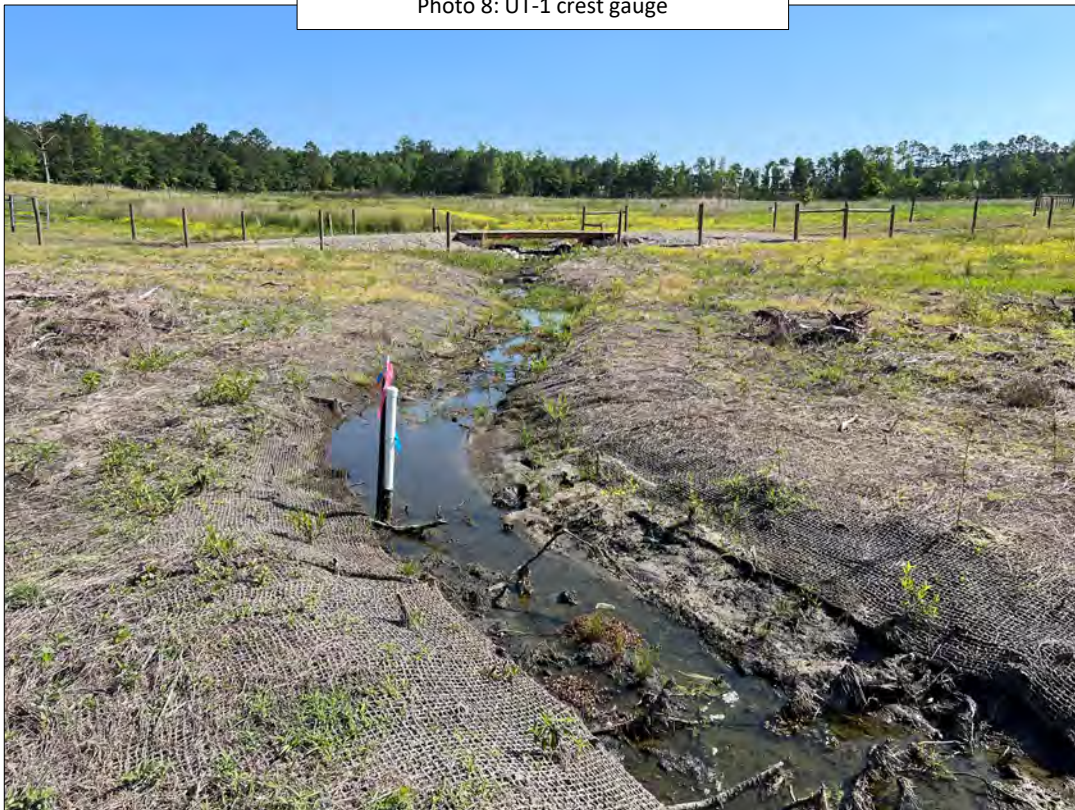
Photo 8: UT-1 crest gauge

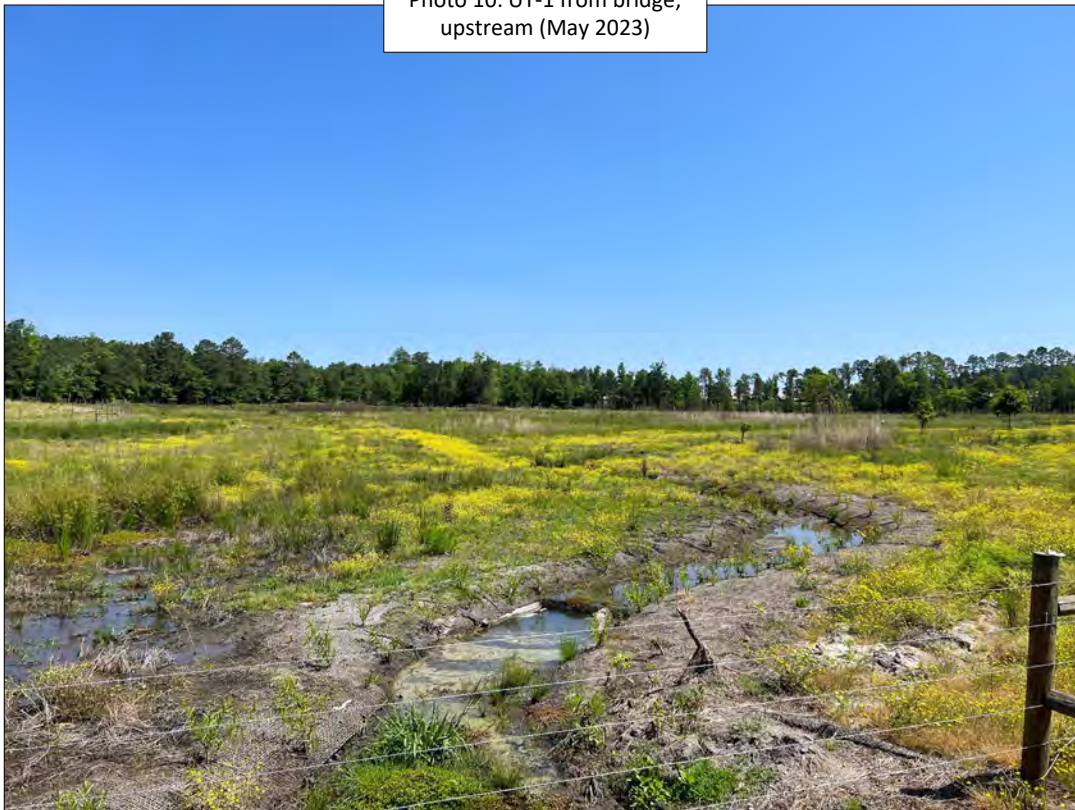
Photo 10: UT-1 from bridge;
upstream (May 2023)

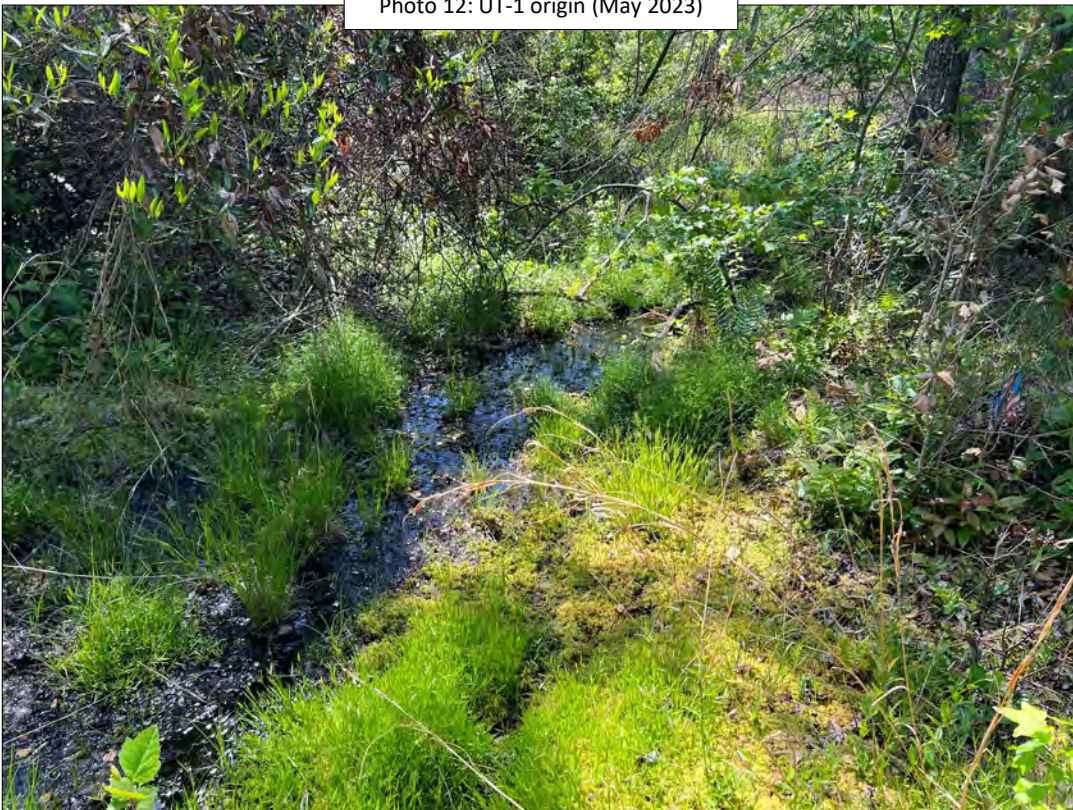
Photo 12: UT-1 origin (May 2023)

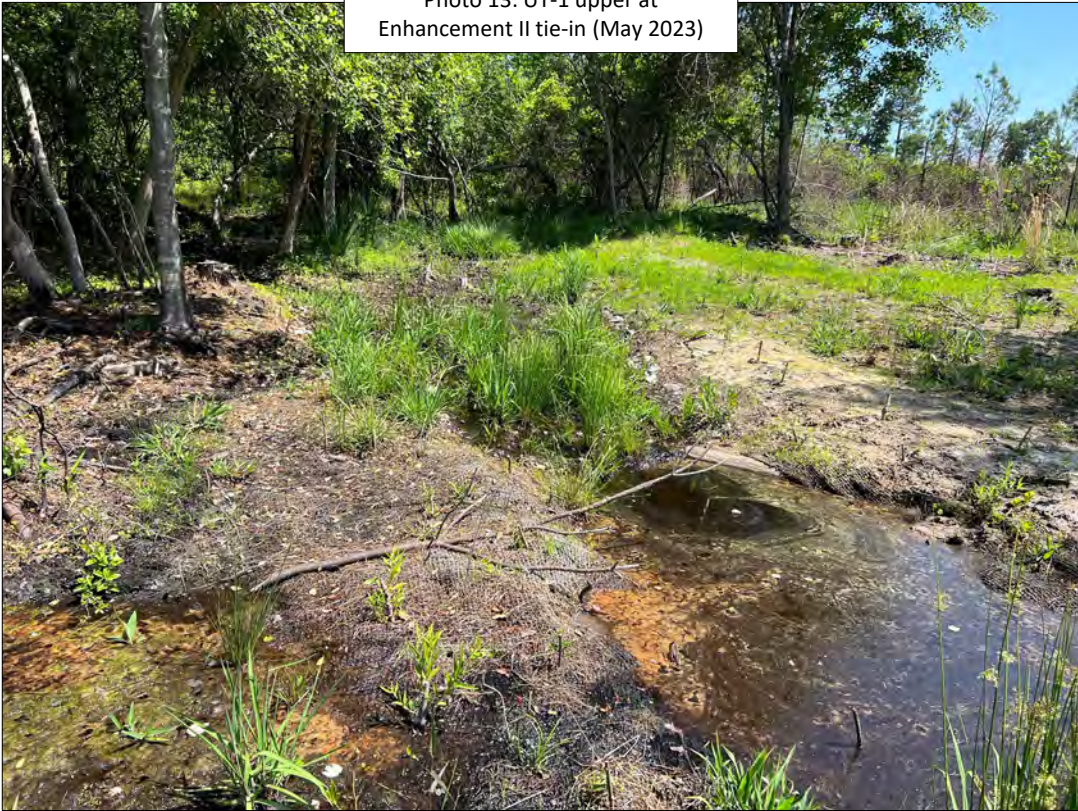
Photo 13: UT-1 upper at
Enhancement II tie-in (May 2023)

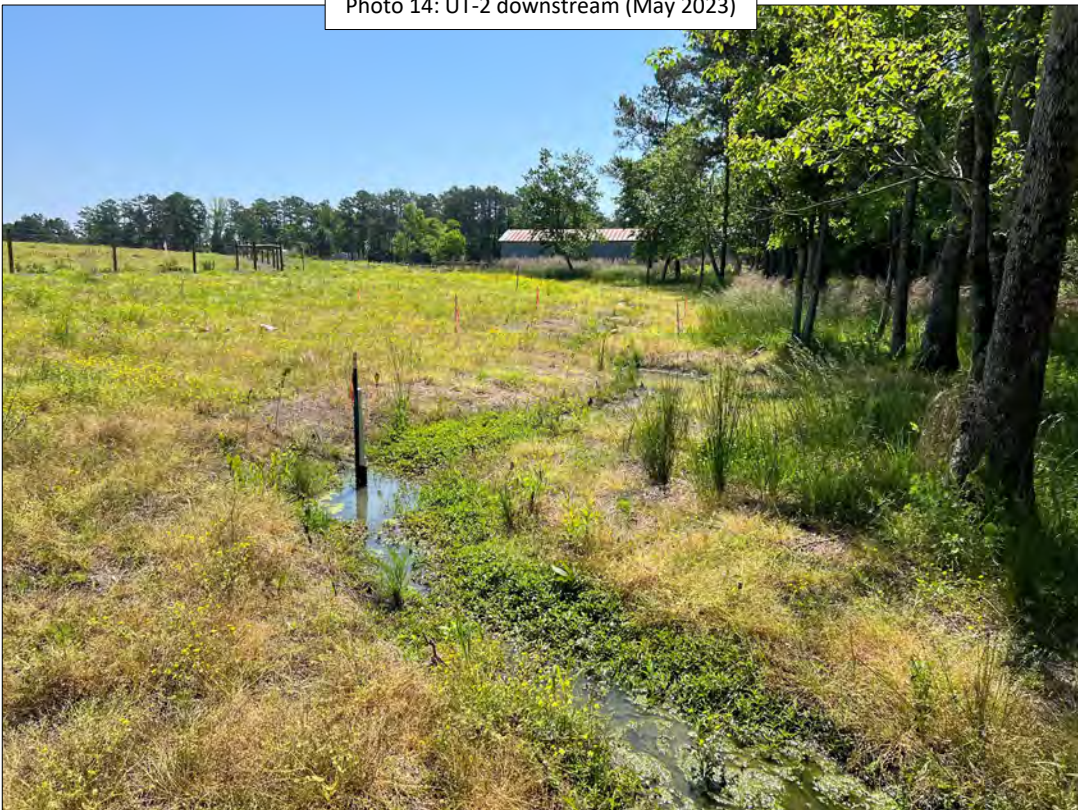
Photo 14: UT-2 downstream (May 2023)

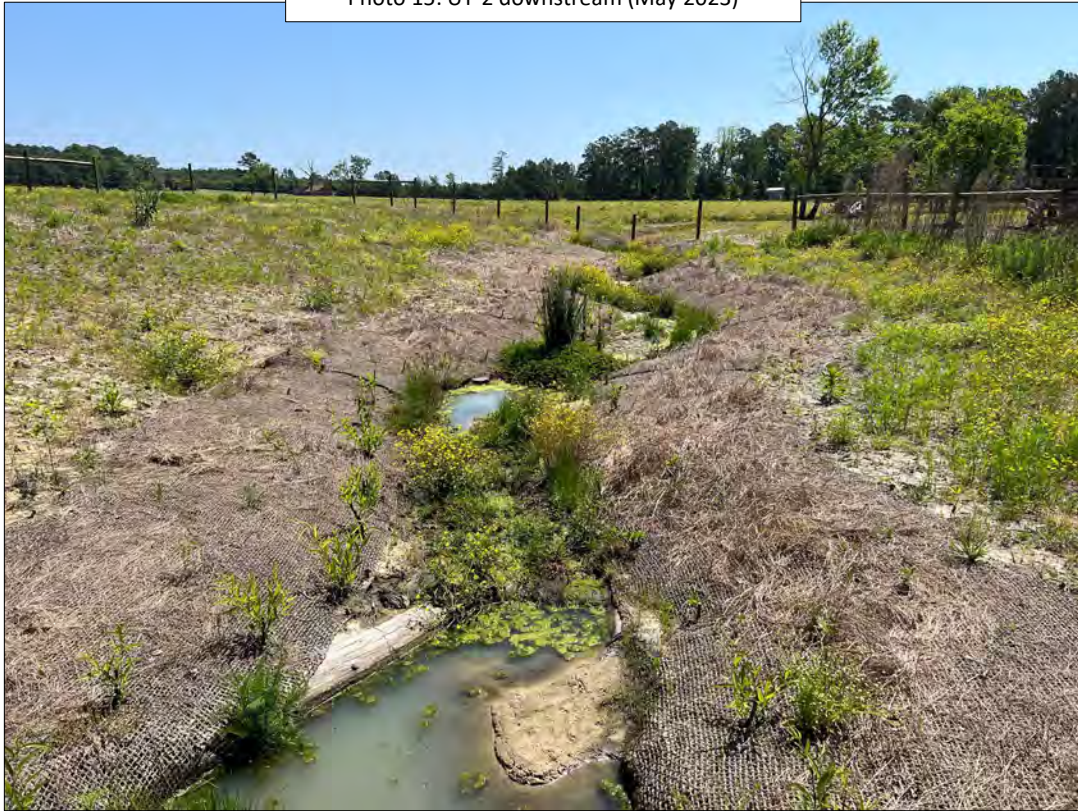
Photo 15: UT-2 downstream (May 2023)

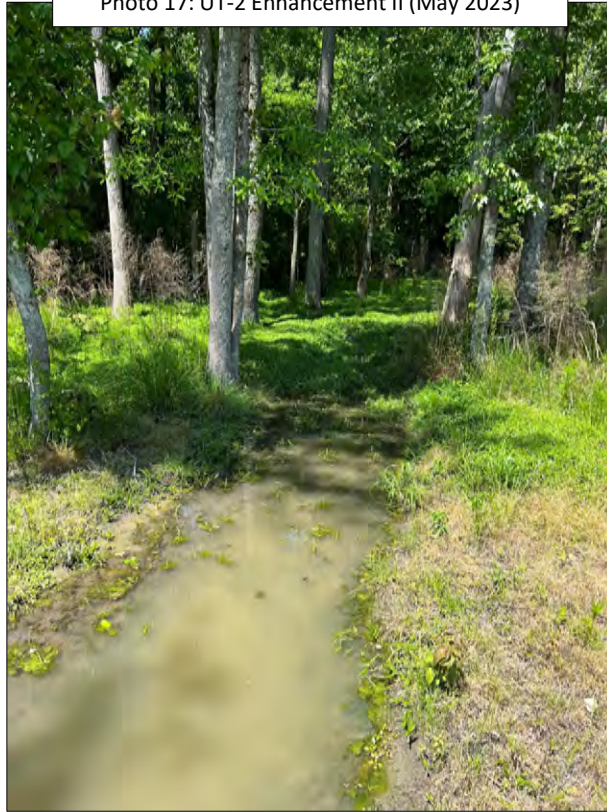
Photo 17: UT-2 Enhancement II (May 2023)

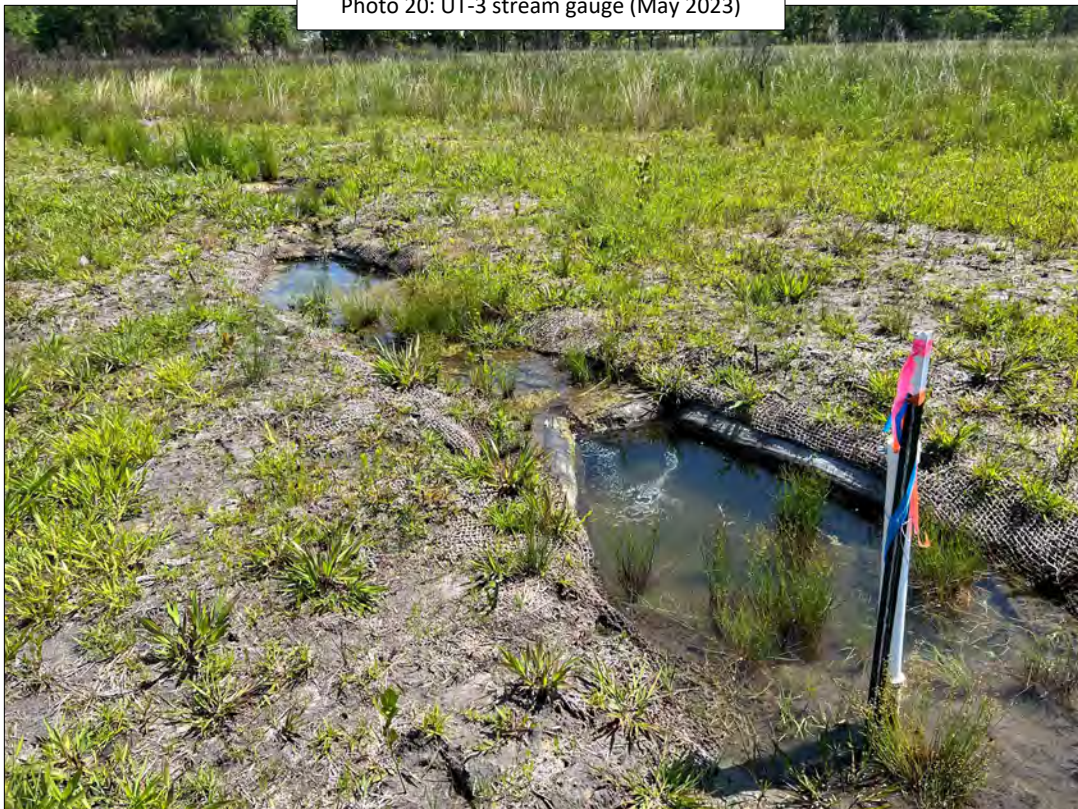
Photo 20: UT-3 stream gauge (May 2023)

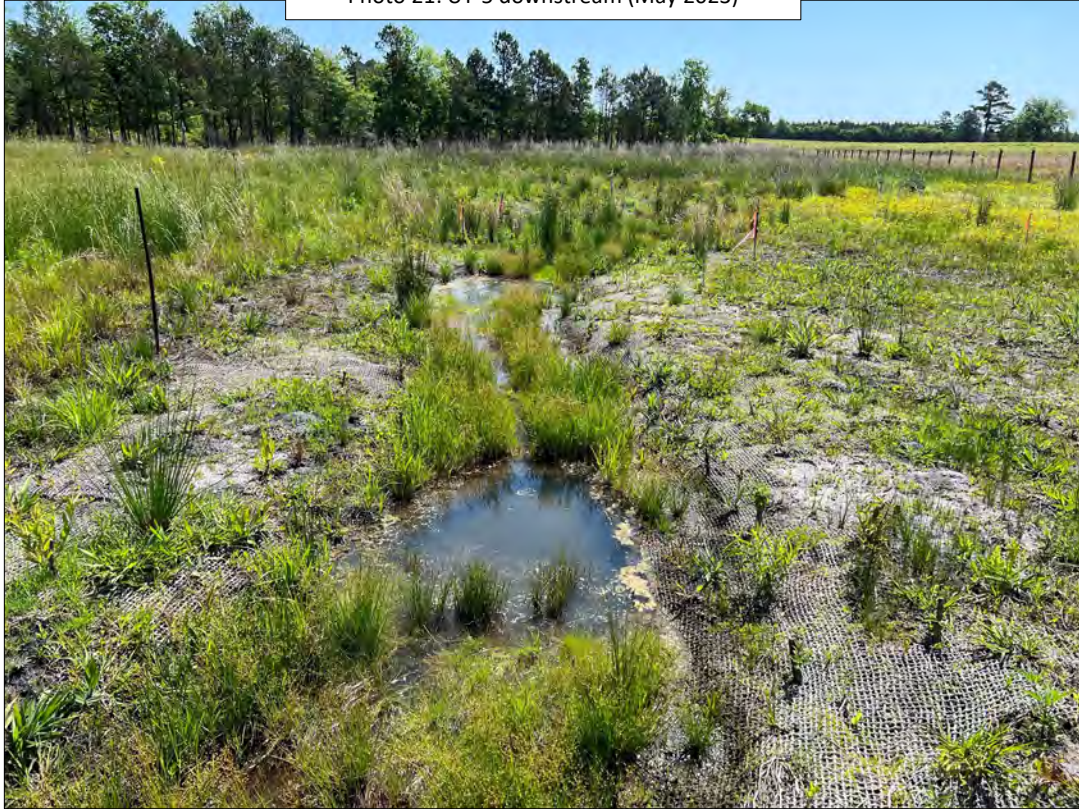
Photo 21: UT-5 downstream (May 2023)

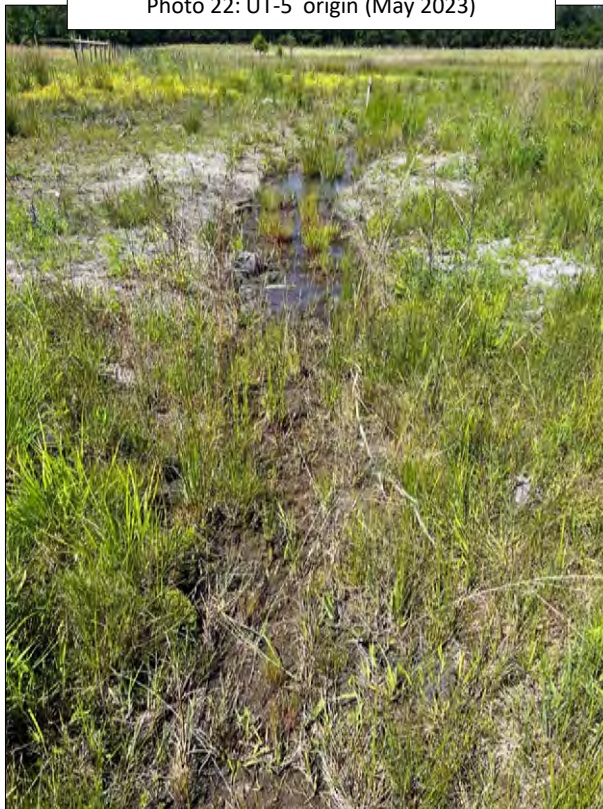
Photo 22: UT-5 origin (May 2023)

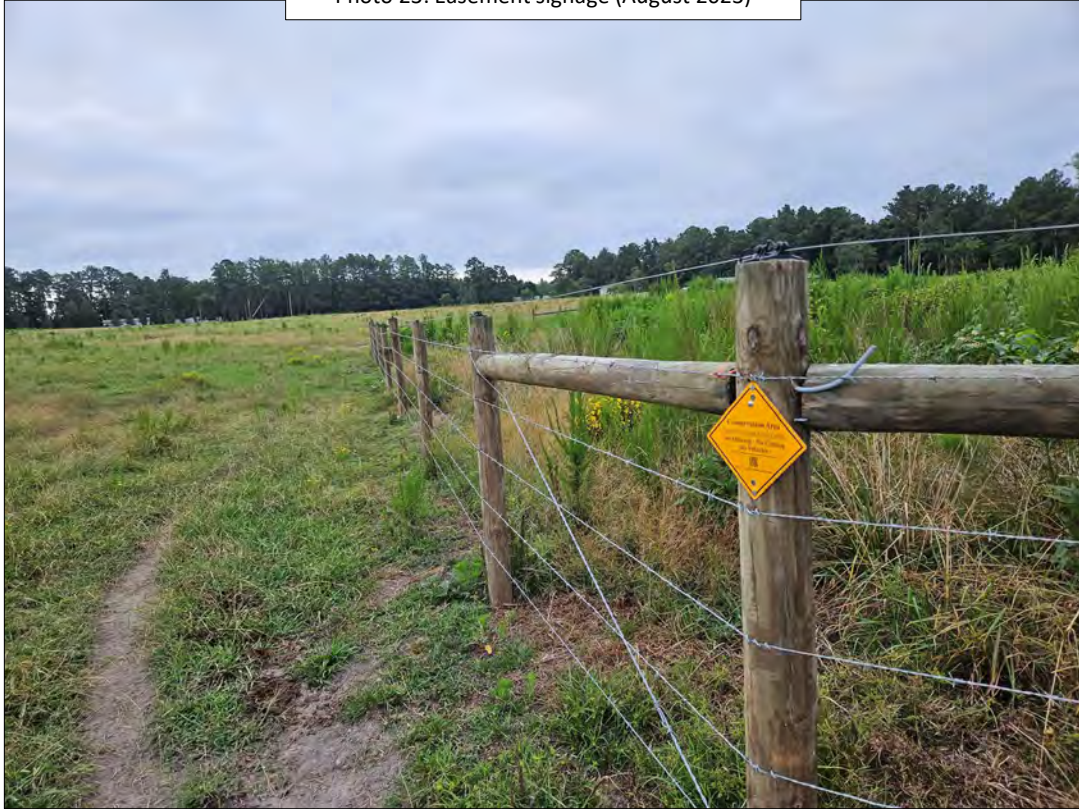
Photo 23: Easement signage (August 2023)

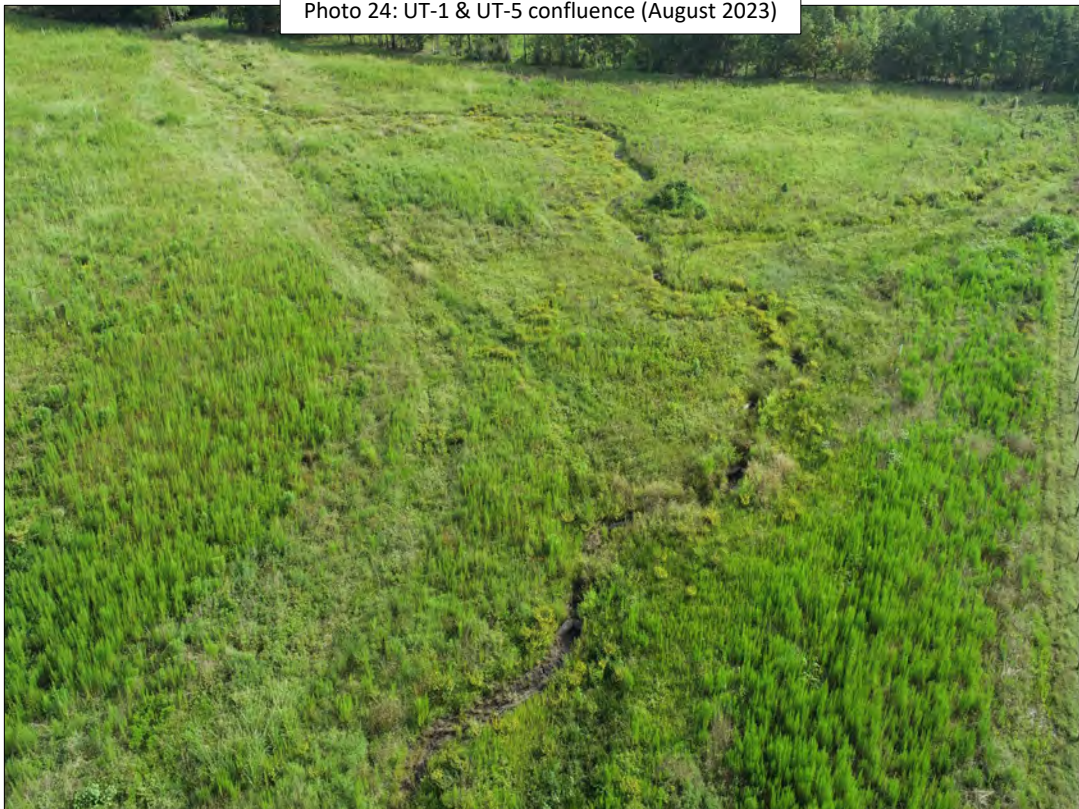
Photo 24: UT-1 & UT-5 confluence (August 2023)

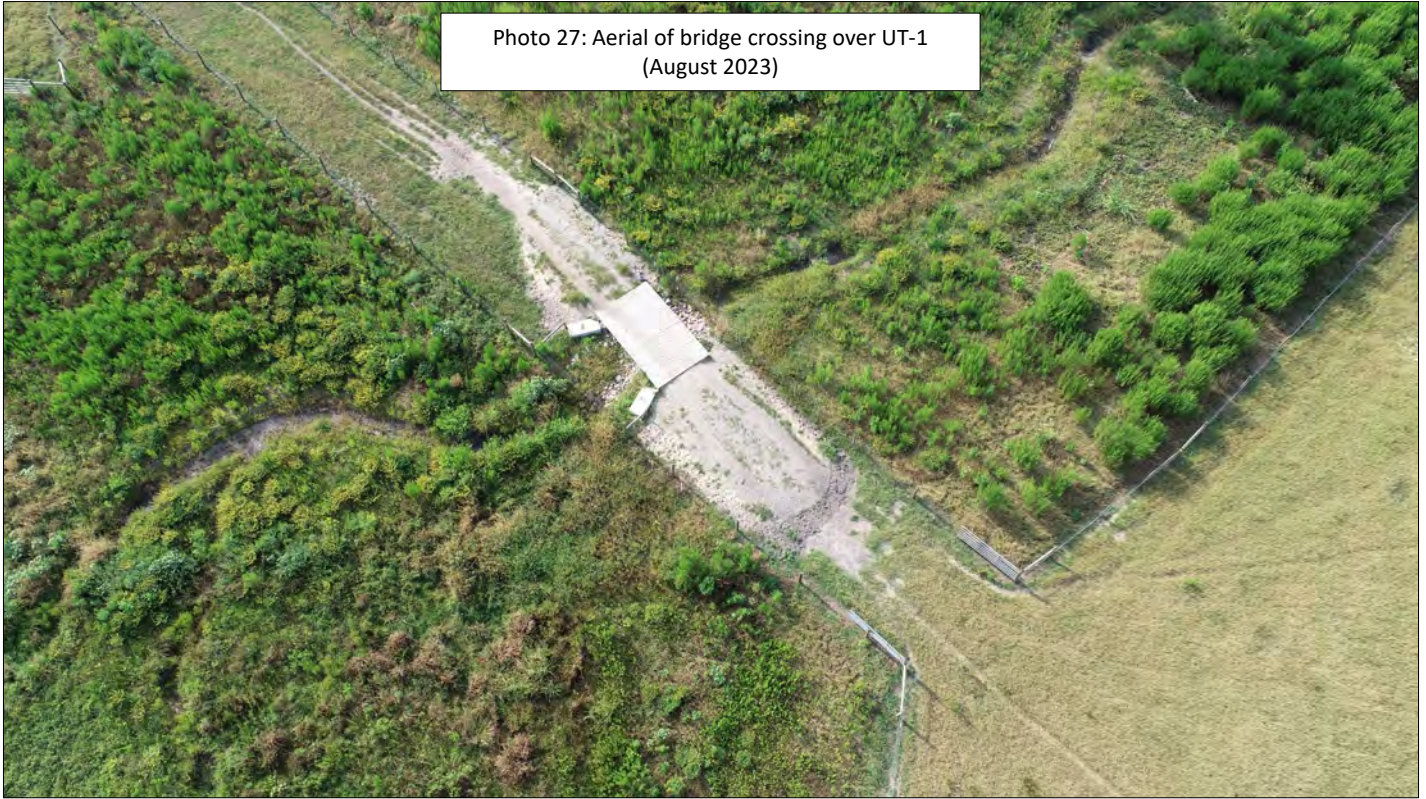
Photo 27: Aerial of bridge crossing over UT-1
(August 2023)

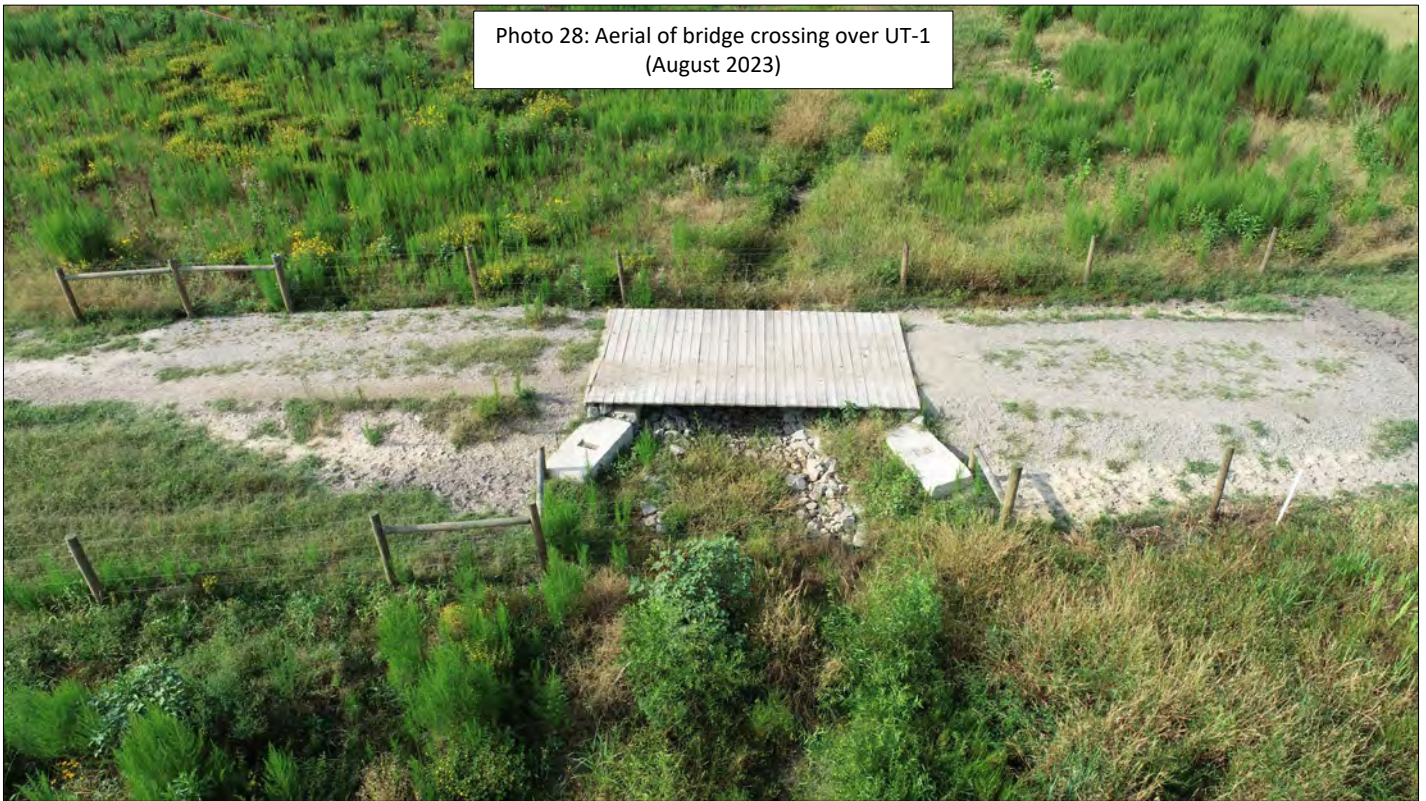
Photo 28: Aerial of bridge crossing over UT-1
(August 2023)

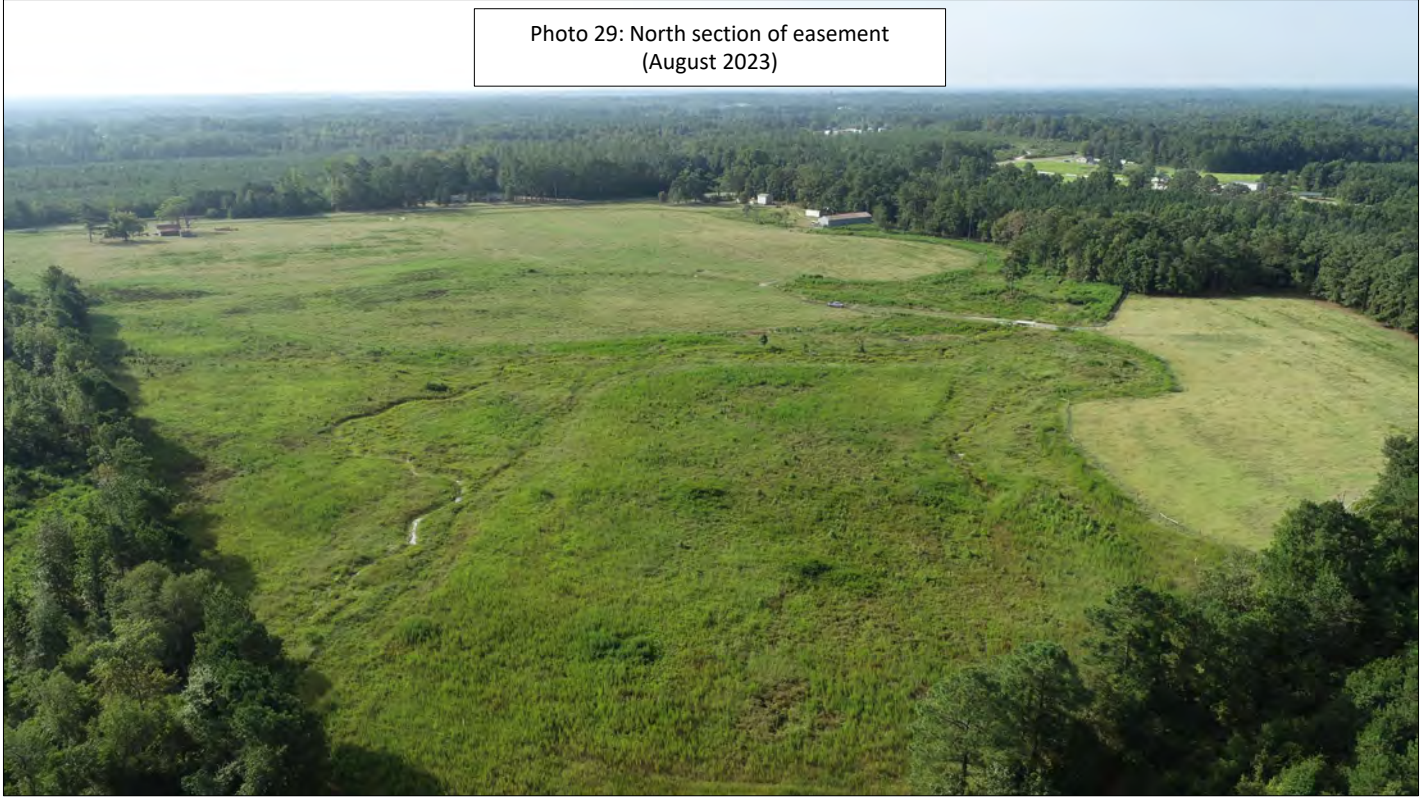
Photo 29: North section of easement
(August 2023)

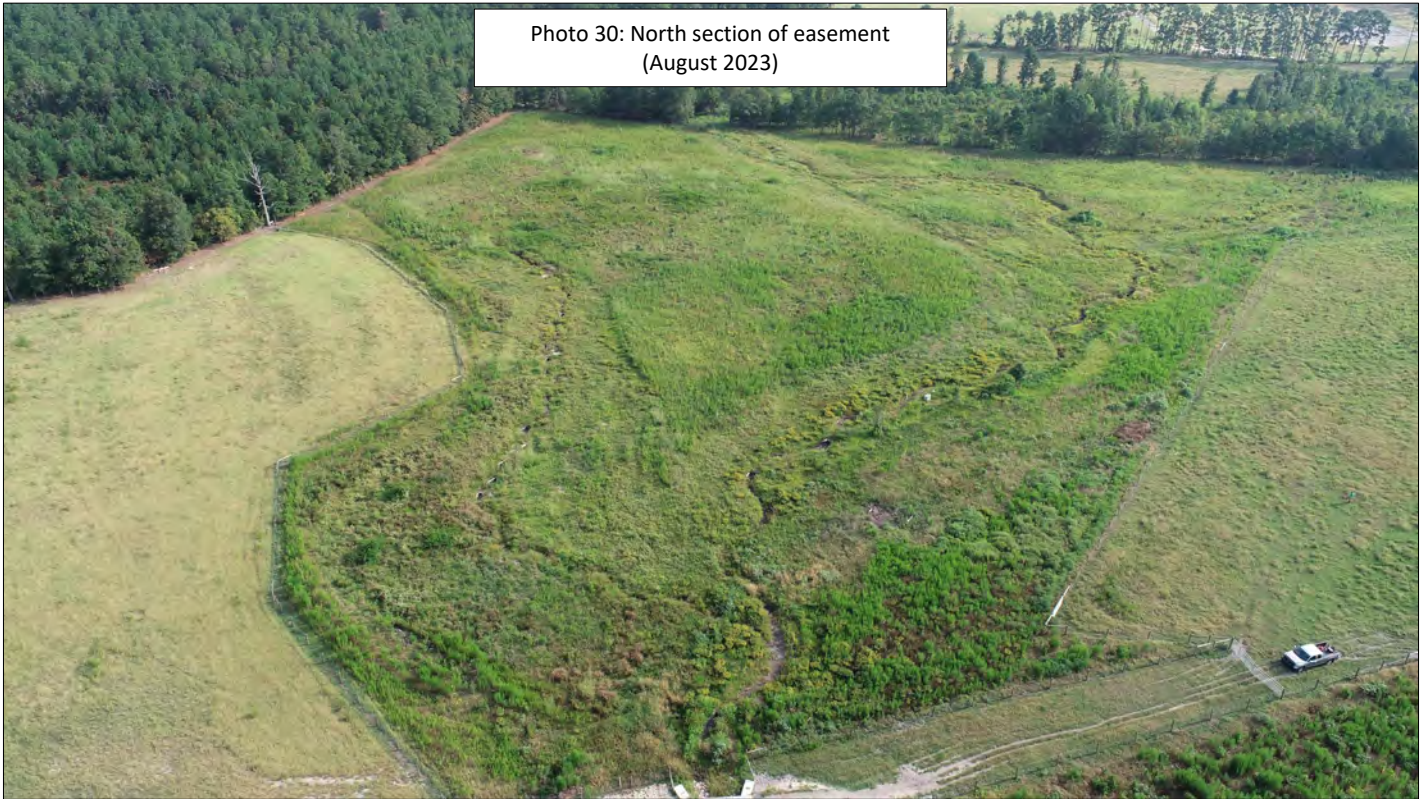
Photo 30: North section of easement
(August 2023)

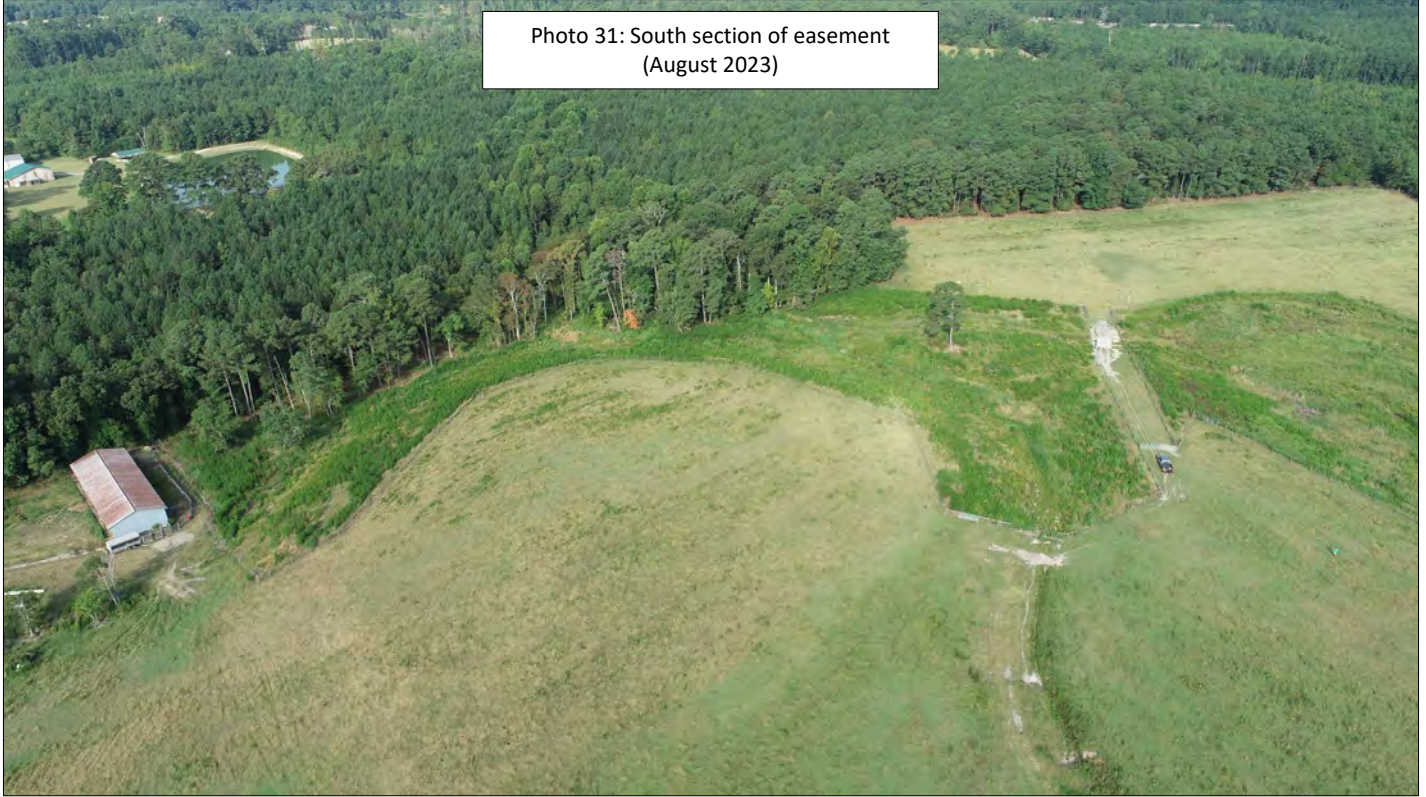
Photo 31: South section of easement
(August 2023)

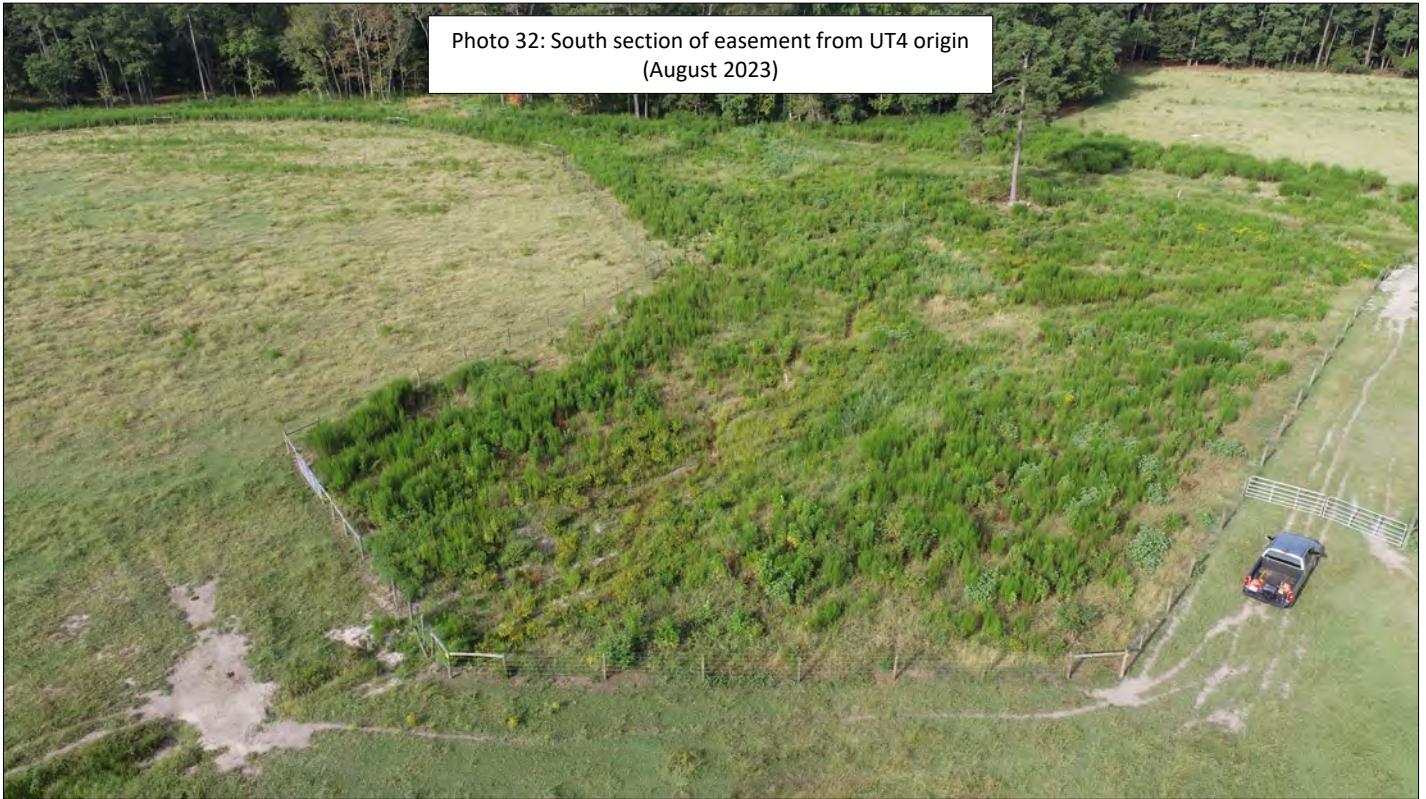
Photo 32: South section of easement from UT4 origin
(August 2023)
