# MONITORING YEAR 7 ANNUAL/CLOSEOUT REPORT

# **CROOKED CREEK #2 RESTORATION PROJECT**

Union County, NC DEQ Contract 6617 DMS Project Number 94687 USACE Permit No. SAW-2011-02201

Submission Date: February 27, 2023

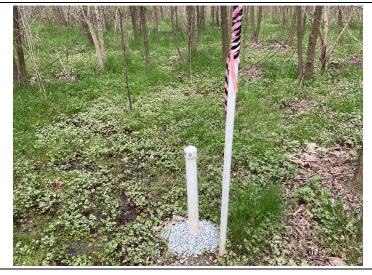
**GWG4** – Surrounding wetland area Spring (4/5/2022)

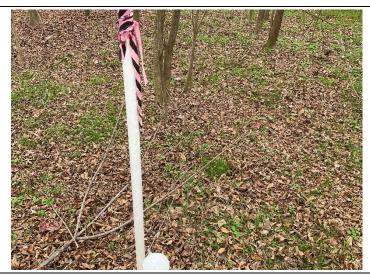
GWG4 – Surrounding wetland area Fall (11/10/2022)

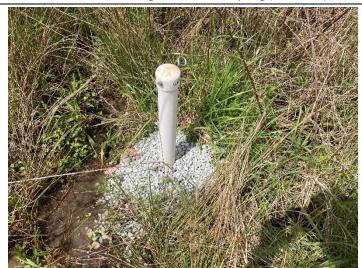
**GWG5** – Surrounding wetland area Spring (4/5/2022)

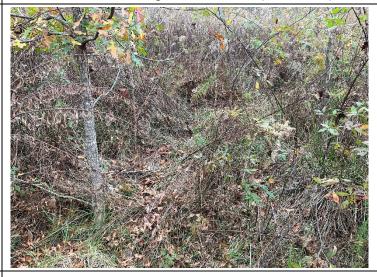
**GWG5** – Surrounding wetland area Fall (11/10/2022)

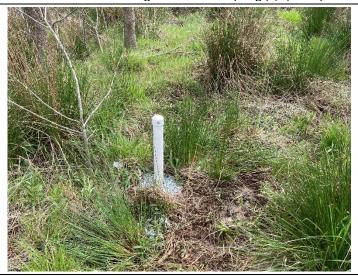
GWG6 – Surrounding wetland area Spring (4/5/2022)

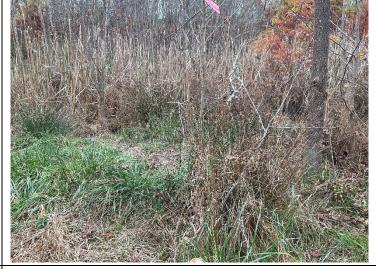
**GWG6** – Surrounding wetland area Fall (11/10/2022)

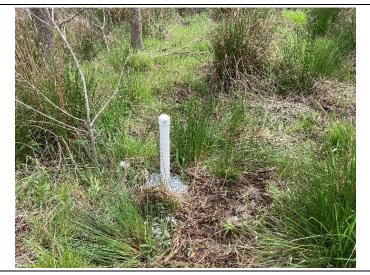
GWG7 - Surrounding wetland area Spring (4/5/2022)

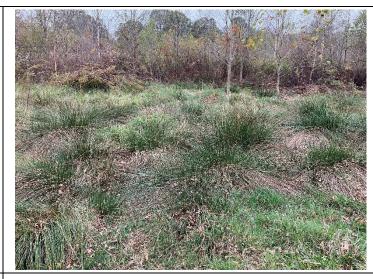
GWG7 - Surrounding wetland area Fall (11/10/2022)

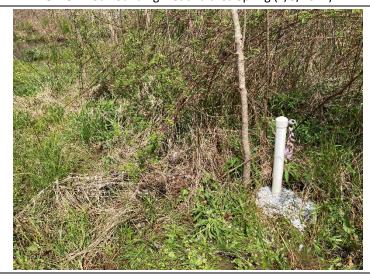
GWG8 – Surrounding wetland area Spring (4/5/2022)

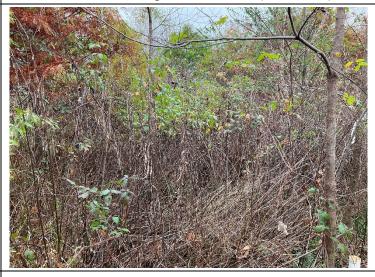
GWG8 – Surrounding wetland area Fall (11/10/2022)

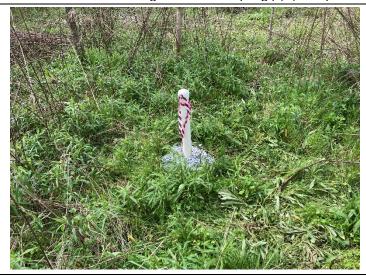
**GWG9** – Surrounding wetland area Spring (4/5/2022)

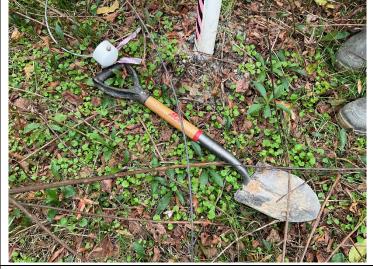
**GWG9** – Surrounding wetland area Fall (11/10/2022)
