MONITORING YEAR 1 ANNUAL REPORT

CROOKED CREEK #2 RESTORATION PROJECT

Union County, NC
NCDEQ Contract D09126S
DMS Project Number 94687

Data Collection Period: Aug. 2016 – Sept. 2016
Draft Submission Date: November 18, 2016
Final Submission Date: December 12, 2016

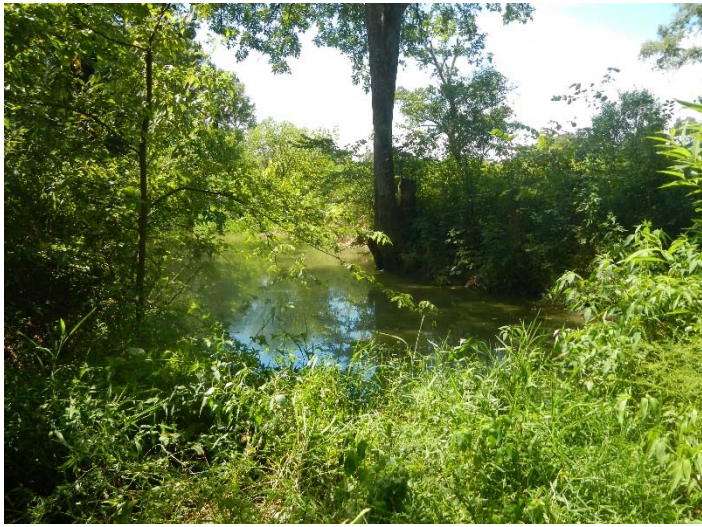
Photo Point 30 –Wetland CC outlet facing W (08/18/2016)

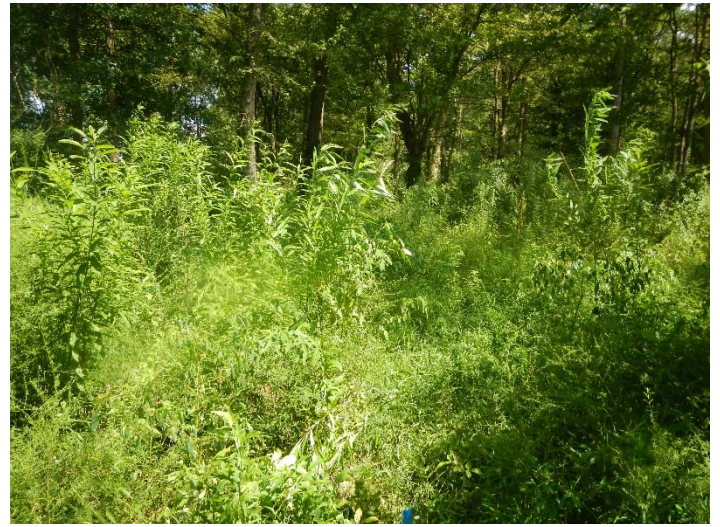
Photo Point 30 –Wetland CC outlet facing E (08/18/2016)

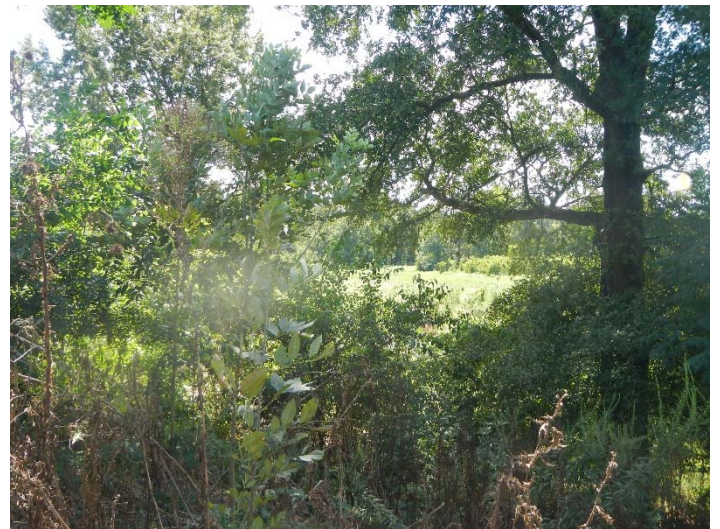
Photo Point 32 – Wetland Zone A facing S(08/18/2016)

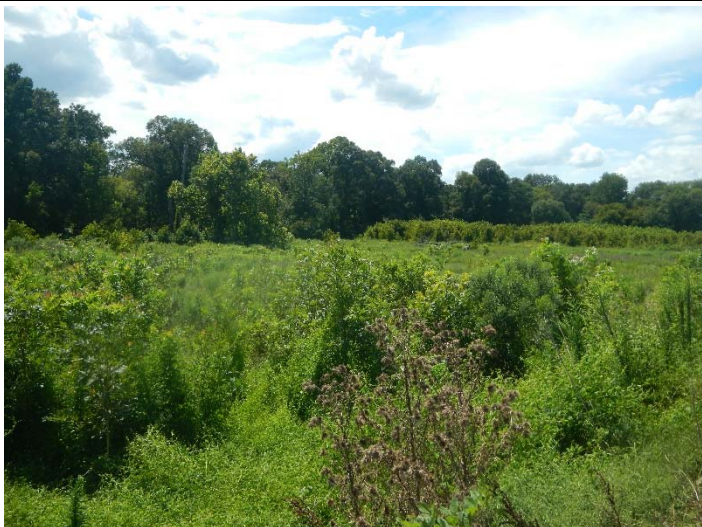
Photo Point 33 – Wetland Zone A & B facing W (08/18/2016)

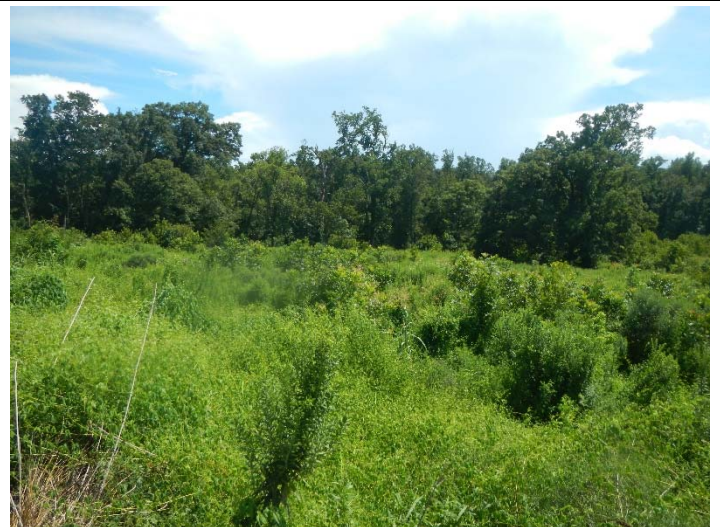
Photo Point 33 - Wetland B facing S (08/18/2016)

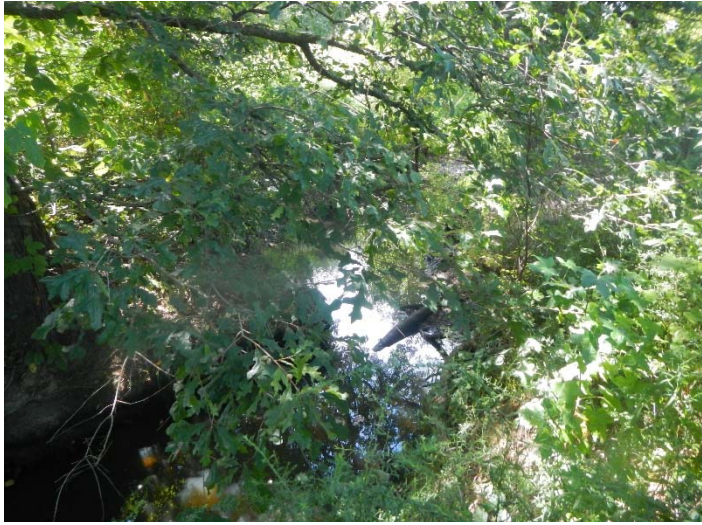
Photo Point 34 –Wetland CC facing NW (08/18/2016)

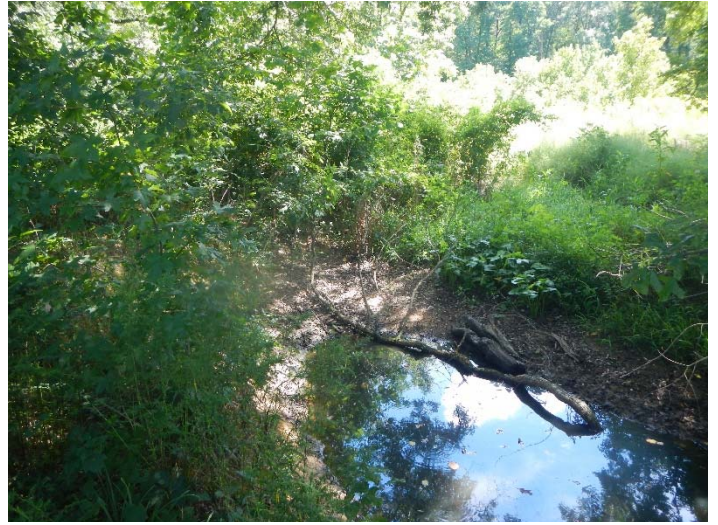
Photo Point 34 –Wetland CC facing S (08/18/2016)
