MONITORING YEAR 2 ANNUAL REPORT

CROOKED CREEK #2 RESTORATION PROJECT

Union County, NC
DEQ Contract D09126S
DMS Project Number 94687

Data Collection Period: April – November 2017
Draft Submission Date: November 30, 2017
Final Submission Date: December 20, 2017

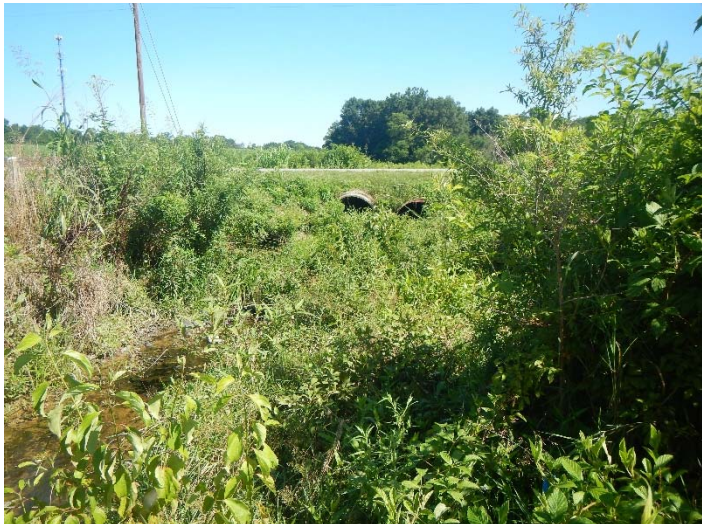
Photo Point 1 – UT1 looking upstream (06/28/2017)

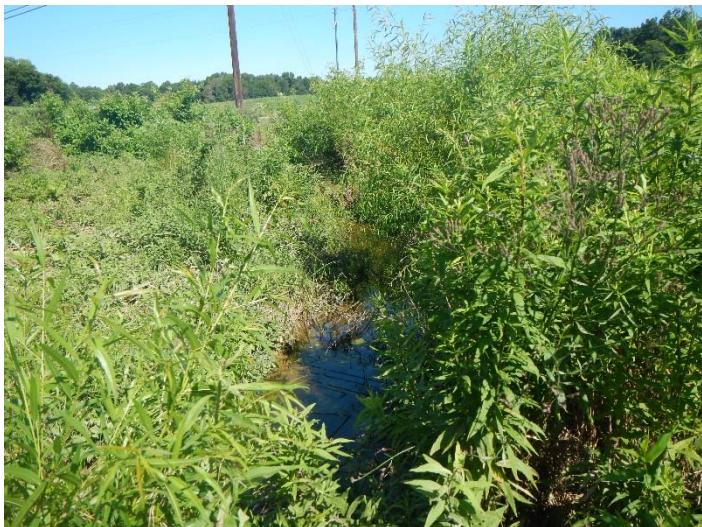
Photo Point 2 – UT1 looking upstream (06/28/2017)

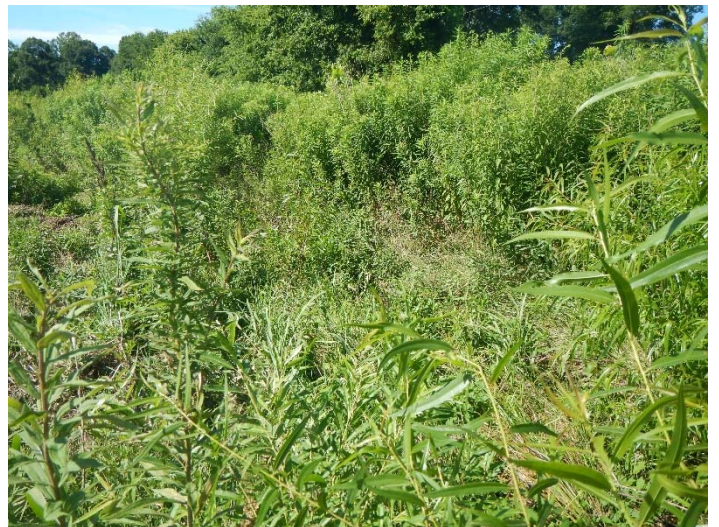
Photo Point 2 – UT1 looking downstream (06/28/2017)

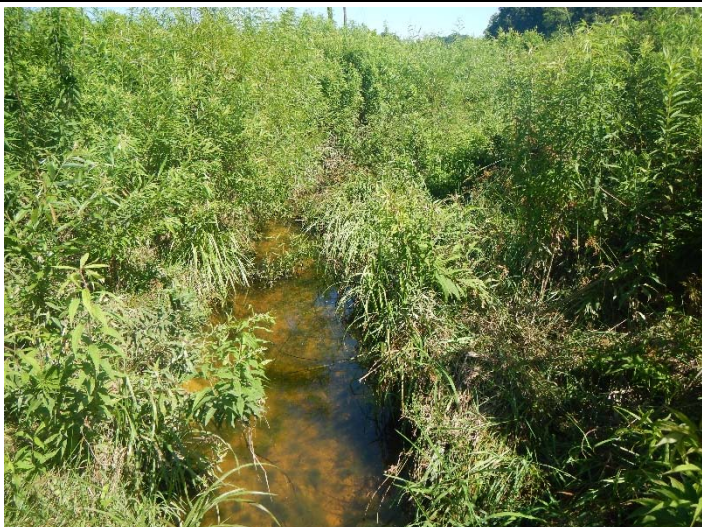
Photo Point 3 – UT1 looking upstream (06/28/2017)

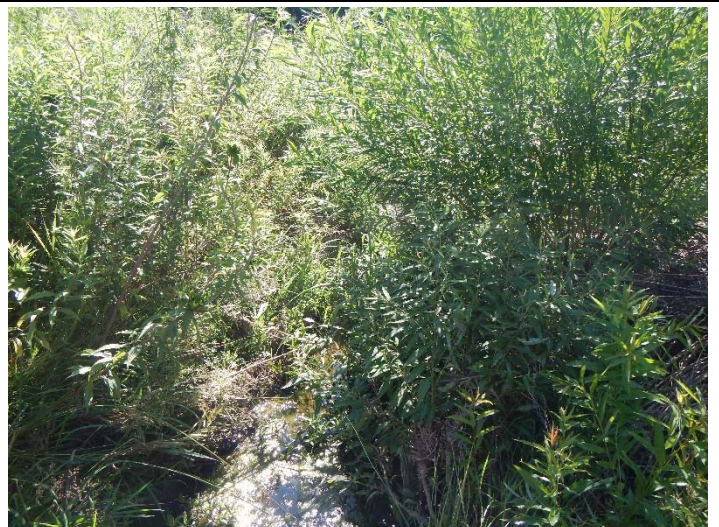
Photo Point 3 – UT1 looking downstream (06/28/2017)

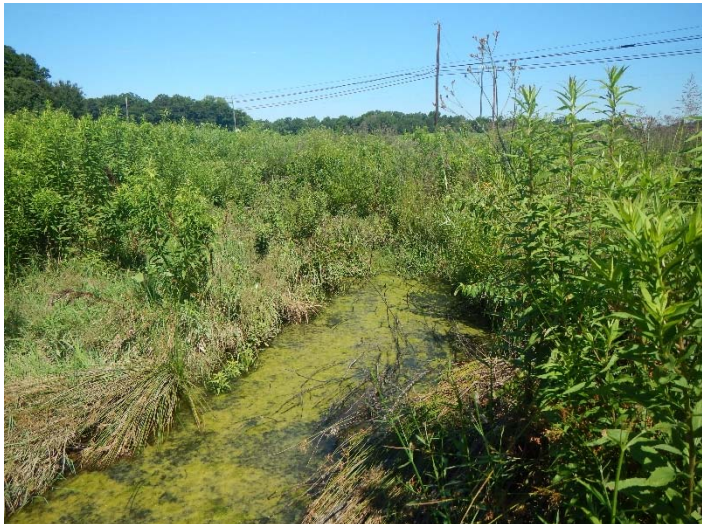
Photo Point 4 – UT1 looking upstream (06/28/2017)

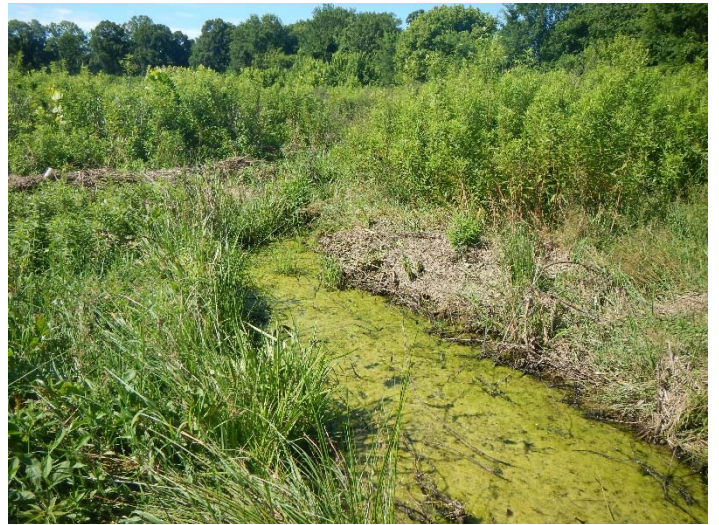
Photo Point 4 – UT1 looking downstream (06/28/2017)

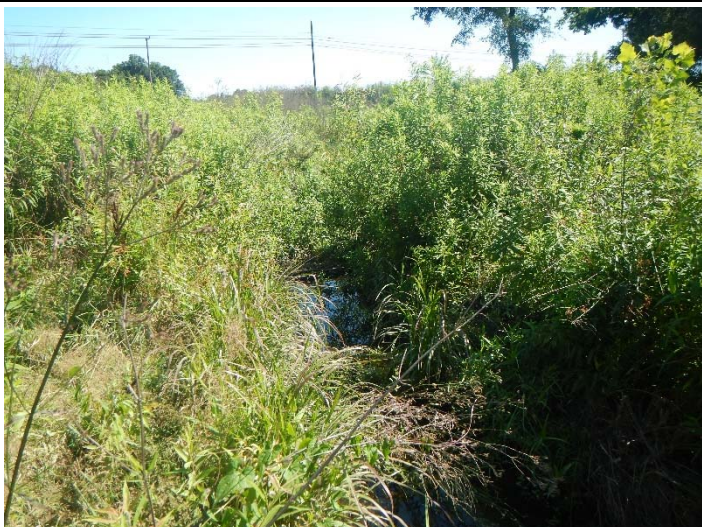
Photo Point 5 – UT1 looking upstream (06/28/2017)

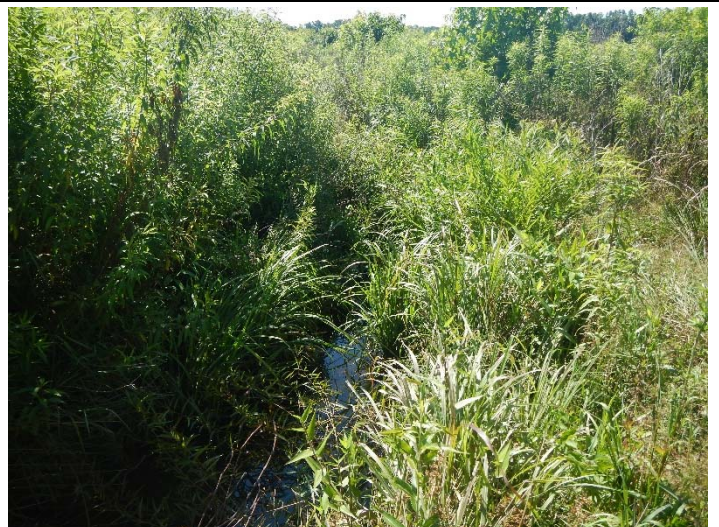
Photo Point 5 – UT1 looking downstream (06/28/2017)

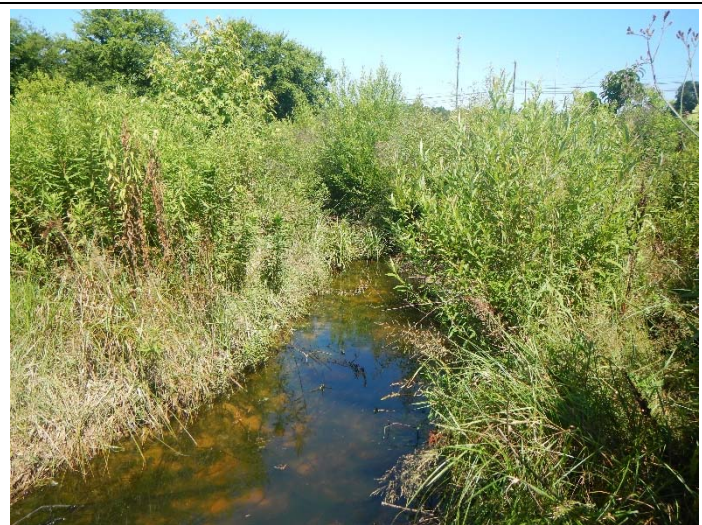
Photo Point 6 – UT1 looking upstream (06/28/2017)

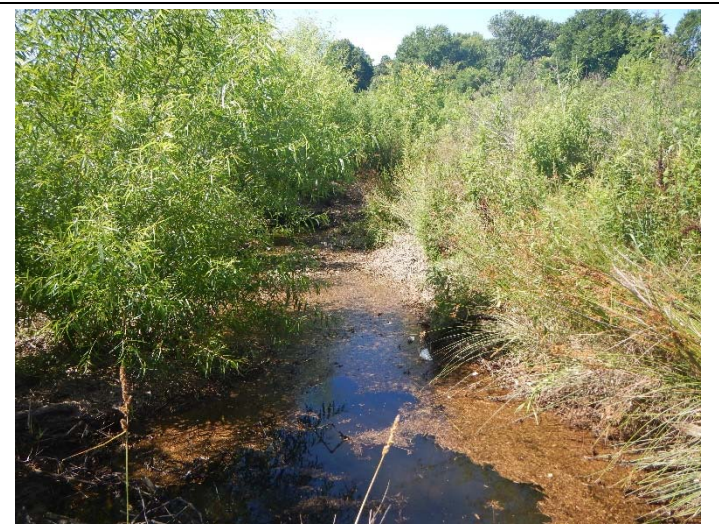
Photo Point 6 – UT1 looking downstream (06/28/2017)

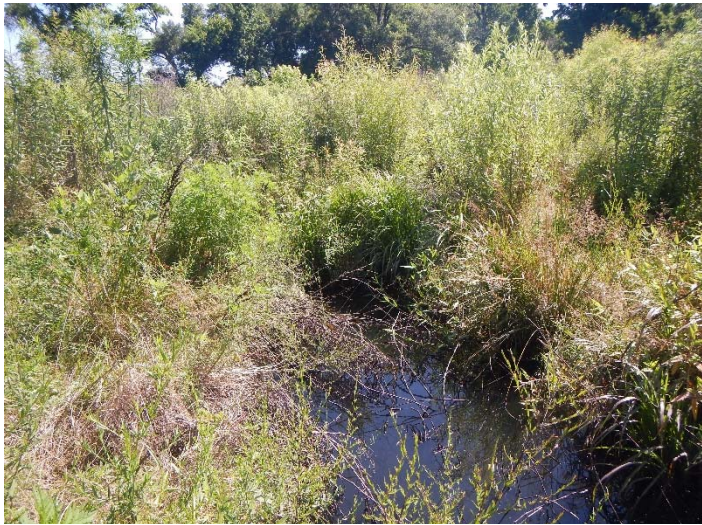
Photo Point 7 – UT1 looking upstream (06/28/2017)

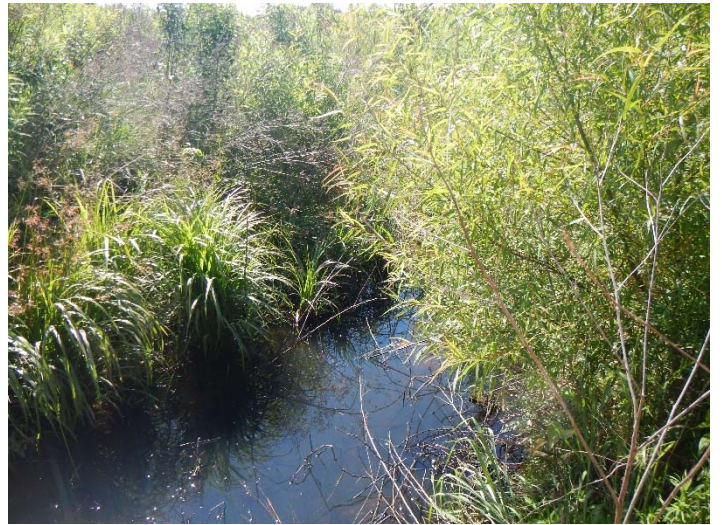
Photo Point 7 – UT1 looking downstream (06/28/2017)

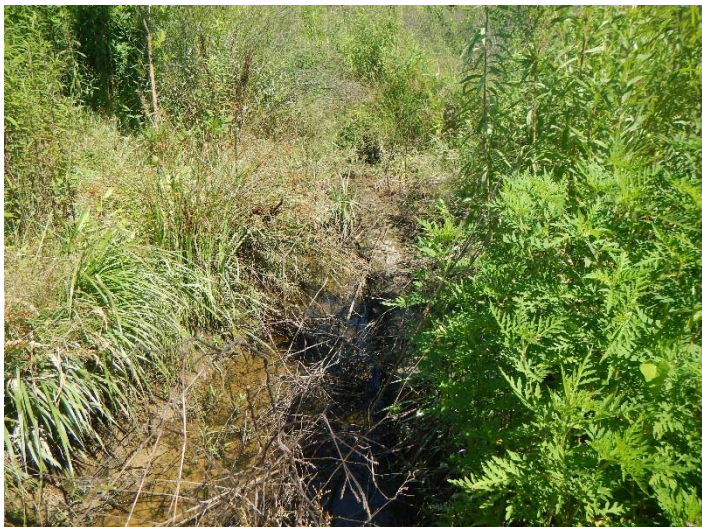
Photo Point 8 – UT1 looking upstream (06/28/2017)

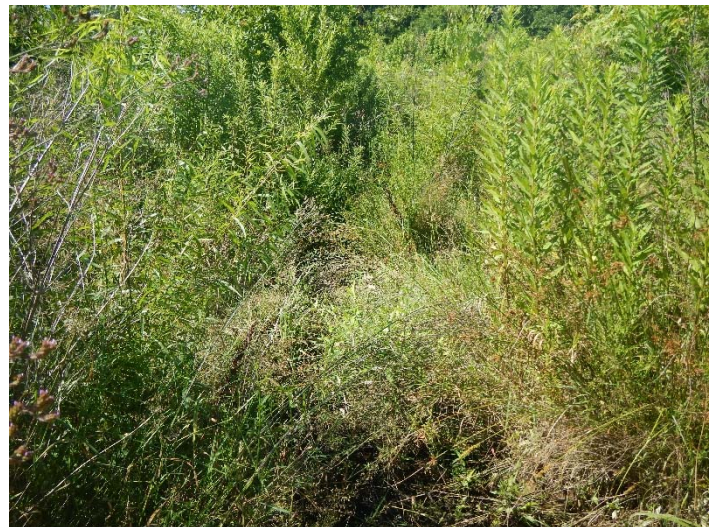
Photo Point 8 – UT1 looking downstream (06/28/2017)

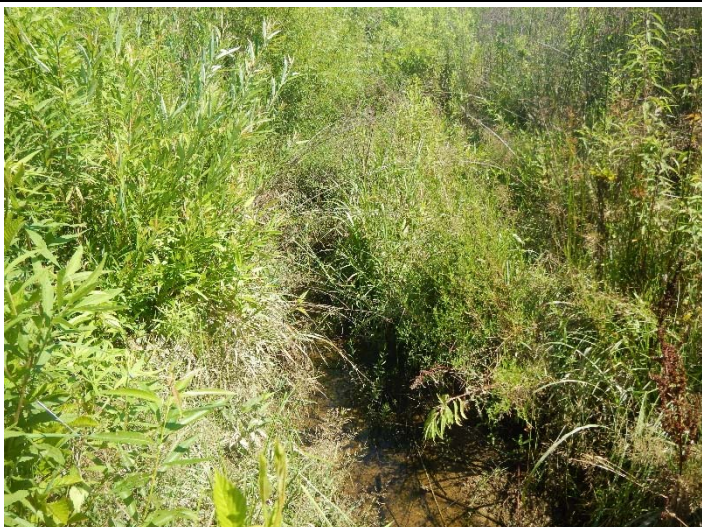
Photo Point 9 – UT1 looking upstream (06/28/2017)

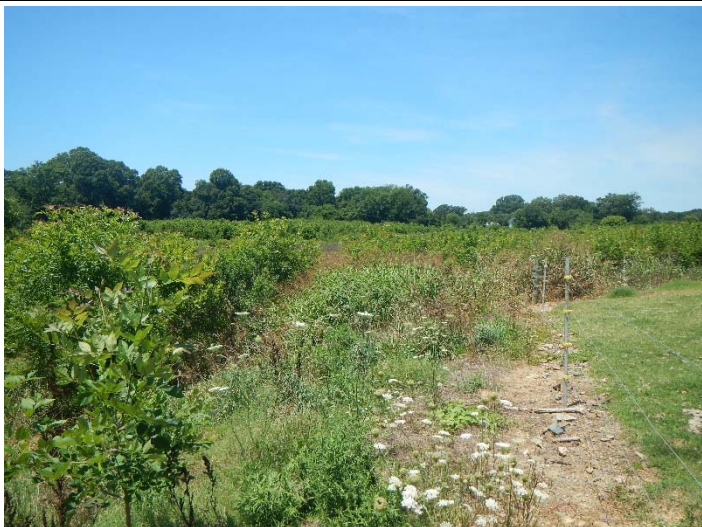
Photo Point 33 – Wetland Zone A & B facing W (06/28/2017)

An herbicide treatment was applied along the fence line around photo point 33. However, the invasive vine species, such as Chinese lantern, Japanese honeysuckle and morning glory, continue to impact the stem growth within the site. Several invasive species were noted throughout the site and include Chinese lantern (*Physalis spp.*), Chinaberry (*Melia azedarach*), Chinese privet (*Ligustrum sinense*), Japanese honeysuckle (*Lonicera japonica*), Johnson grass (*Sorghum halepense*), and morning glory (*Ipomoea sp.*). The native invasive cattail (*Typha latifolia*) has colonized into Vegetation Plot 5, which may impact planted woody stem survival, along with the dense herbaceous coverage of rice cutgrass (*Leersia oryzoides*). Invasive maintenance will need to continue to enable the planted stems to grow within the site.
