MONITORING YEAR 3 ANNUAL REPORT

CROOKED CREEK #2 RESTORATION PROJECT

Union County, NC

DMS Project Number 94687

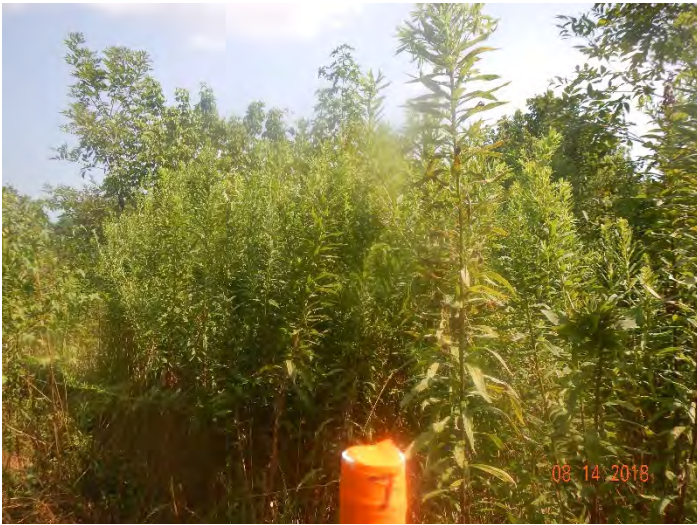
Vegetation Plot 7 – (08/14/2018)

The headcut located in the Wetland Creation Zone B area, between GWG 8 and vegetation plot 7, has decreased in size since the repair work completed in February 15, 2018. The repair consisted of straw waddles, juncus plugs and placement of live stakes. Straw bales were also placed in the eroded ditch that had developed and backfilled with dirt and herbaceous material. Since the repair, the herbaceous groundcover has become established and the trees have increased in size, especially the bald cypress (*Taxodium distichum*). This area will continue to be monitored.

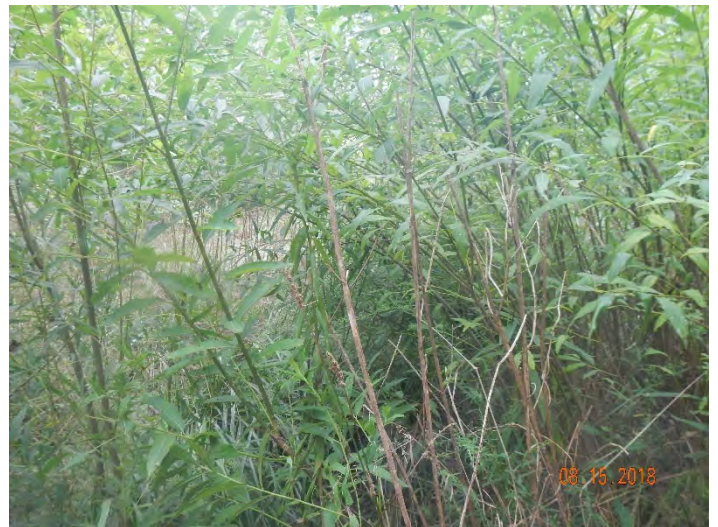
Photo Point 11 – UT1 looking upstream (8/15/2018)

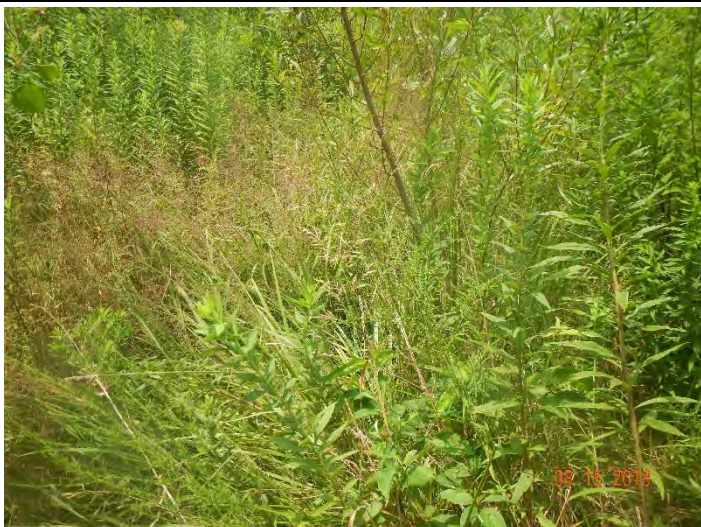
Photo Point 11 – UT1 looking downstream (8/15/2018)

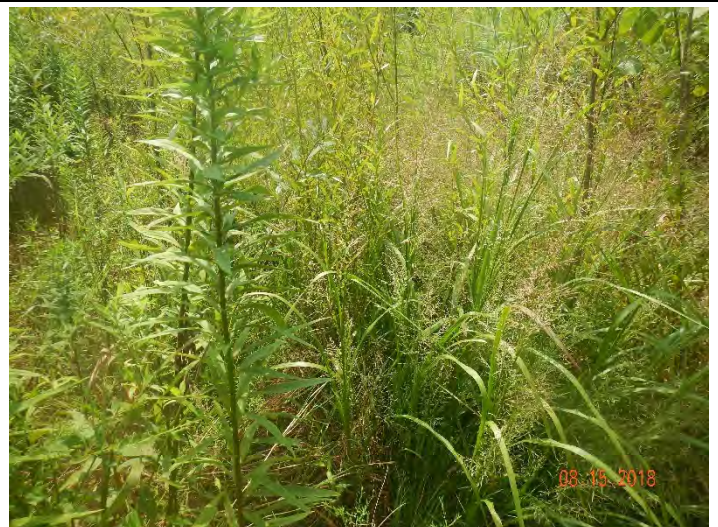
Photo Point 12 – UT1 looking upstream (8/15/2018)

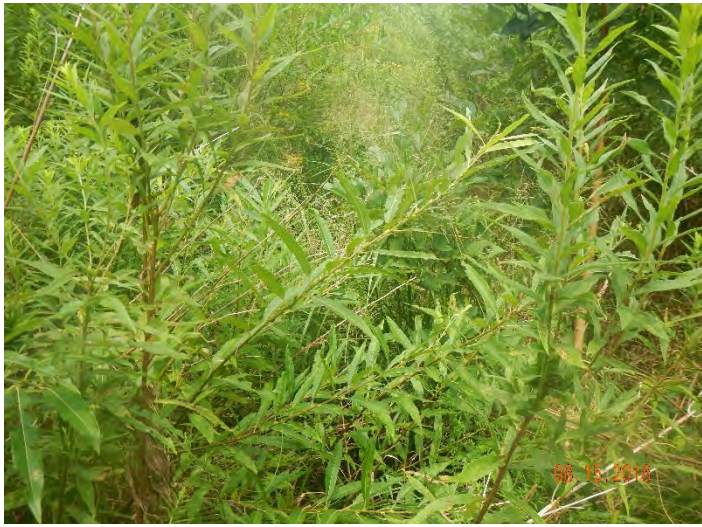
Photo Point 12 – UT1 looking downstream (8/15/2018)

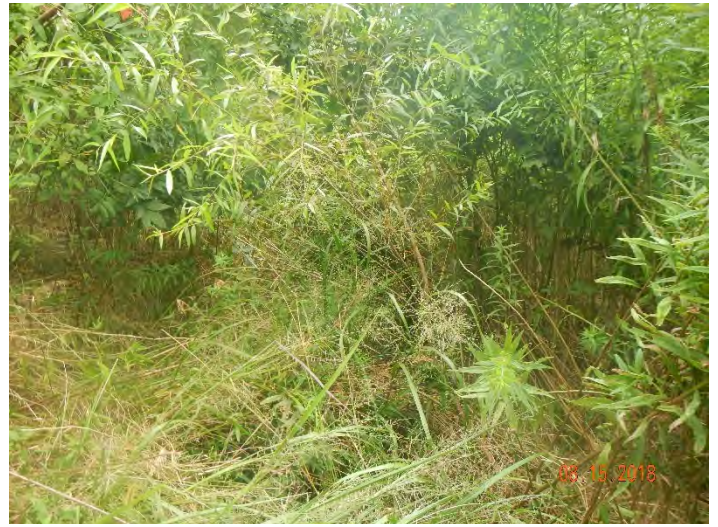
Photo Point 13 – UT1 looking upstream (8/15/2018)

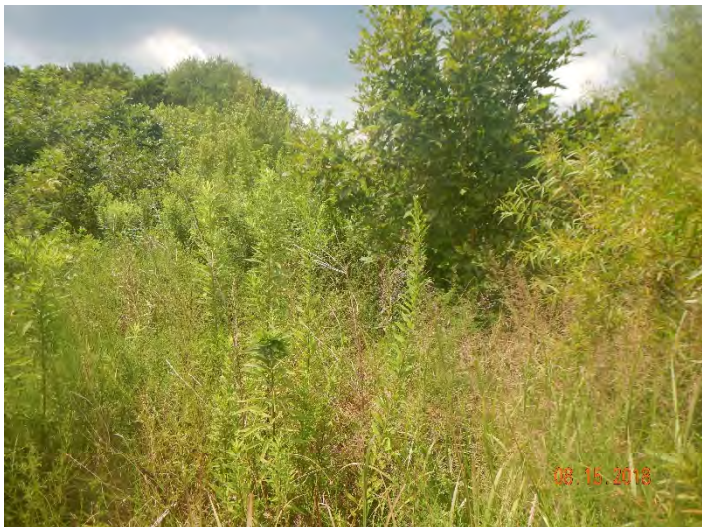
Photo Point 13 – UT1 looking downstream (8/15/2018)

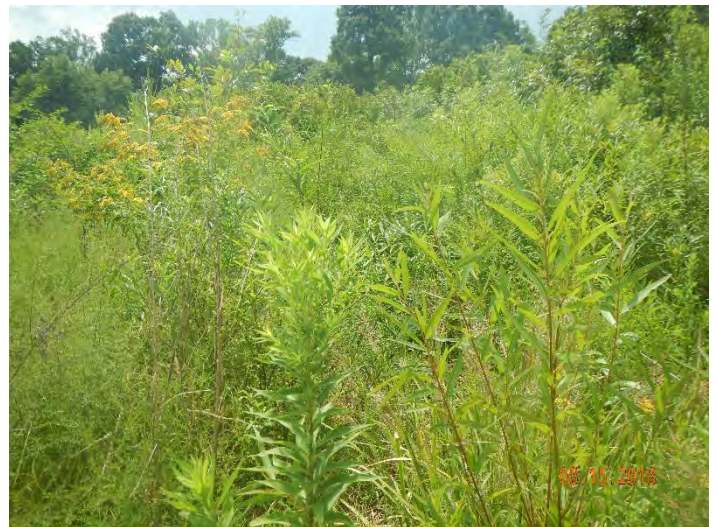
Photo Point 14 – UT1 looking upstream (8/15/2018)

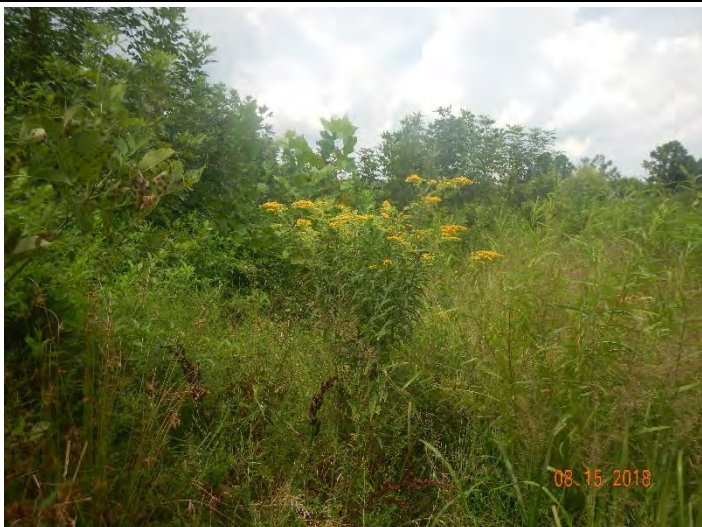
Photo Point 14 – UT1 looking downstream (8/15/2018)

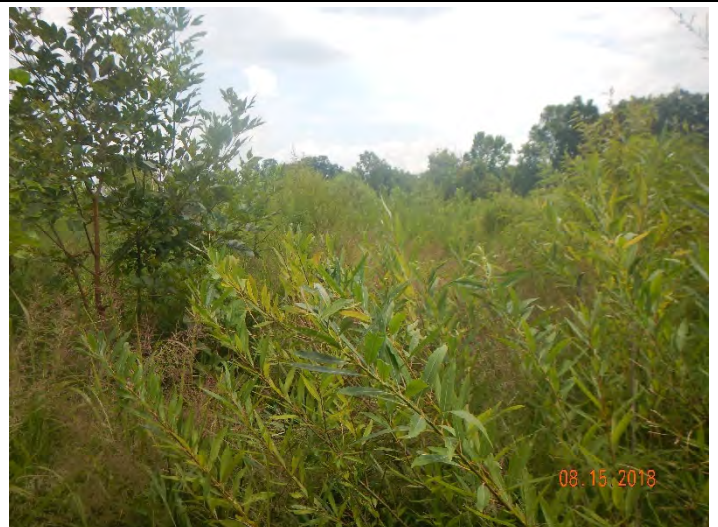
Photo Point 15 – UT1 looking upstream (8/15/2018)

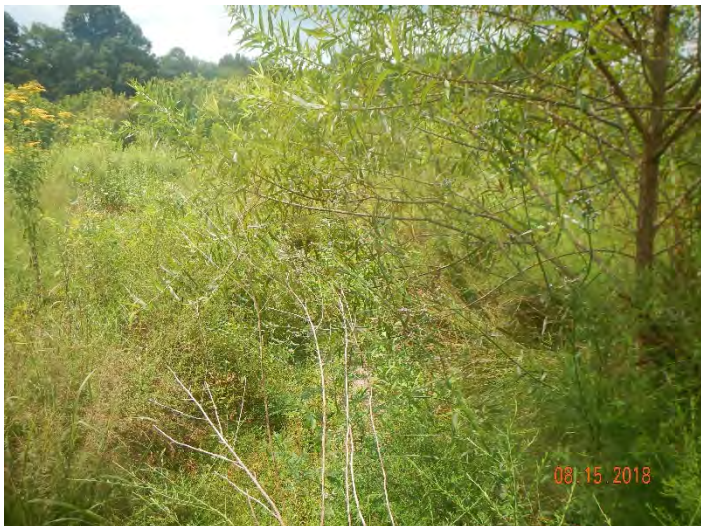
Photo Point 15 – UT1 looking downstream (8/15/2018)

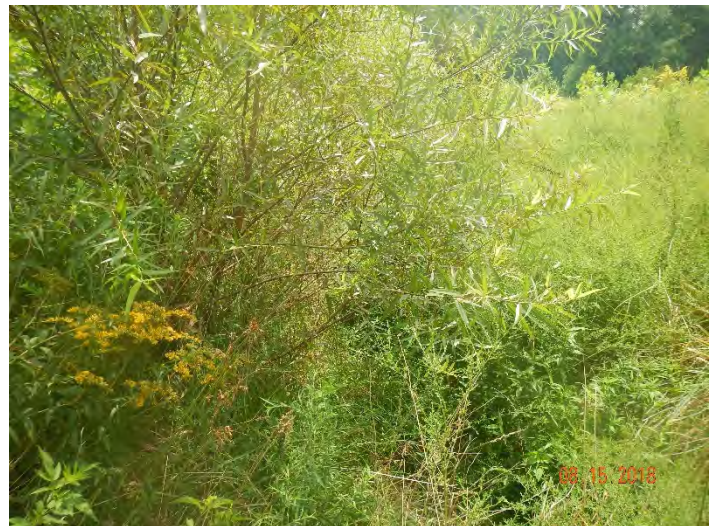
Photo Point 16 – UT1 looking upstream (8/15/2018)

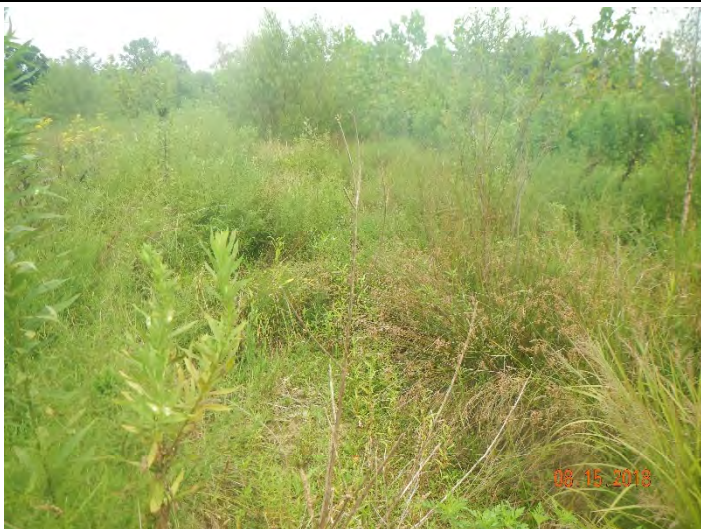
Photo Point 16 – UT1 looking downstream (8/15/2018)

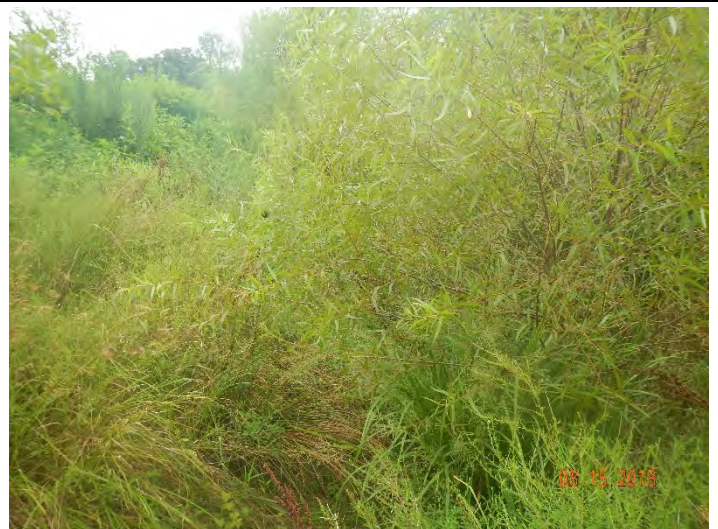
Photo Point 17 – UT1 looking upstream (8/15/2018)

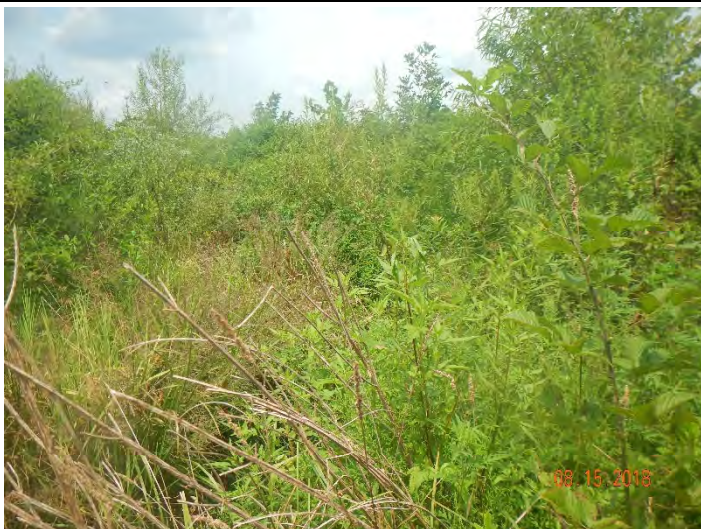
Photo Point 17 – UT1 looking downstream (8/15/2018)

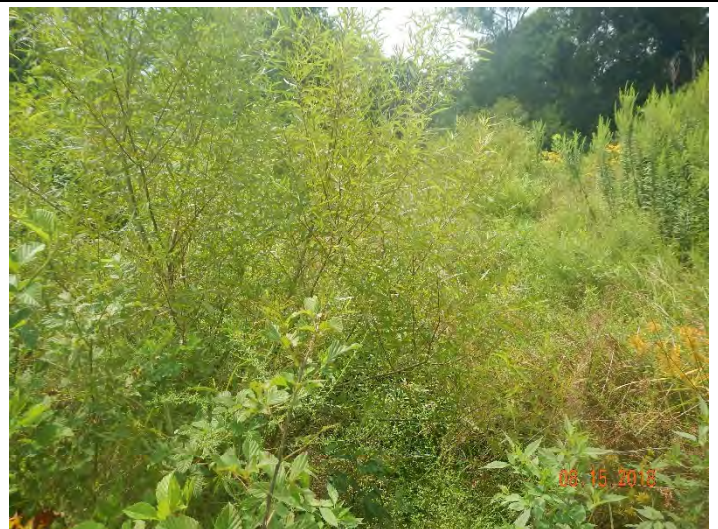
Photo Point 18 – UT1 looking upstream (8/15/2018)

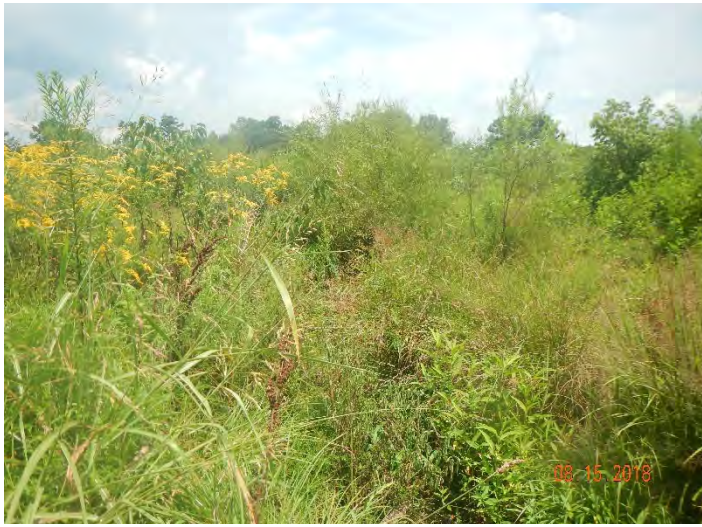
Photo Point 18 – UT1 looking downstream (8/15/2018)

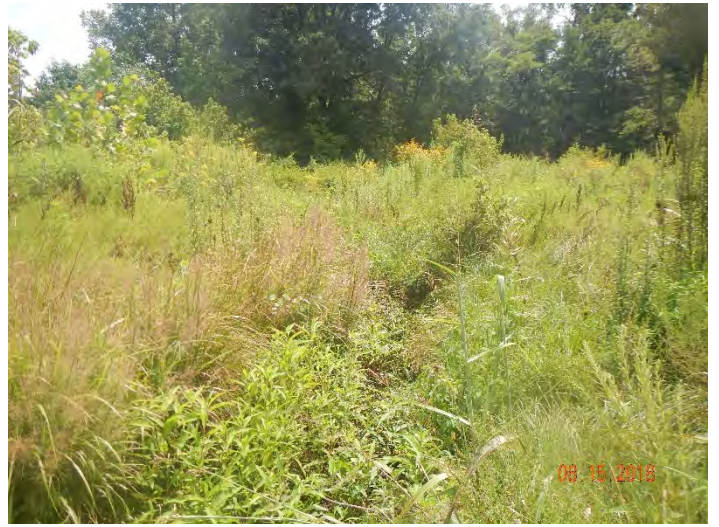
Photo Point 19 – UT1 looking upstream (8/15/2018)

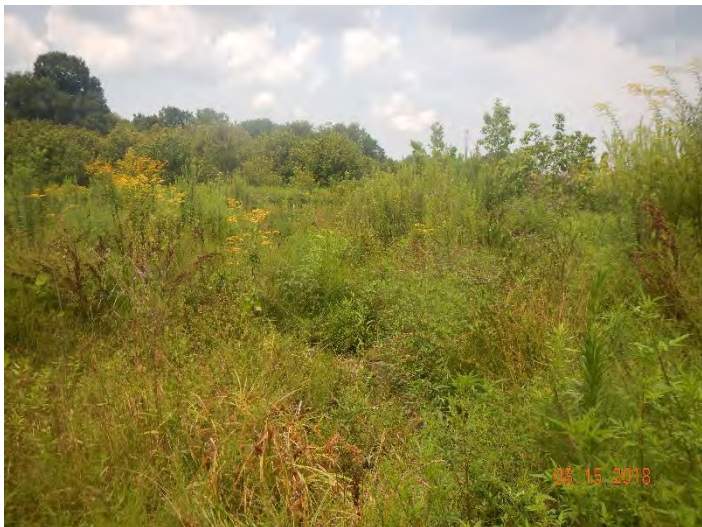
Photo Point 19 – UT1 looking downstream (8/15/2018)

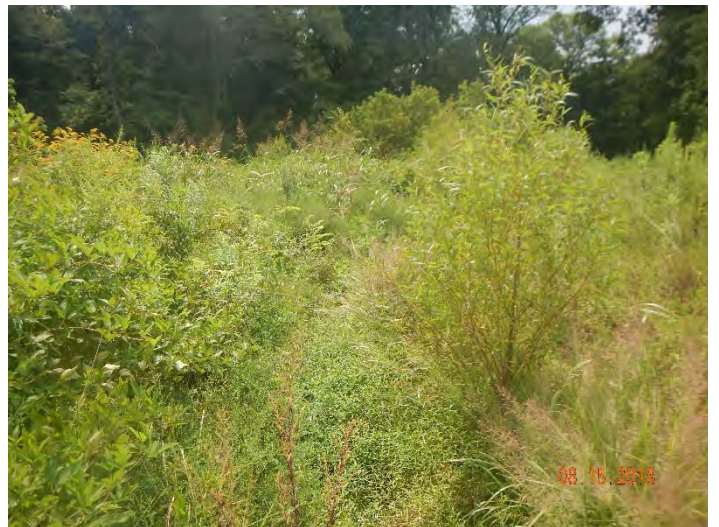
Photo Point 20 – UT1 looking upstream (8/15/2018)

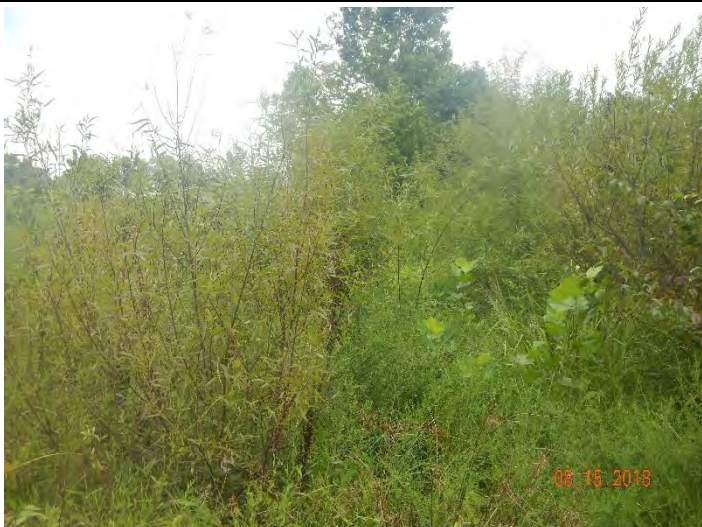
Photo Point 20 – UT1 looking downstream (8/15/2018)

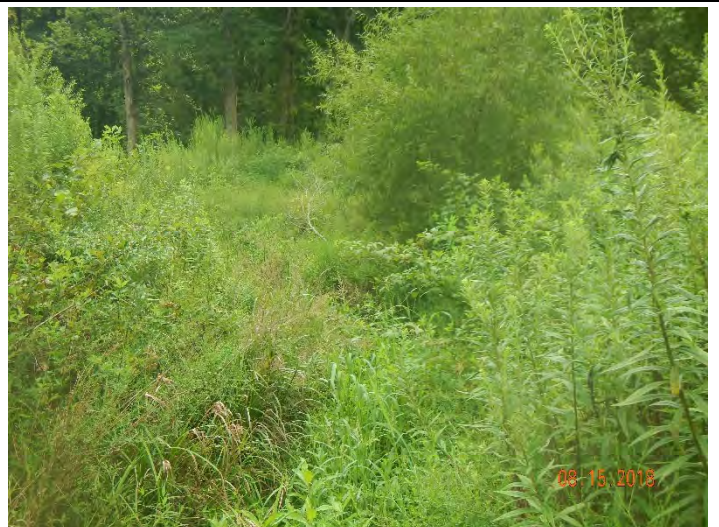
Photo Point 21 – UT1 looking upstream (8/15/2018)

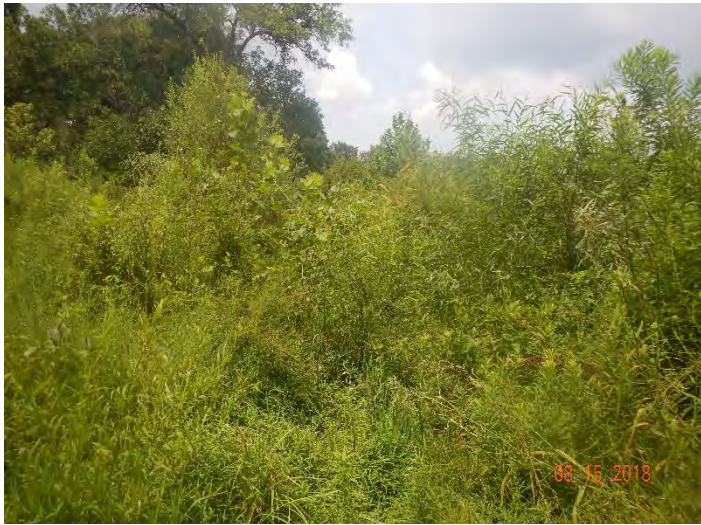
Photo Point 21 – UT1 looking downstream (8/15/2018)

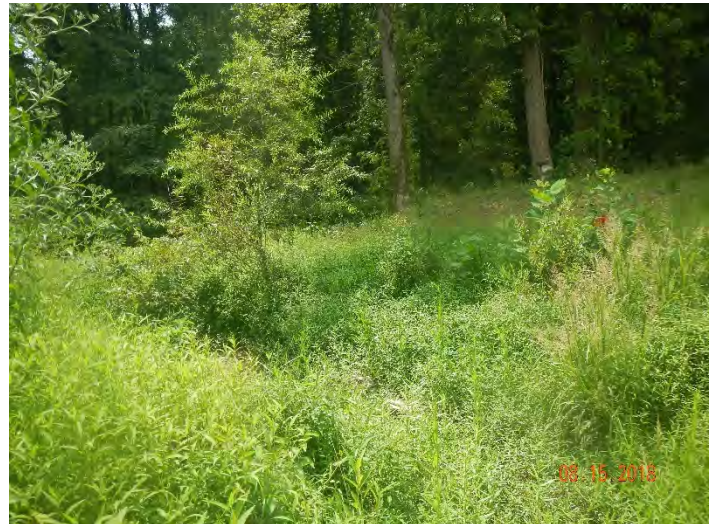
Photo Point 22 – UT1 looking upstream (8/15/2018)

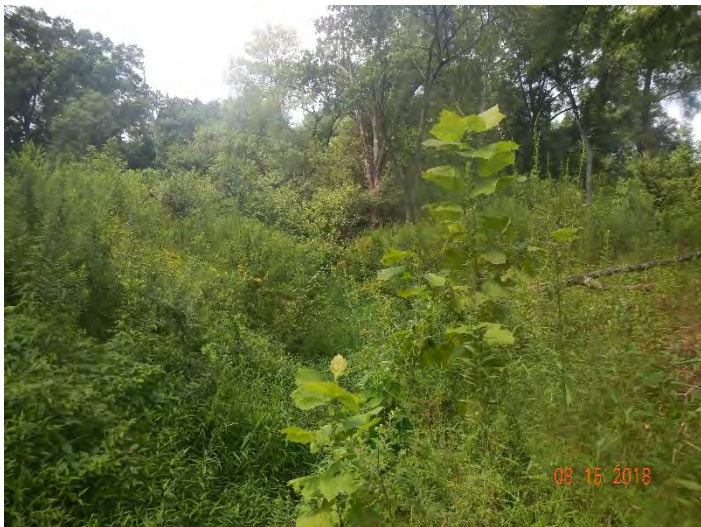
Photo Point 22 – UT1 looking downstream (8/15/2018)

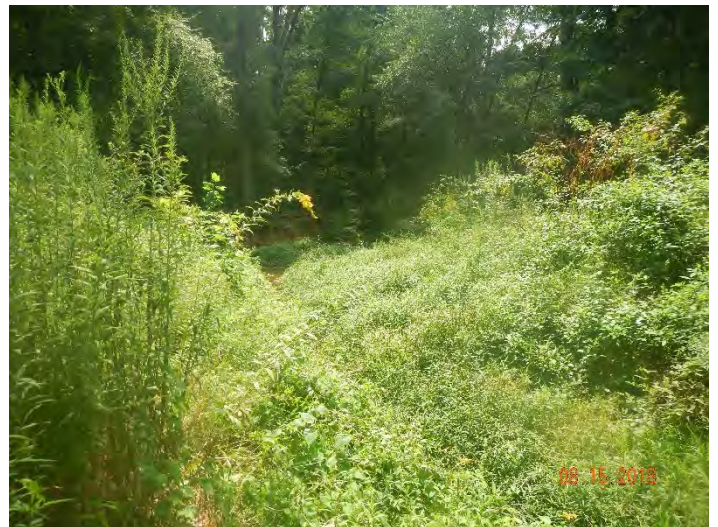
Photo Point 23 – UT1 looking upstream (8/15/2018)

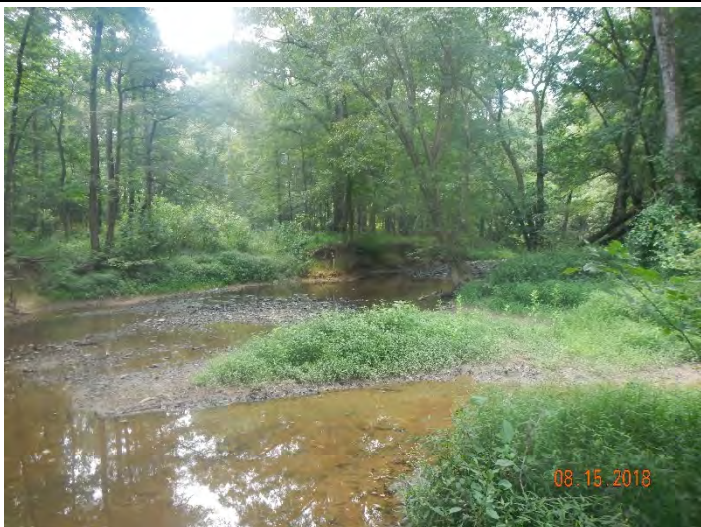
Photo Point 23 – UT1 looking downstream (8/15/2018)

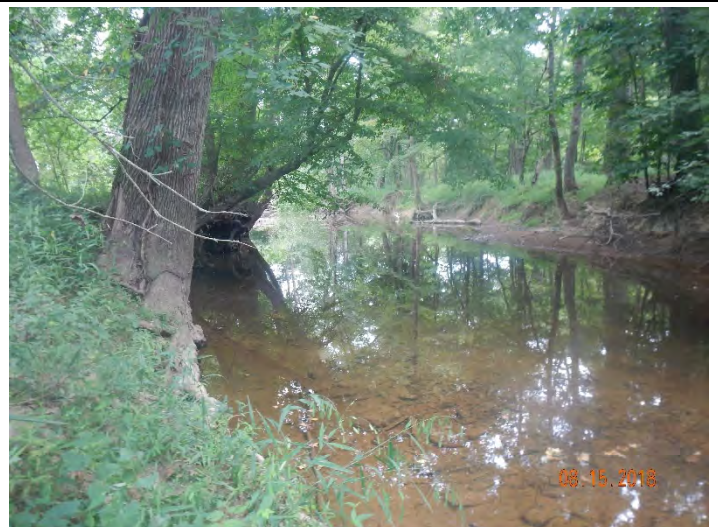
Photo Point 24 – Crooked Creek looking upstream (8/15/2018)

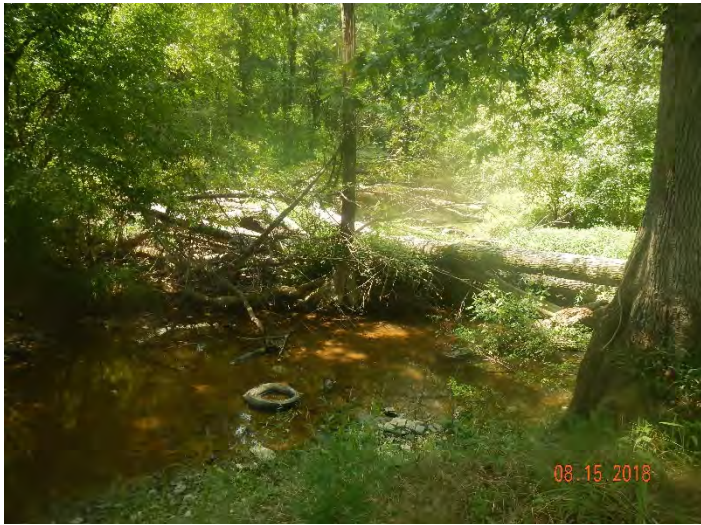
Photo Point 24 – Crooked Creek looking downstream (8/15/2018)

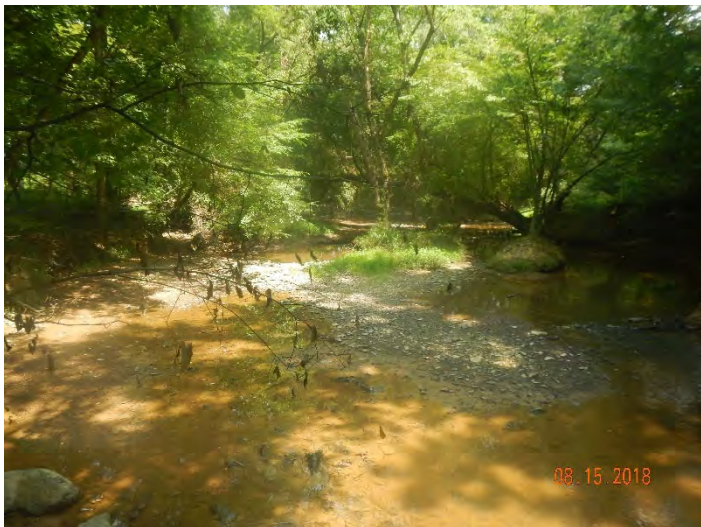
Photo Point 25 – Crooked Creek looking downstream (8/15/2018)

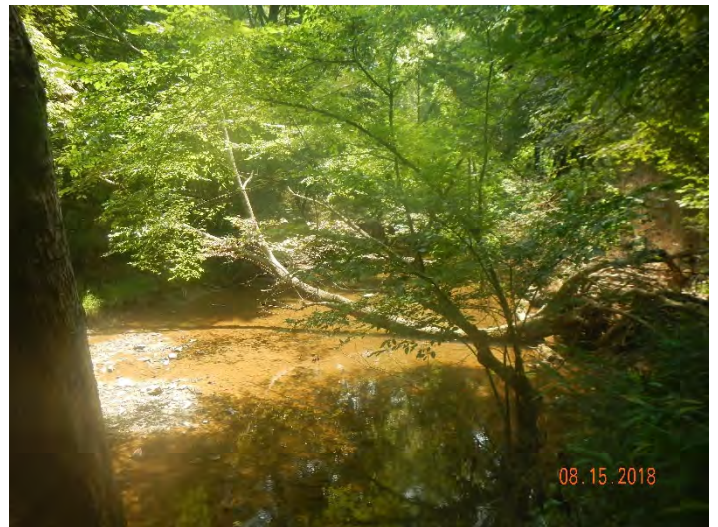
Photo Point 26 – Crooked Creek looking upstream (8/15/2018)

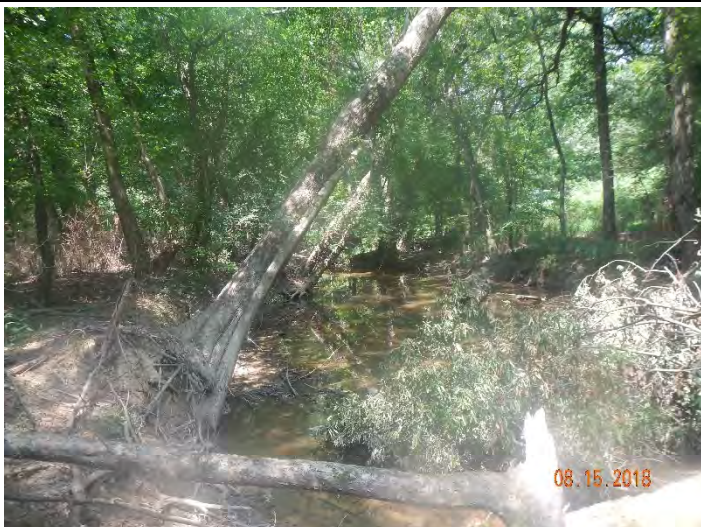
Photo Point 26 – Crooked Creek looking downstream (8/15/2018)

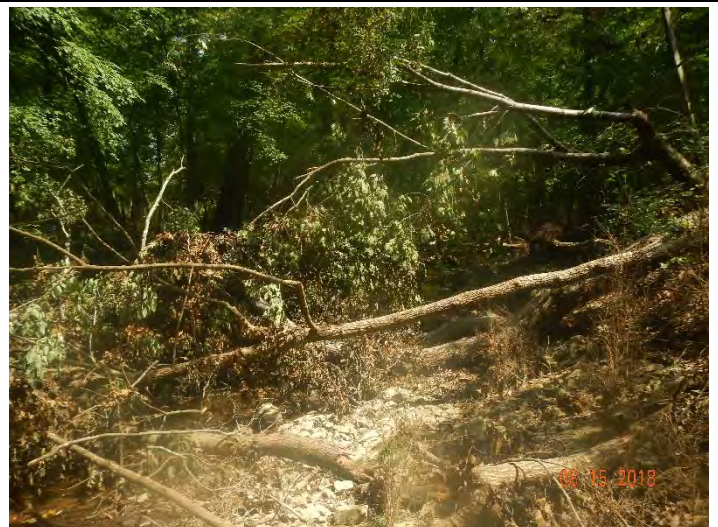
Photo Point 27 – Crooked Creek looking upstream (8/15/2018)

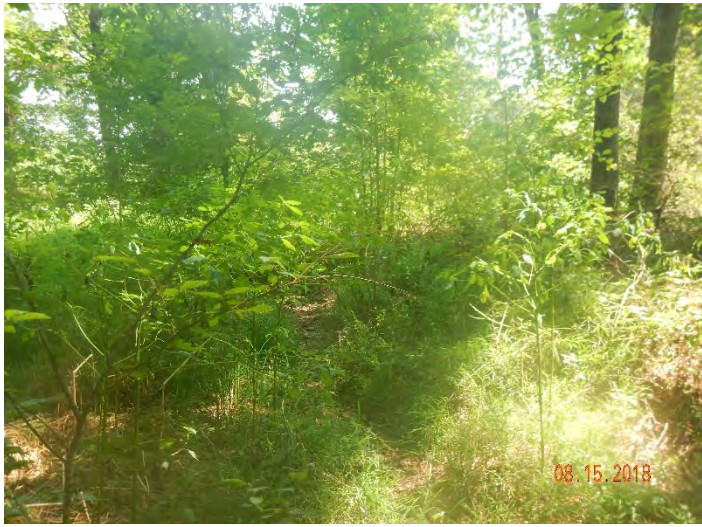
Photo Point 27 – Crooked Creek looking downstream (8/15/2018)

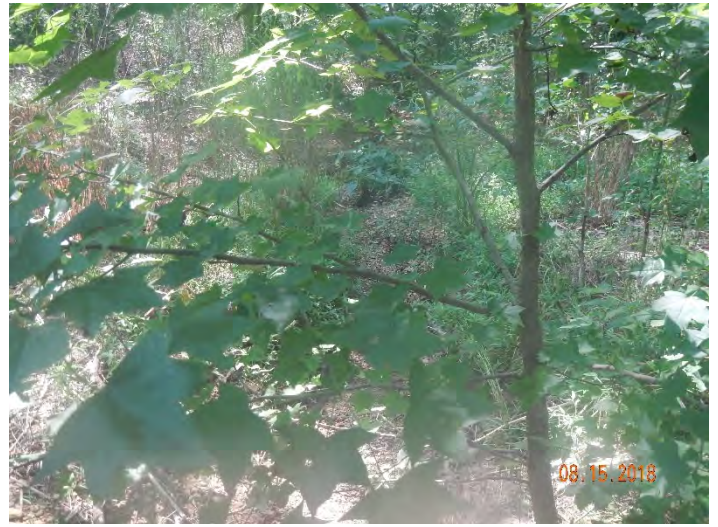
Photo Point 28 – UT2 looking upstream (8/15/2018)

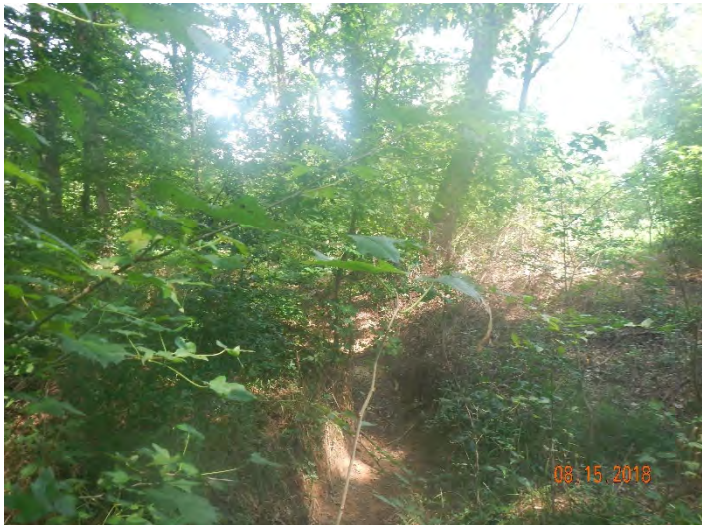
Photo Point 28 – UT2 looking downstream (8/15/2018)

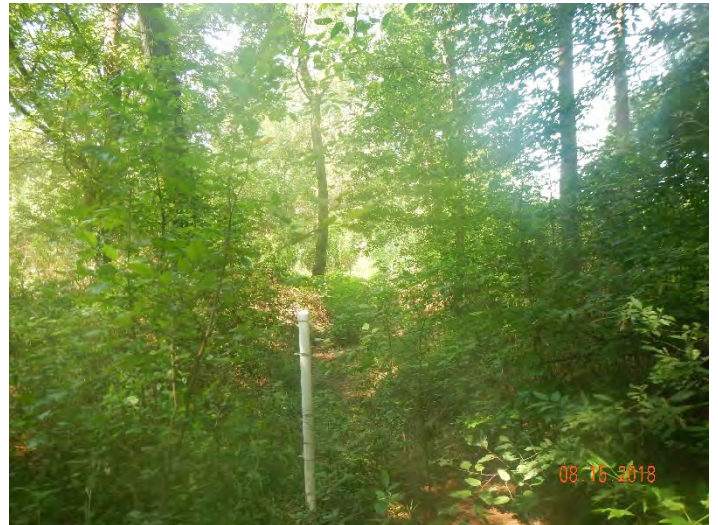
Photo Point 29 – UT2 looking upstream (8/15/2018)

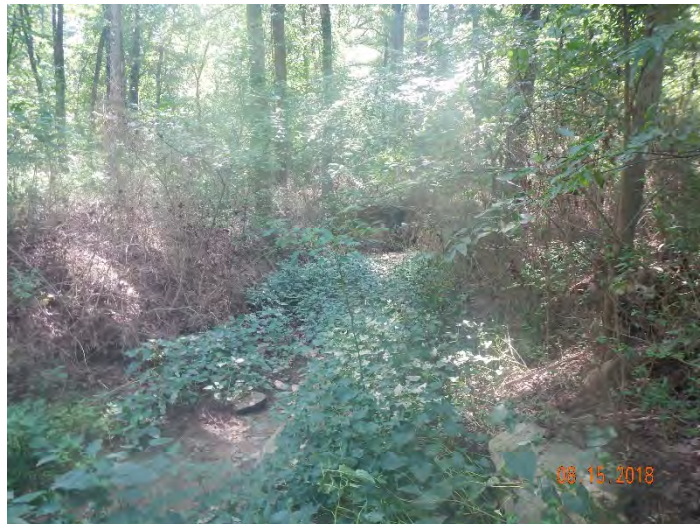
Photo Point 29 – UT2 looking downstream (8/15/2018)

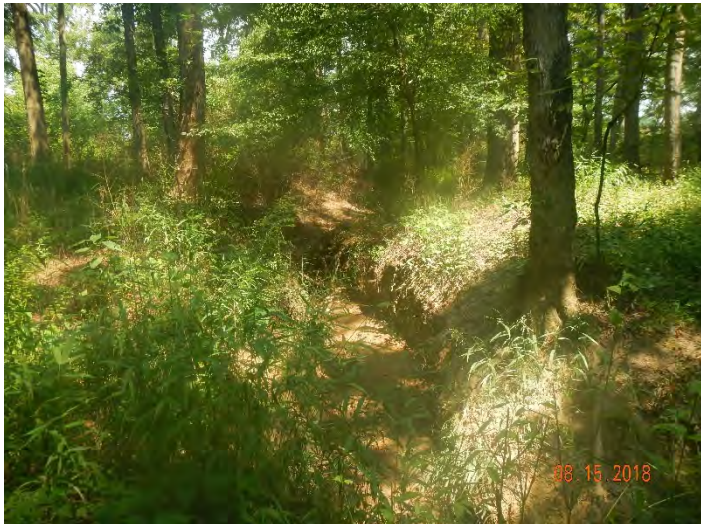
Photo Point 30 – UT2 looking downstream to UT2 (8/15/2018)

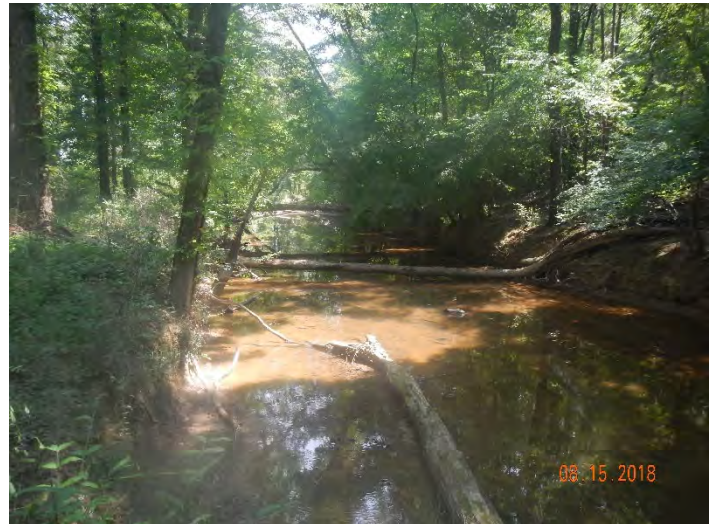
Photo Point 31 – UT2 looking upstream Crooked Creek

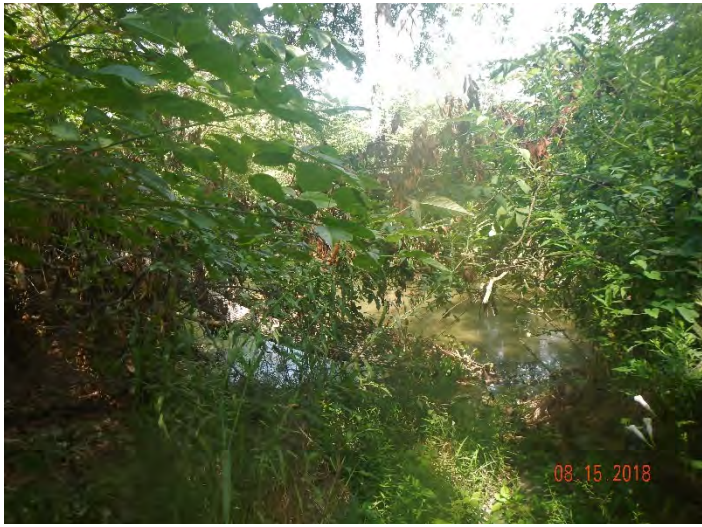
Photo Point 30 –Wetland CC outlet facing W (8/15/2018)

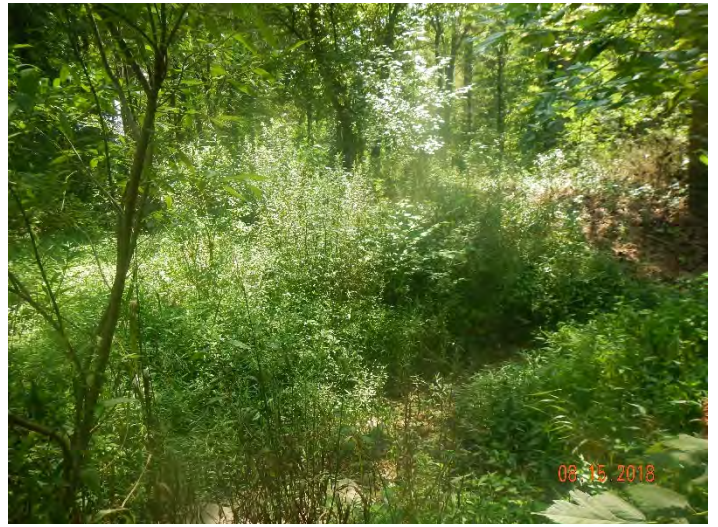
Photo Point 30 –Wetland CC outlet facing E (8/15/2018)

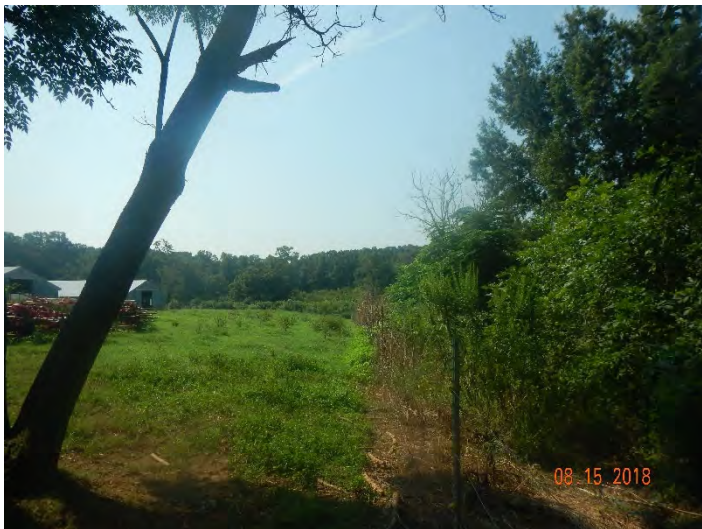
Photo Point 32 –Wetland AA facing W (8/15/2018)

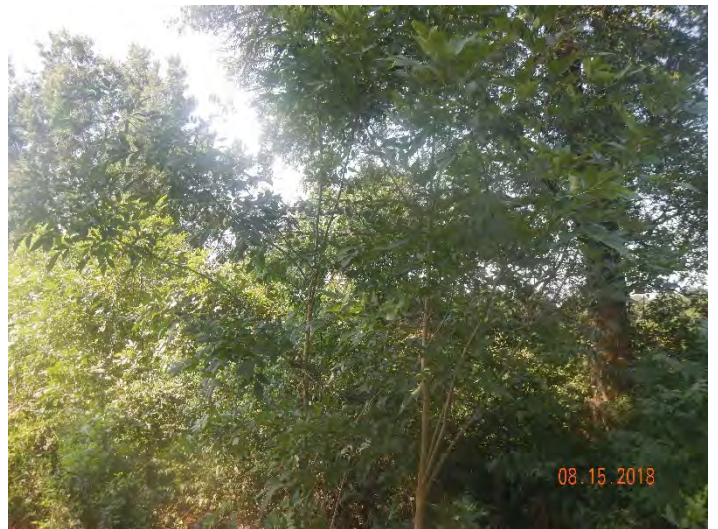
Photo Point 32 – Wetland Zone A facing S (8/15/2018)

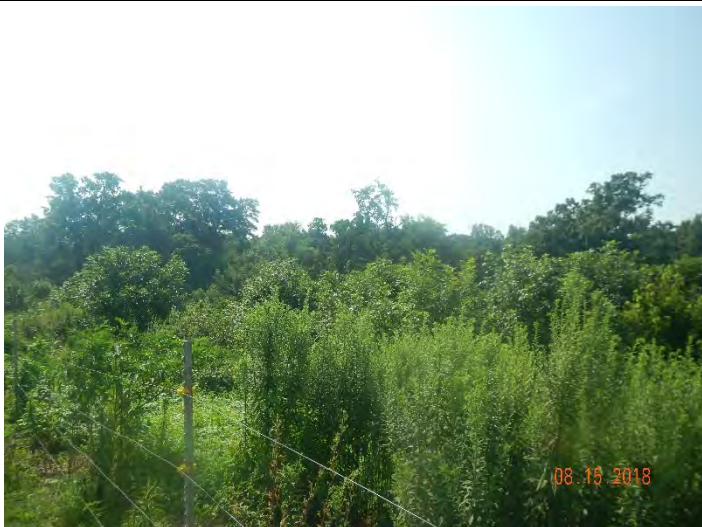
Photo Point 33 – Wetland Zone A & B facing W (8/15/2018)

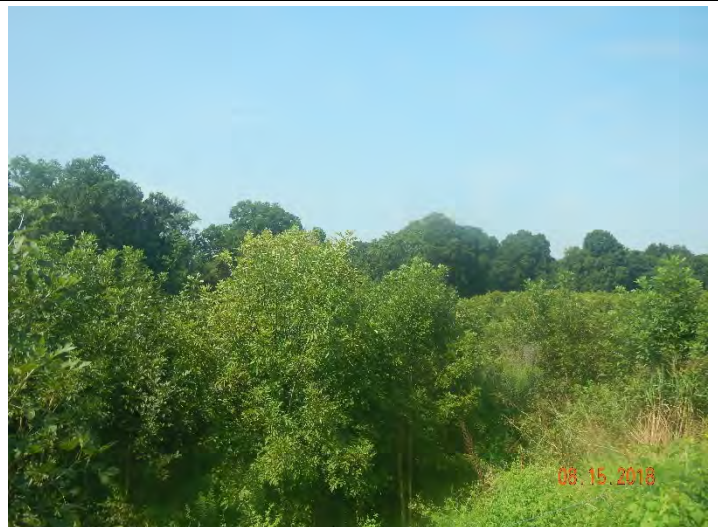
Photo Point 33 - Wetland B facing S (8/15/2018)

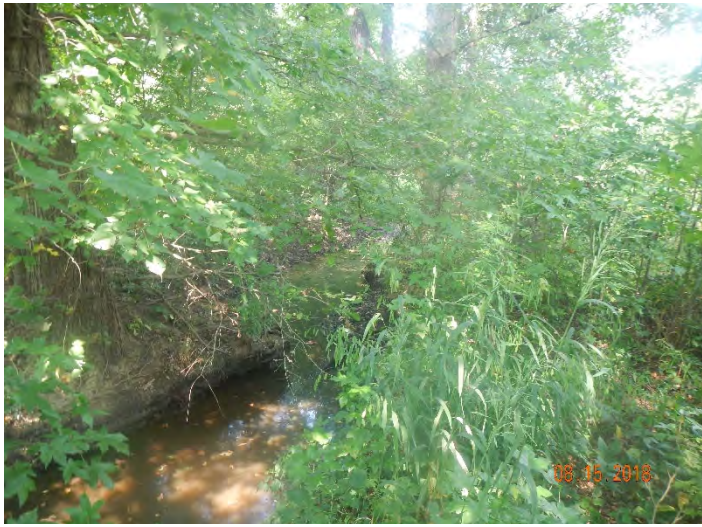
Photo Point 34 –Wetland CC facing NW (8/15/2018)

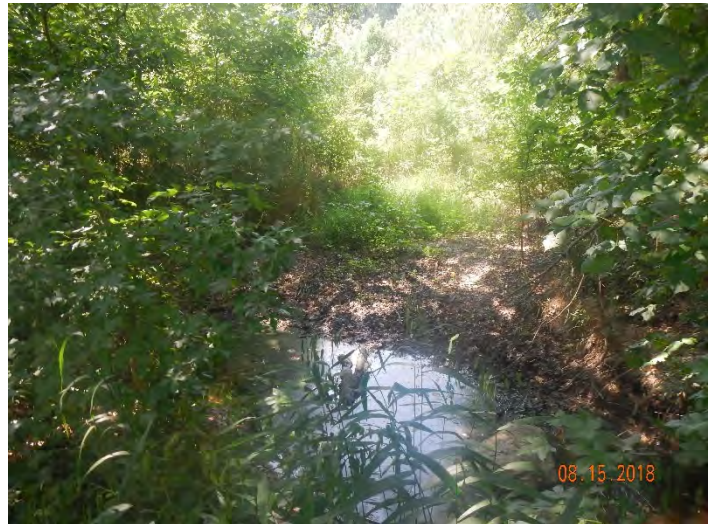
Photo Point 34 –Wetland CC facing S (8/15/2018)
