MONITORING YEAR 4 ANNUAL REPORT

CROOKED CREEK #2 RESTORATION PROJECT

Union County, NC

DMS Project Number 94687

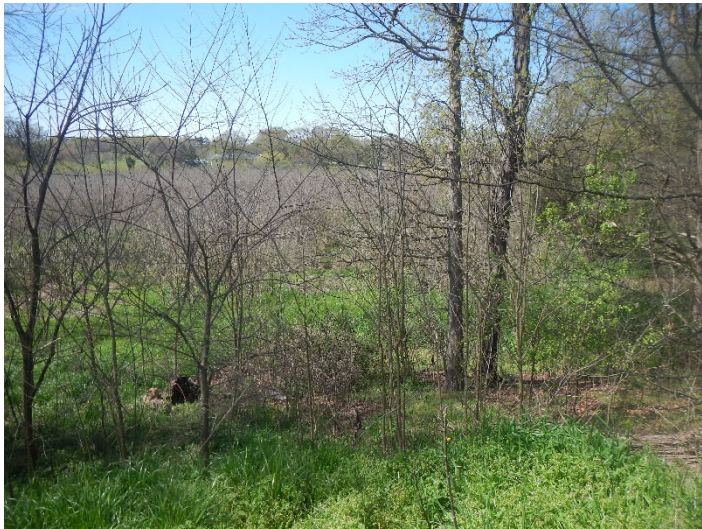
Photo Point 32 –Wetland AA facing West (4/1/2019)

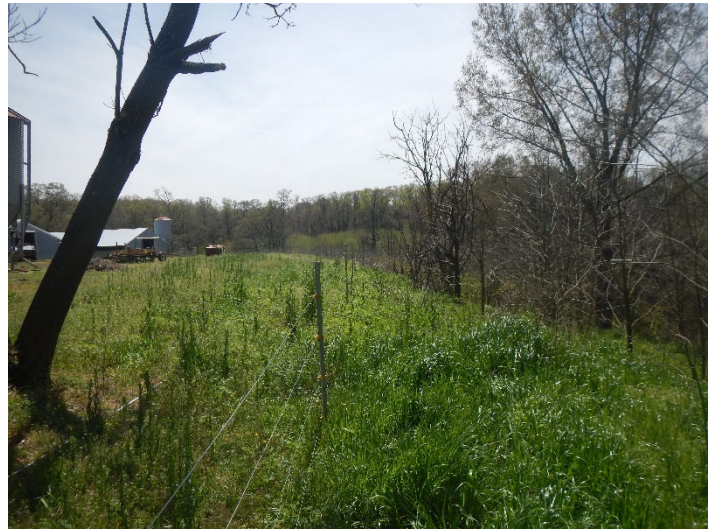
Photo Point 32 – Wetland Zone A facing South (4/1/2019)

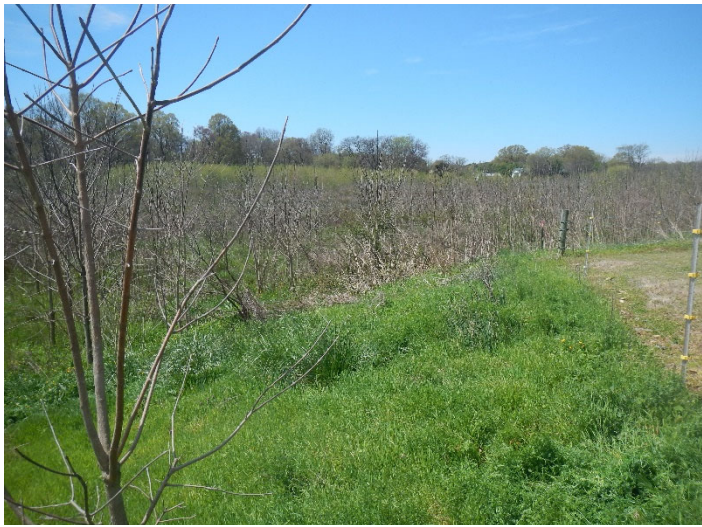
Photo Point 33 – Wetland Zone A & B facing West (4/1/2019)

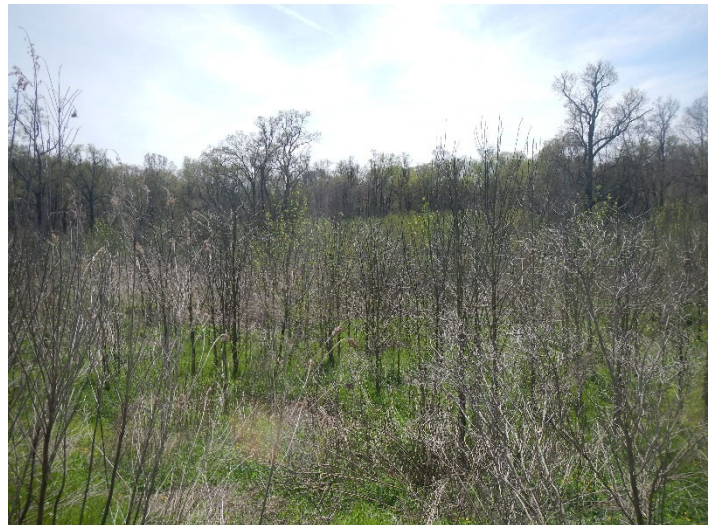
Photo Point 33 - Wetland B facing South (4/1/2019)

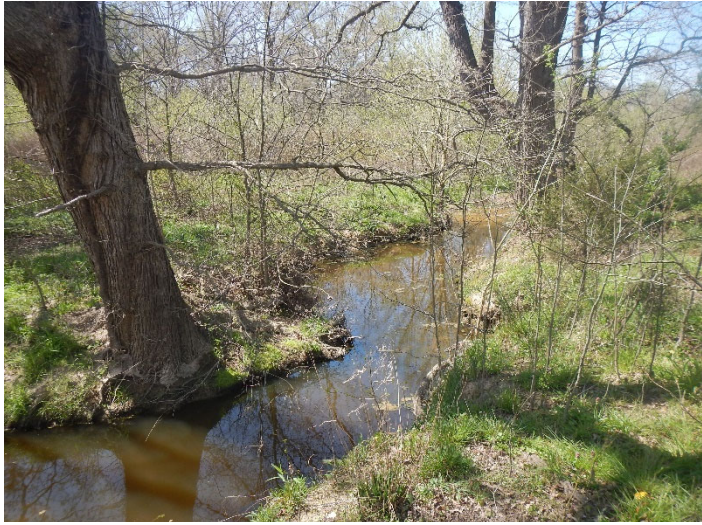
Photo Point 34 –Wetland CC facing Northwest (4/1/2019)

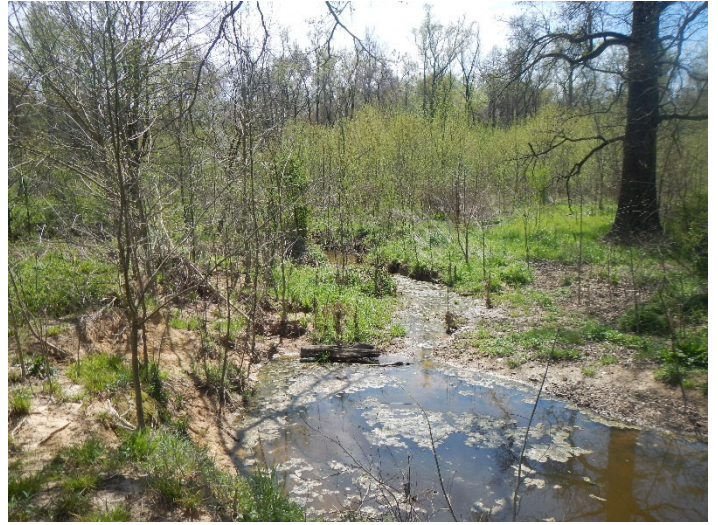
Photo Point 34 –Wetland CC facing South (4/1/2019)

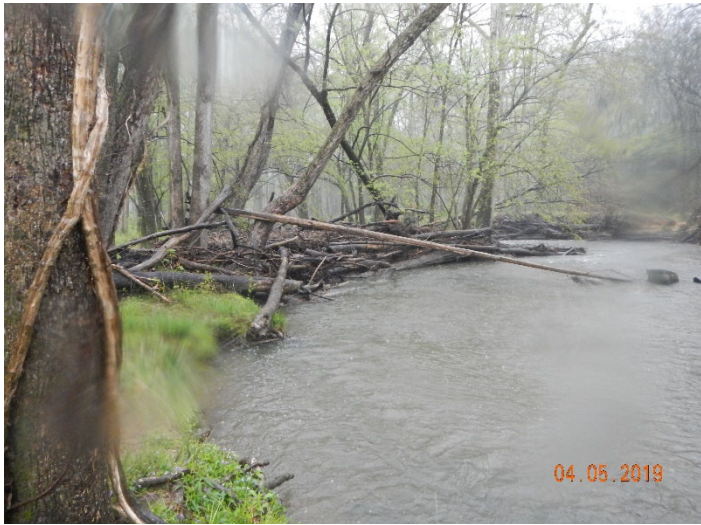
Bankfull Flow – Crooked Creek (4/5/2019)

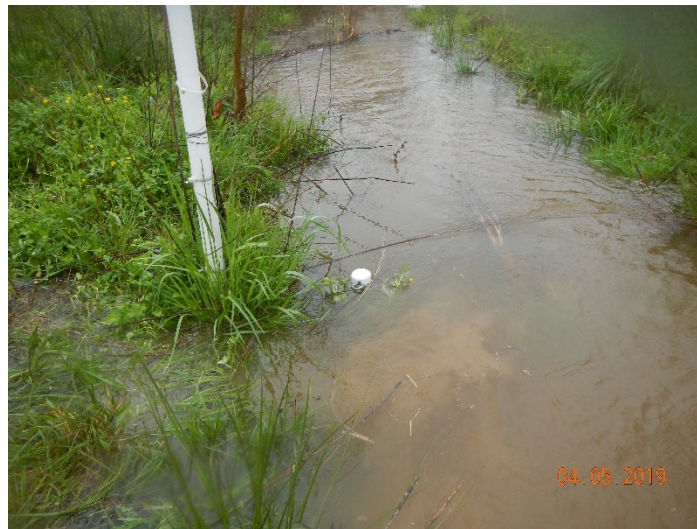
Bankfull Flow – UT1 (4/5/2019)
