# **MONITORING YEAR 5 ANNUAL REPORT**

## **CROOKED CREEK #2 RESTORATION PROJECT**

DMS Project Number 94687

Data Collection Period: March – November 2020

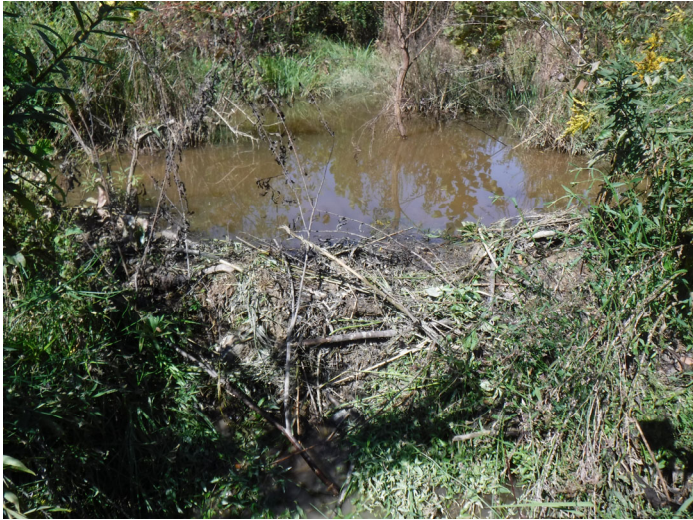
Beaver Dam at XS3 (9/29/2020)

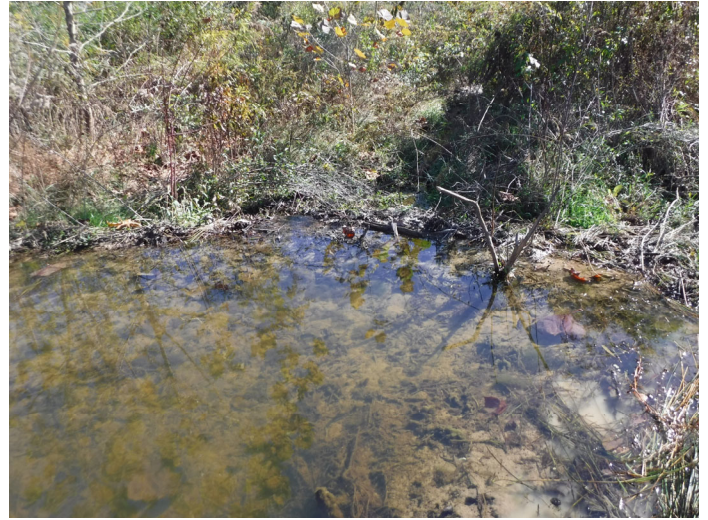
Beaver Dam at XS3 (11/2/2020)

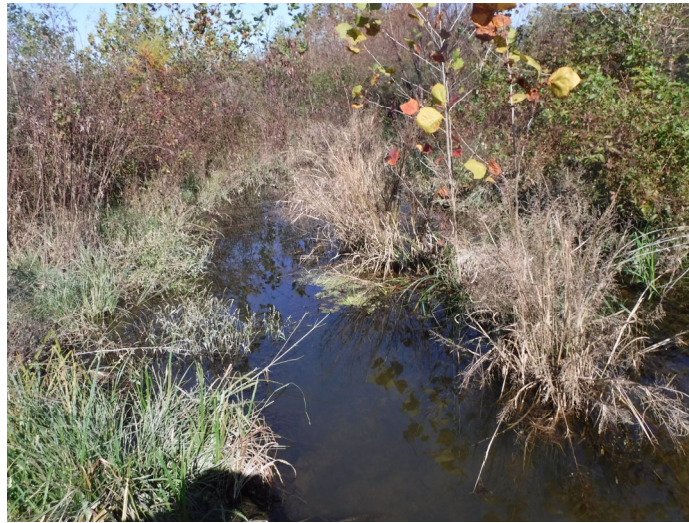
Water ponded behind beaver dam at XS3 (9/29/2020)

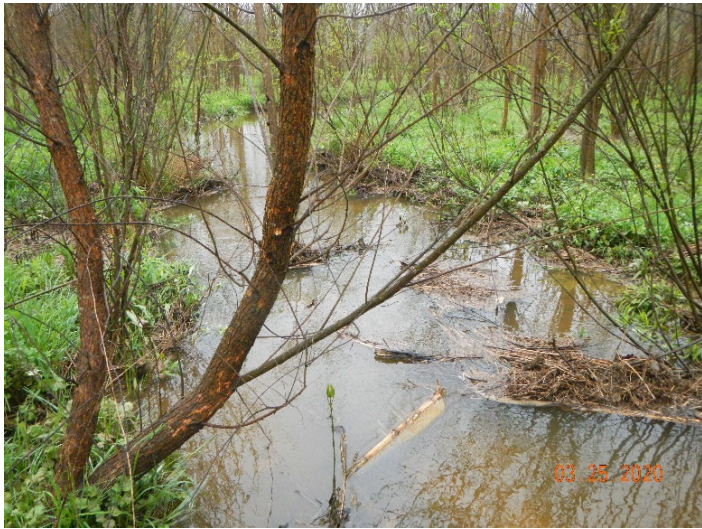
**Bankfull Flow – UT1(3/25/2020)**

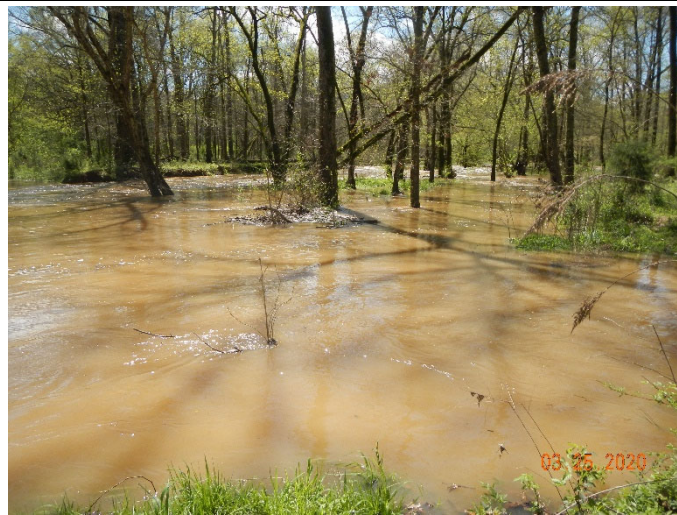
**Bankfull Flow – Crooked Creek (3/25/2020)**

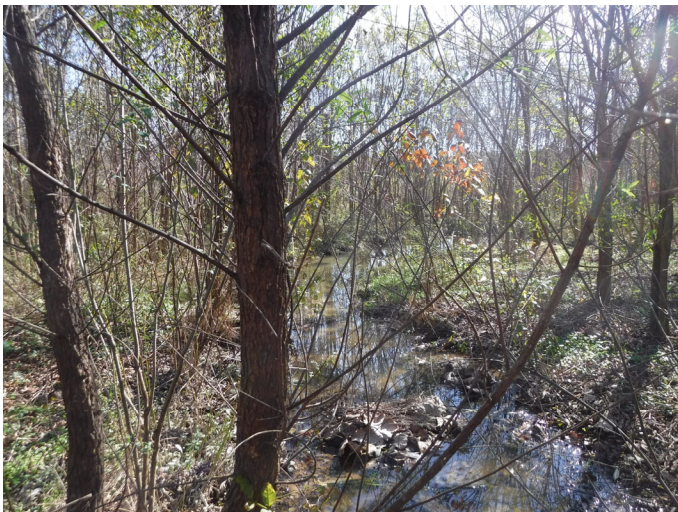
**Wrack Lines – Crooked Creek (11/5/2020)**
