CROWNS WEST STREAM RESTORATION PROJECT

ANNUAL MONITORING REPORT FOR 2008 (YEAR 2)

Contract Number D06003-2

December 2008

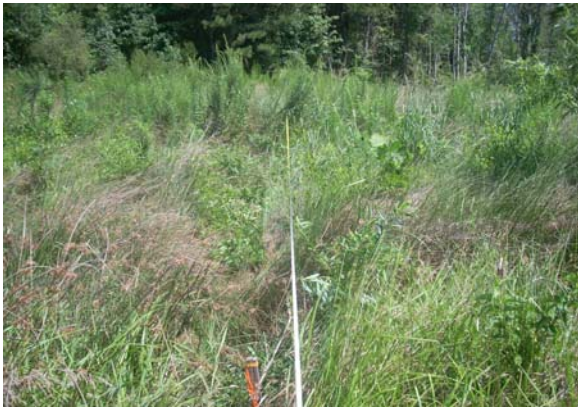
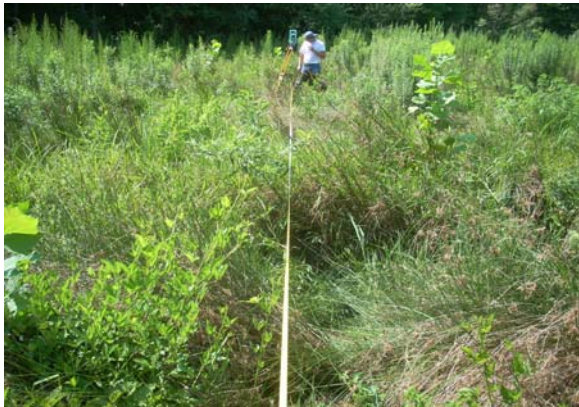
Permanent Cross-section 1
(Year 2 Data - Collected August 2008)

Feature	Stream Type	BKF Area	BKF Width	BKF Depth	Max BKF Depth	W/D	BH Ratio	ER	BKF Elev	TOB Elev
Riffle	Cc	6	9.79	0.61	0.97	16.05	1	6.1	64.04	64.05

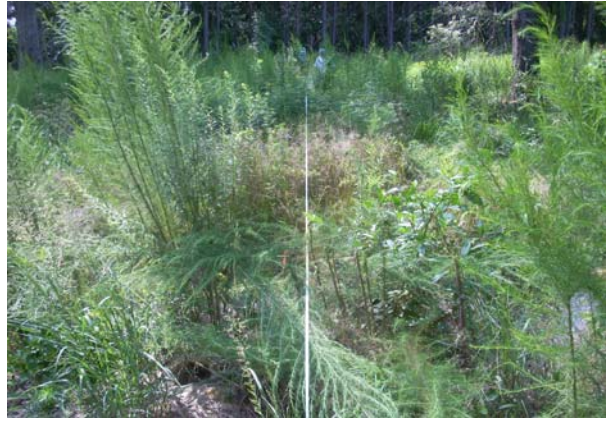
Permanent Cross-section 2
(Year 2 Data - Collected August 2008)

Feature	Stream Type	BKF Area	BKF Width	BKF Depth	Max BKF Depth	W/D	BH Ratio	ER	BKF Elev	TOB Elev
Pool		16.4	10.43	1.57	2.75	6.64	1.2	6.7	62.45	62.98

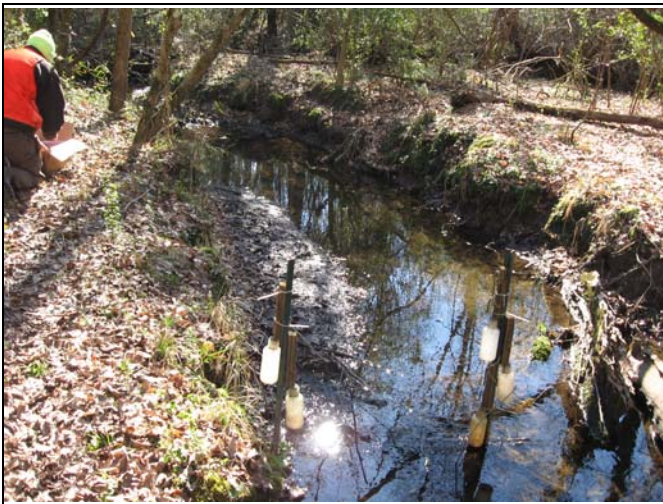
Site 2 – Beaverdam Branch macroinvertebrate sampling site, view is upstream

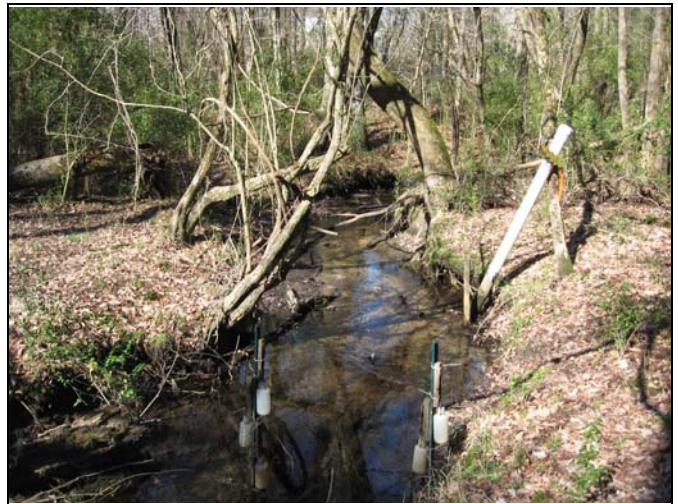
Site 2 – Beaverdam Branch macroinvertebrate sampling site, view is downstream

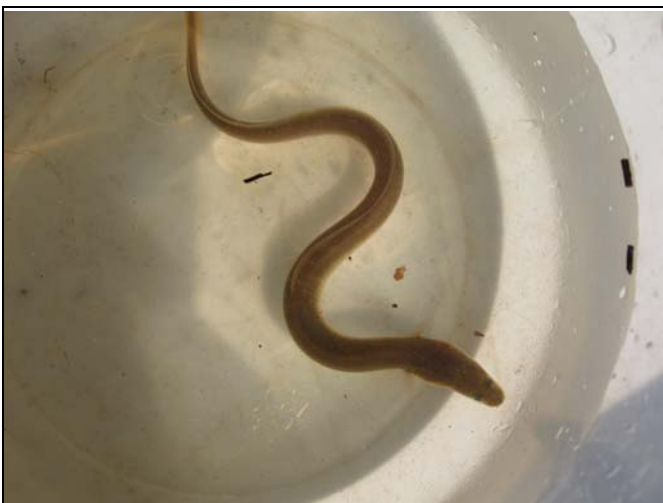
Site 1 - American eel (*Anguilla rostrata*)
