CROWNS WEST STREAM RESTORATION PROJECT

ANNUAL MONITORING REPORT FOR 2009 (YEAR 3)

Contract Number D06003-2

December 2009

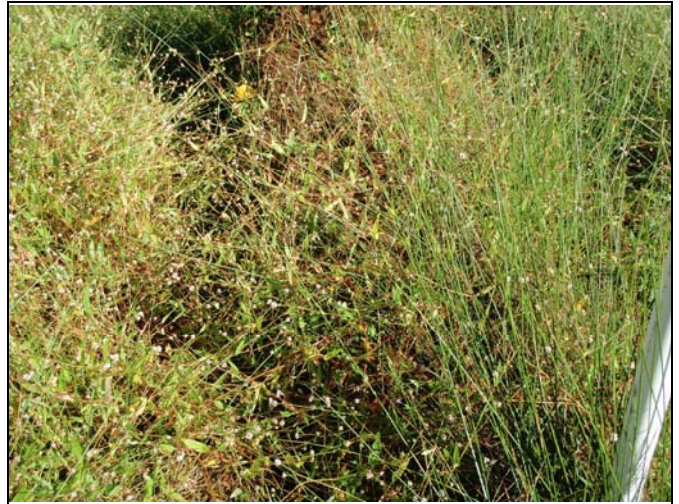
Vegetation Plot 1

During monitoring Year 3, vegetation plot 1 encountered two different problems that may threaten future survivability of the plot and the surrounding area. These problems are weedy species occurring within the vegetation plot and saturated soils due to beaver dams. The strong presence of arrowleaf tearthumb (*Polygonum sagittatum*) and an unknown vine species in this area is affecting the survivability of the smaller planted stems. Two beaver dams in the area have caused the soils to become saturated for an extended period, which has caused planted stems, mostly sycamores, to begin to lean. The beaver dams will be removed during the winter of 2009/2010.

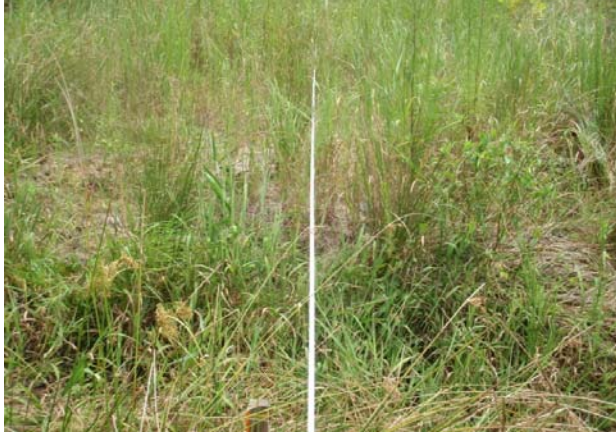
Looking at the Left Bank

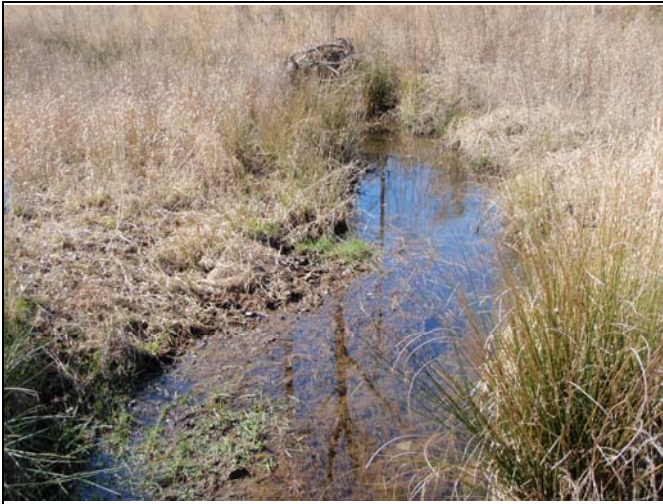
Site 1 – Crowns West macroinvertebrate sampling site, view is upstream (Year 2)

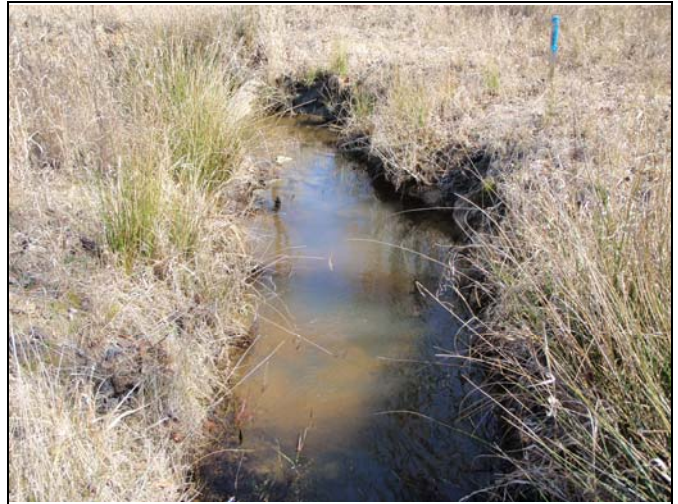
Site 1 – Crowns West macroinvertebrate sampling site, view is downstream (Year 2)

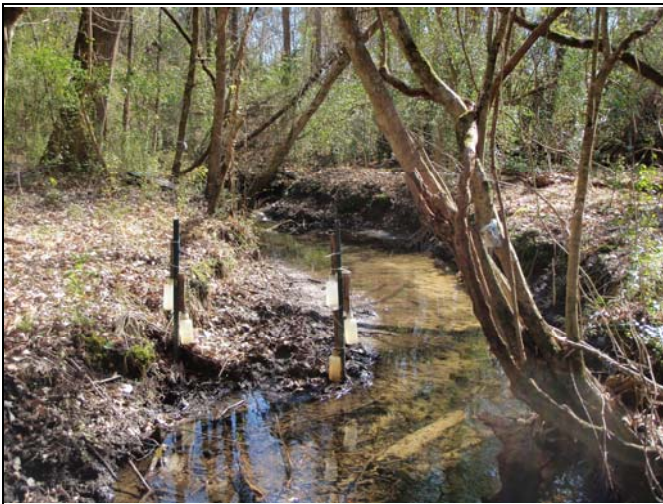
Site 2 – Beaverdam Branch macroinvertebrate sampling site, view is upstream (Year 2)

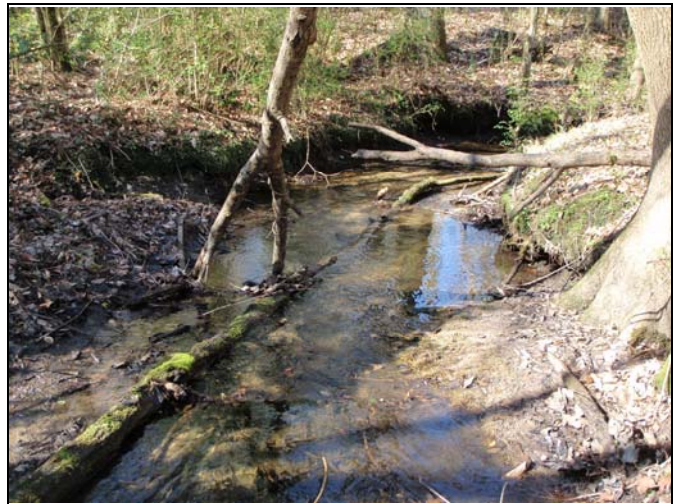
Site 2 – Beaverdam Branch macroinvertebrate sampling site, view is downstream (Year 2)
