CROWNS WEST STREAM RESTORATION PROJECT

ANNUAL MONITORING REPORT FOR 2011 (YEAR 5)

Contract Number D06003-2

December 2011

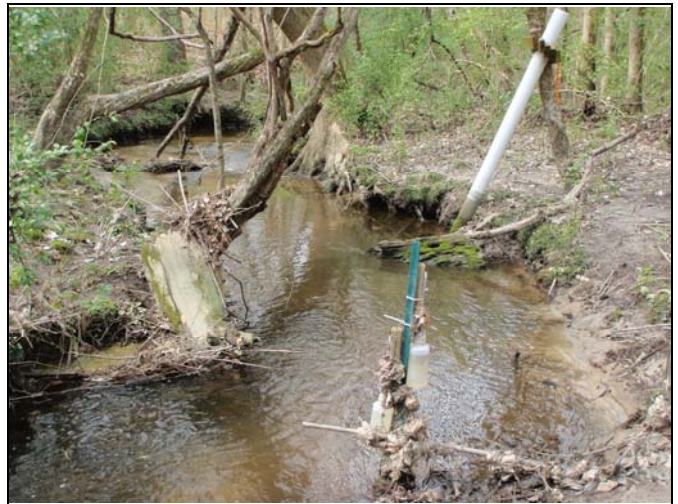
Site 2 – Beaverdam Branch macroinvertebrate sampling site, view is downstream (Year 3)
