Year 2 Monitoring Report for Stream Restoration of Davis Branch and Unnamed Tributary

Union County, NC
SCO # D06054-F

Submitted: January 2011

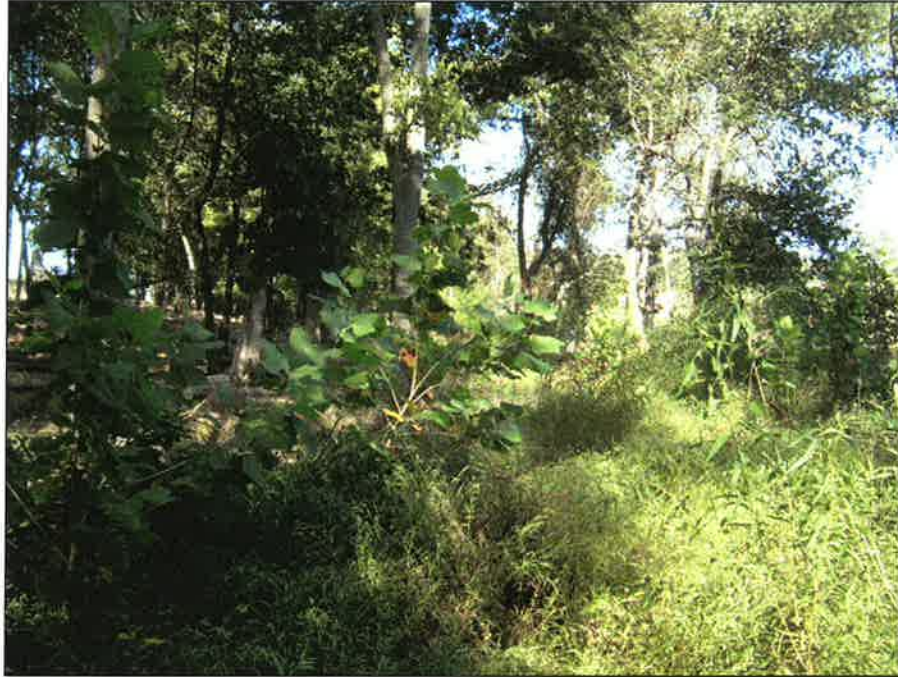
Fixed Station 7
Overview of UT1, looking upstream near Station 6+50.
(EMH&T, Inc. 9/20/10)

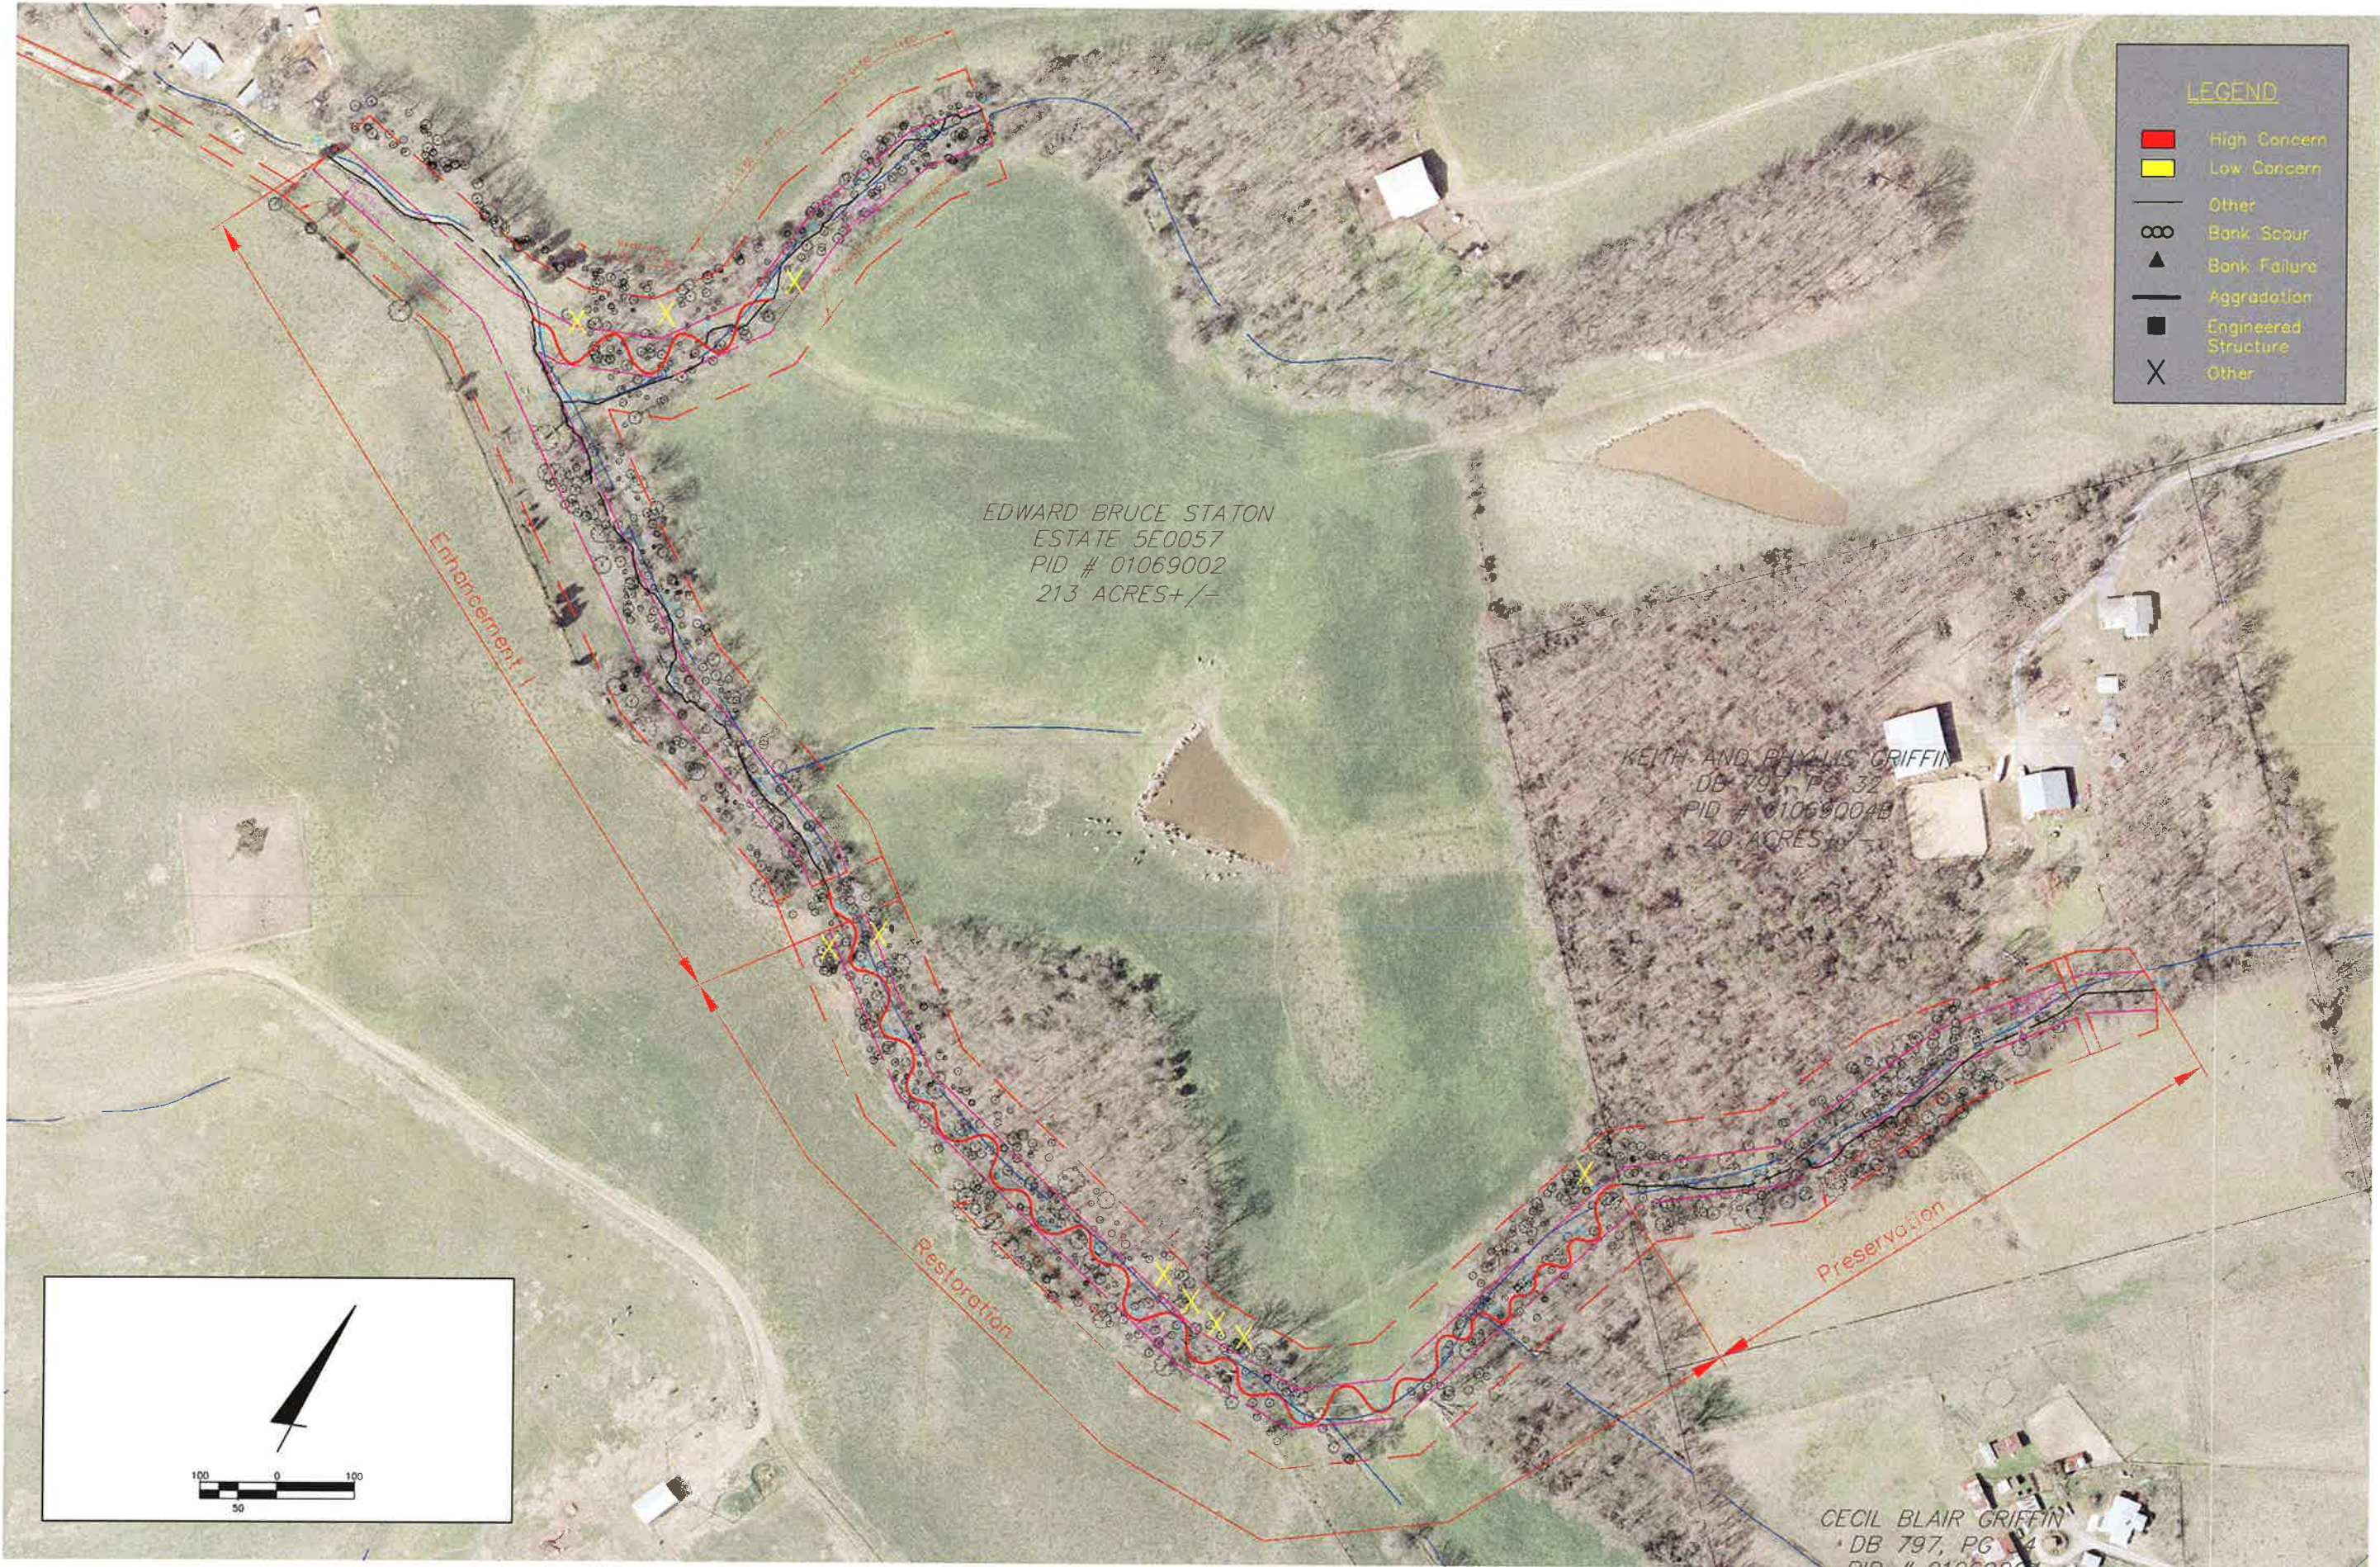
Job No. 2009-0326	Date January, 2011	Scale 1" = 100'	Sheet 1-1
UNION COUNTY, NORTH CAROLINA STREAM RESTORATION PLAN FOR DAVIS BRANCH AND UNNAMED TRIBUTARY APPENDIX B STREAM PROBLEM AREAS

Table X. Stream Problem Areas			
Davis Branch Stream Restoration / EEP Project No. D06054-F			
Feature Issue	Station Numbers	Suspected Cause	Photo Number
Other	8+00 Mainstem	Bare banks - concern for future stability if vegetation does not develop	SPA 1
	11+00-13+00 Mainstem	Bare banks (patchy distribution along this section) - concern for future stability if vegetation does not develop	SPA 2
	29+90 Mainstem	Bare banks - concern for future stability if vegetation does not develop	
	7+25, 5+50 UT1 PI/II	Bare banks - concern for future stability if vegetation does not develop	
	3+50 – 0+50 UT1 PI/II	Bare banks (patchy distribution along this section) - concern for future stability if vegetation does not develop	SPA 3

The other type of problem area is isolated to a few meander bends along the project streams. The banks of the outside bends have little established vegetation to stabilize the slopes. These areas are considered low concern at this time, as the bends are not actively eroding beyond the minor sloughing of loose soil. Additionally, vegetation in 2010 is beginning to infiltrate the bare areas. This is resulting in an increased root density which provides better stabilization for the stream banks. No remedial maintenance is scheduled at this time. These areas are noted in order that they be watched to catch any erosion problems that may occur before vegetation becomes fully established along these slopes. Actively monitoring these areas will allow developing problems to be caught early and managed without the need for mechanical intervention. If erosion problems arise, the outside meander bends could be stabilized using vegetative methods such as seeding and live stakes, or with a natural fiber (coconut) geotextile.
