Subject: Year 3 Monitoring Report for Stream Mitigation of Davis Branch
SCO# D06054-F

Year 3 Monitoring Report for Stream Restoration of Davis Branch and Unnamed Tributary

Union County, NC
SCO # D06054-F

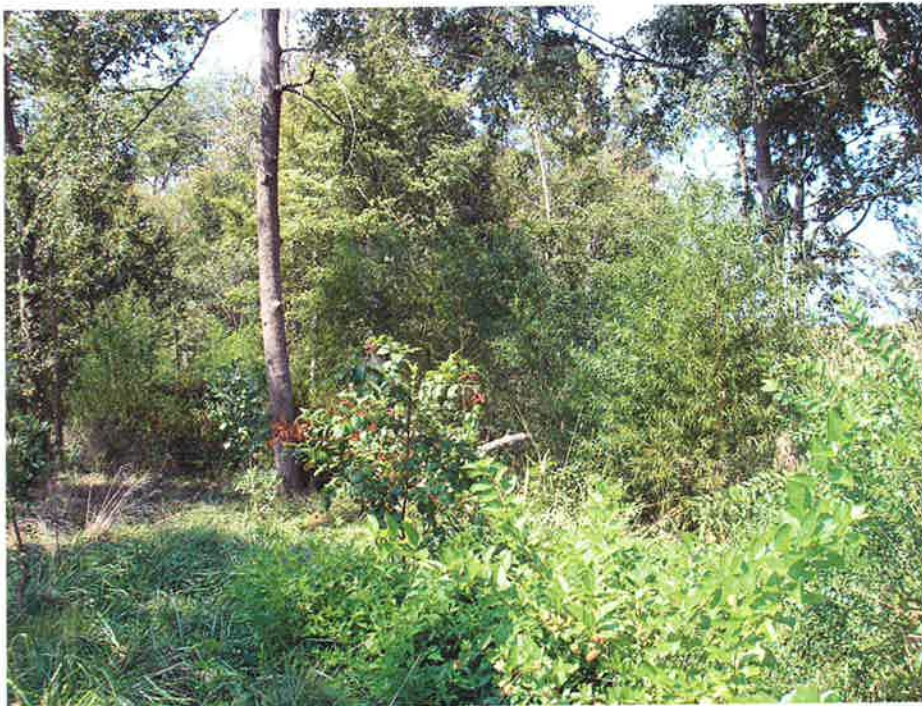
Fixed Station 2
Overview of Davis Branch, looking downstream near Station 14+75.
(EMH&T, 9/14/11)

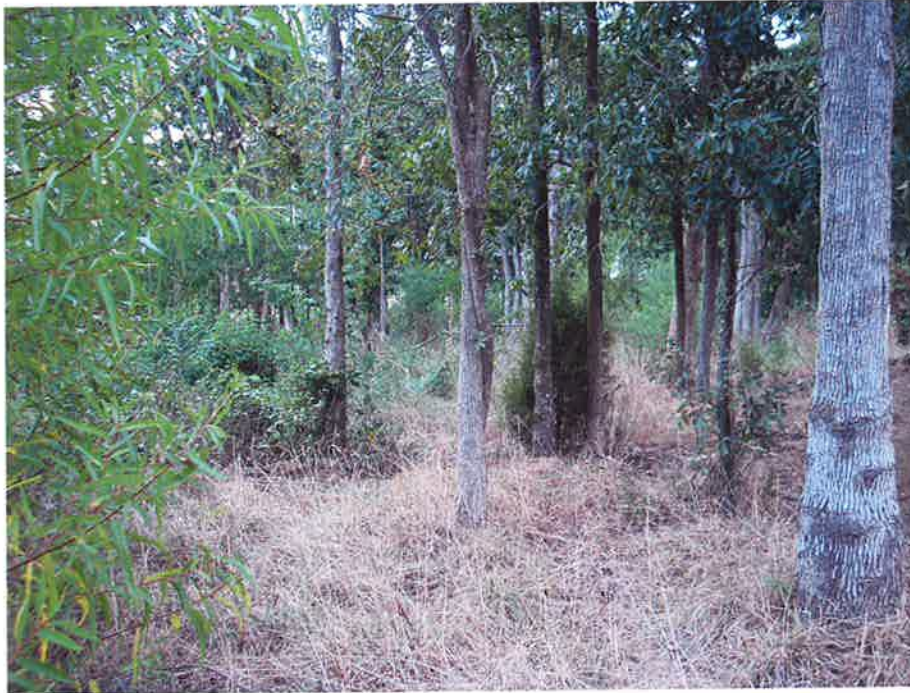
Fixed Station 3
Overview of Davis Branch, looking downstream near Station 15+50.
(EMH&T, 9/14/11)

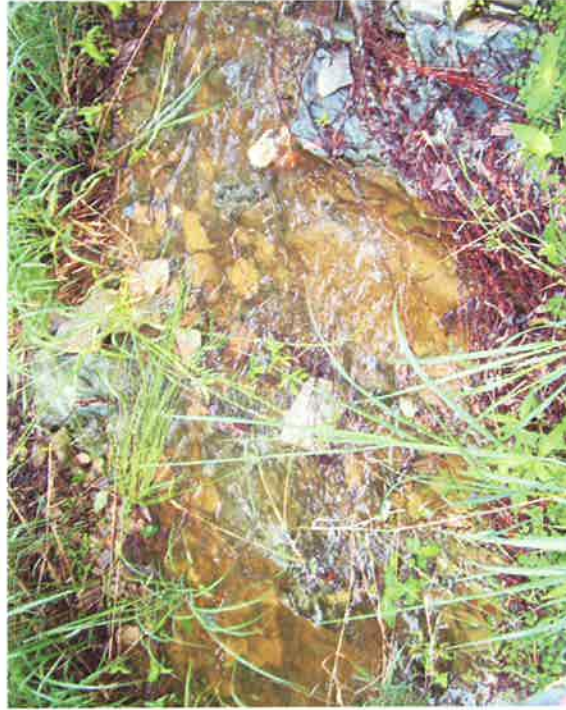
CROSS SECTION: 3
FEATURE: Riffle

Bankfull Area	18.71 ft ²
Bankfull Width	19.37 ft
Mean Depth	0.97 ft
Maximum Depth	1.94 ft
Width/Depth Ratio	19.97
Entrenchment Ratio	3.20

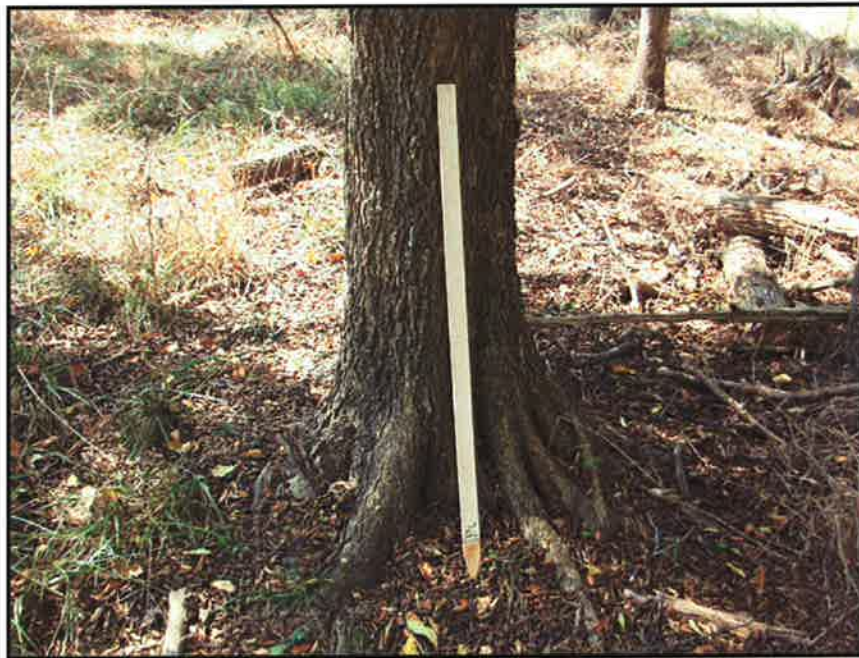
BF 3
Crest Gage on the mainstem of Davis Branch (Year 3).
(EMH&T, 9/14/11)

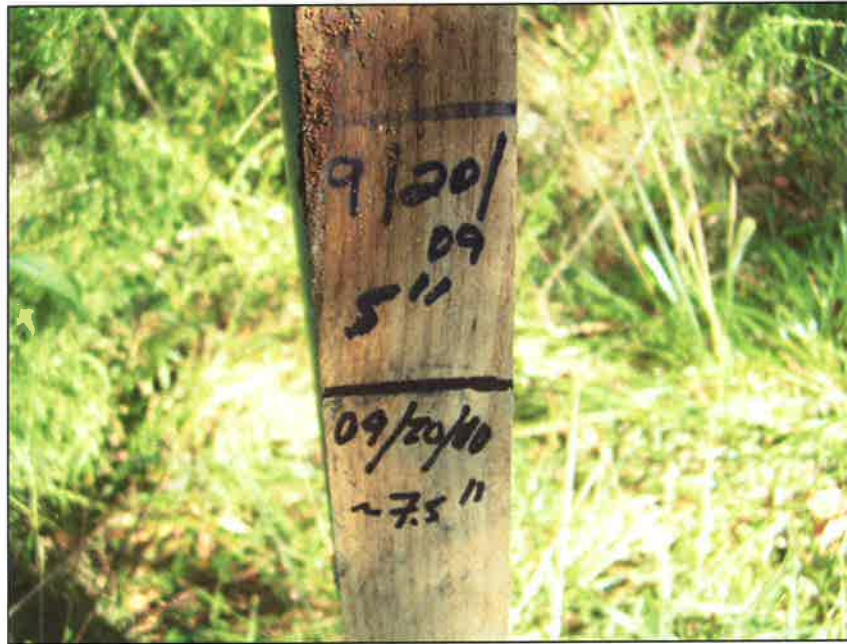
BF 2
Crest Gage 4 on UT1 of Davis Branch (Year 1).
(EMH&T, 9/20/09)
