Subject: Year 4 Monitoring Report for Stream Mitigation of Davis Branch
SCO# D06054-F

Year 4 Monitoring Report for Stream Restoration of Davis Branch and Unnamed Tributary

Union County, NC
SCO # D06054-F

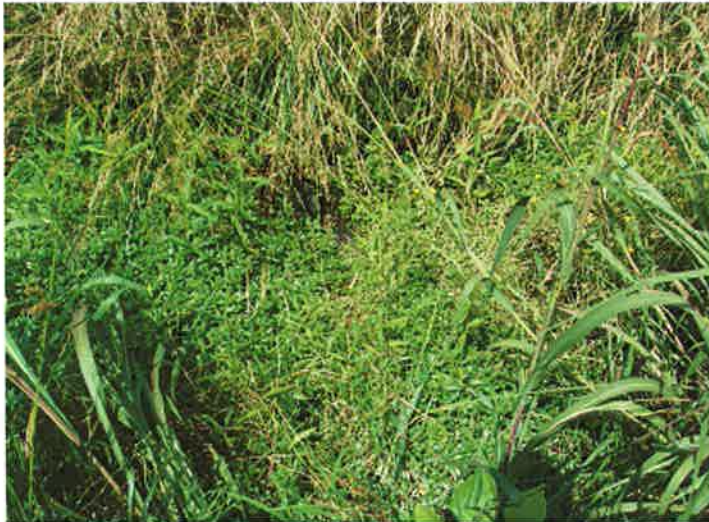
CROSS SECTION: 6

Cross-section photo – looking left bank to right bank

Davis Branch Mainstem - Pool XS 6 - Year 4

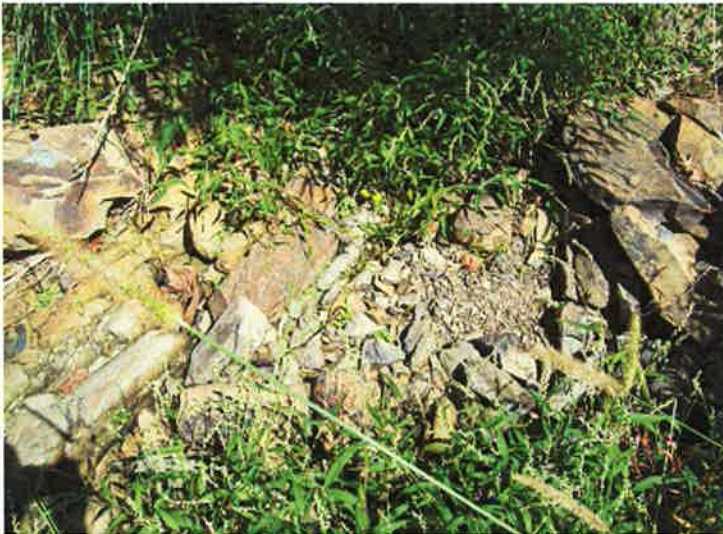
CROSS SECTION: 7

Cross-section photo – looking across channel from left bank to right bank

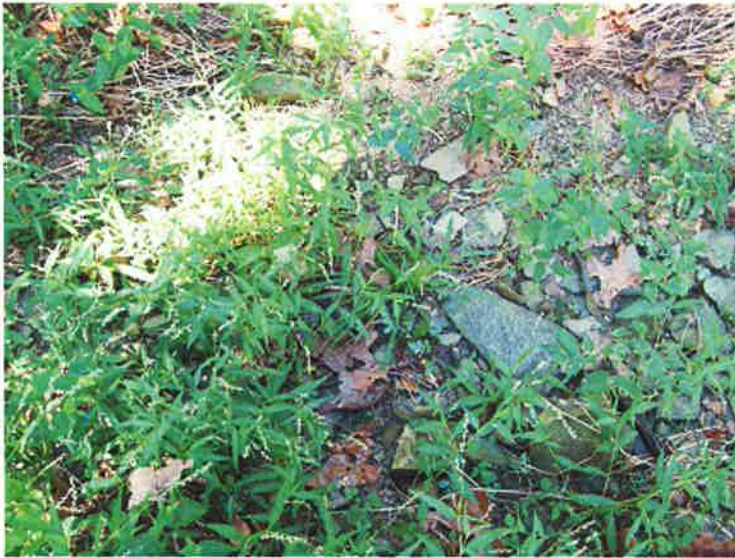
CROSS SECTION: 8
FEATURE: Riffle

Cross-section photo – looking right bank to left bank

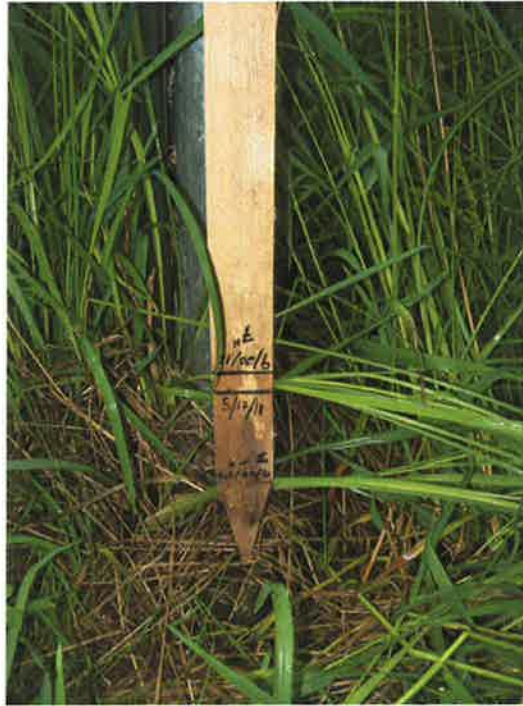
On September 14, 2011, the crest gage on UT1 was observed and indicated a bankfull event at a level of 6 and 5/8 inches above the bottom of the crest gage. The crest gage on the Davis Branch mainstem reach also documented the bankfull event, with a height of 6 and 3/8 inches above the bottom of the crest gage. These crest gages are set at or above the bankfull elevation of each stream channel. Photographs of the crest gages are shown in Appendix B.

BF 3
Crest Gage on the mainstem of Davis Branch (Year 3).
(EMH&T, 9/14/11)

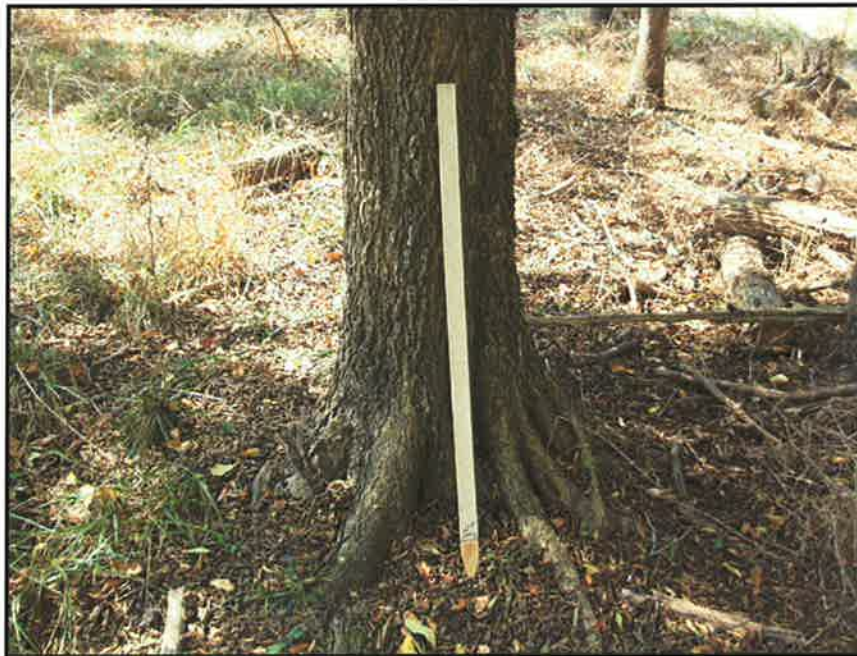
BF 2
Crest Gage 4 on UT1 of Davis Branch (Year 1).
(EMH&T, 9/20/09)

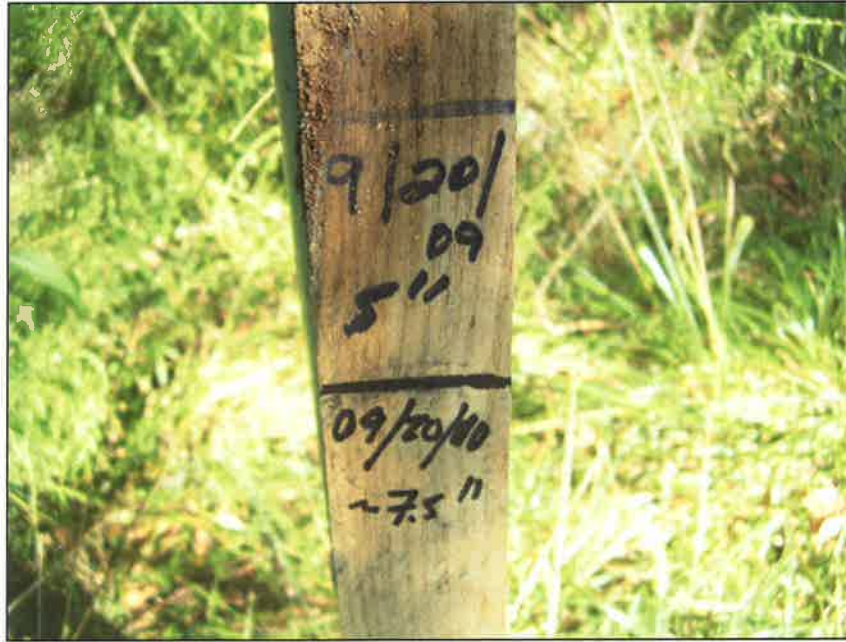
BF 5
Crest Gage 4 on UT1 of Davis Branch (Year 2).
(EMH&T, 9/20/10)

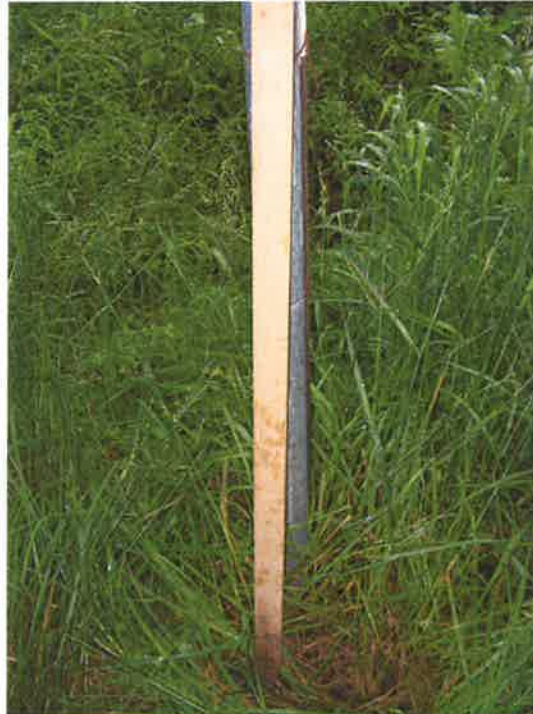
BF 6
Crest Gage 4 on UT1 of Davis Branch (Year 3).
(EMH&T, 9/14/11)
