Subject: Year 5 Monitoring Report for Stream Mitigation of Davis Branch and UT1; Union County, NC; SCO# D06054-F

# **Year 5 Monitoring Report for Stream Restoration of Davis Branch and Unnamed Tributary**

Union County, NC  
SCO # D06054-F

**Submitted:** January 6, 2014

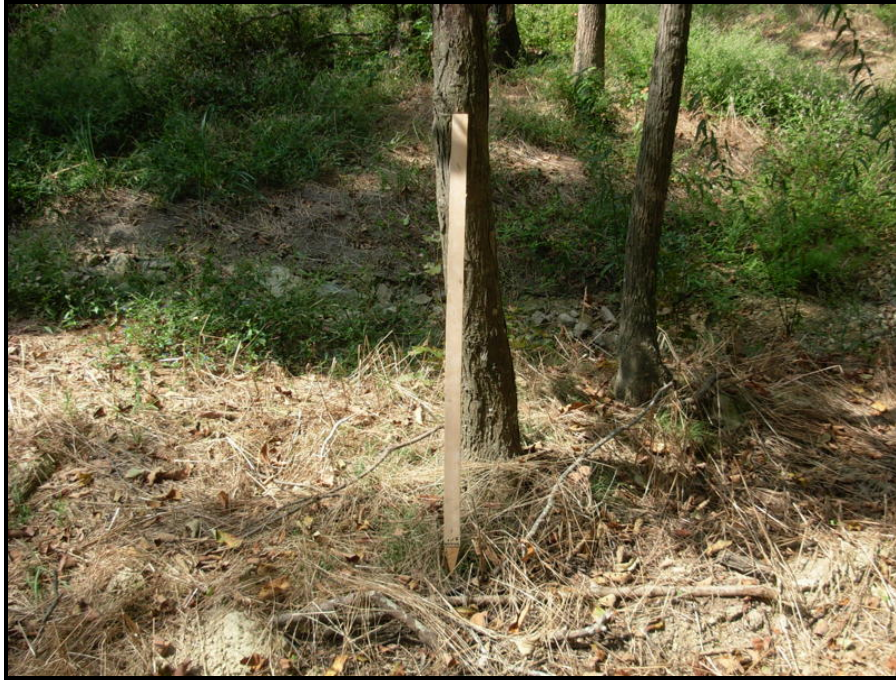
**BF 1**  
**Crest Gage on the mainstem of Davis Branch (Year 1).**  
(EMH&T, 9/20/09)

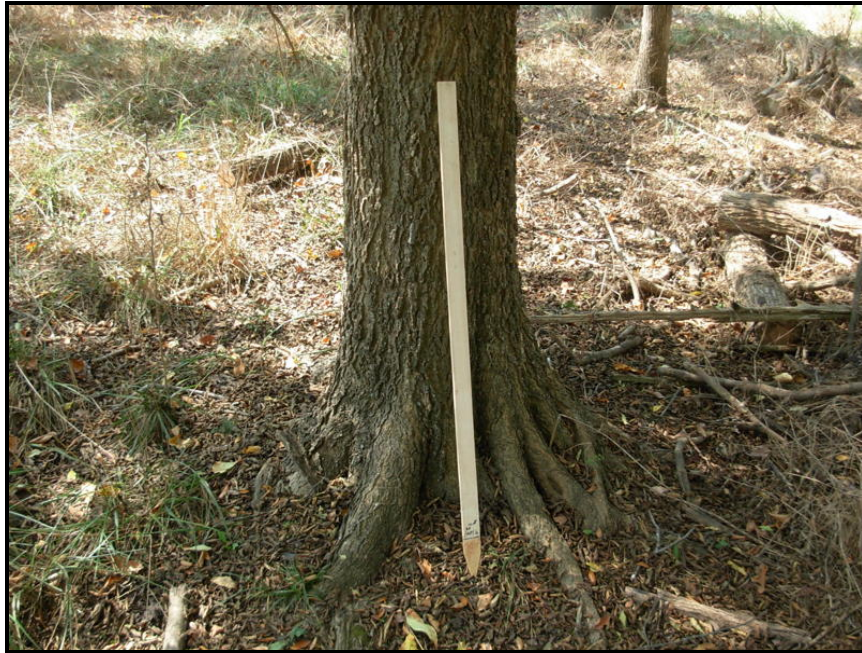
**BF 5**  
**Crest Gage 4 on UT1 of Davis Branch (Year 1).**  
(EMH&T, 9/20/09)

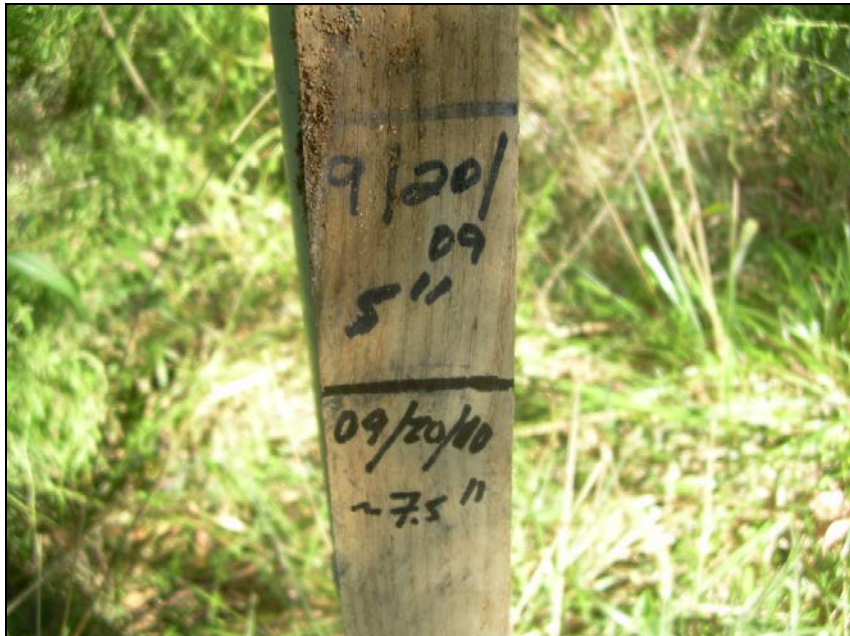
**BF 6**  
**Crest Gage 4 on UT1 of Davis Branch (Year 2).**  
(EMH&T, 9/20/10)

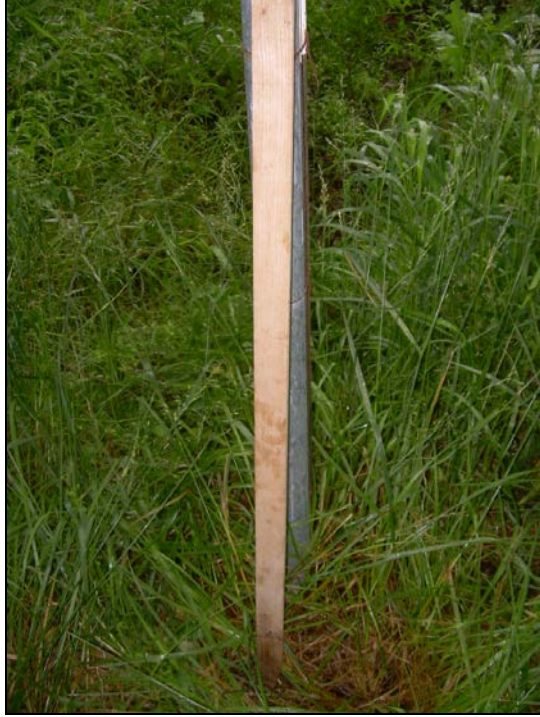
**BF 7**

**Crest Gage 4 on UT1 of Davis Branch (Year 3).**  
(EMH&T, 9/14/11)
