MONITORING YEAR 3 ANNUAL REPORT

DEEP MEADOW MITIGATION SITE

Union County, NC
Yadkin River Basin
HUC 03040105

DMS Project No. 97131
NC DEQ Contract No. 6887
DWR Certification No. 18-0264
USACE Action ID No. SAW-2012-01107
Data Collection Period: March 2022 – November 2022
Final Submission Date: February 2023

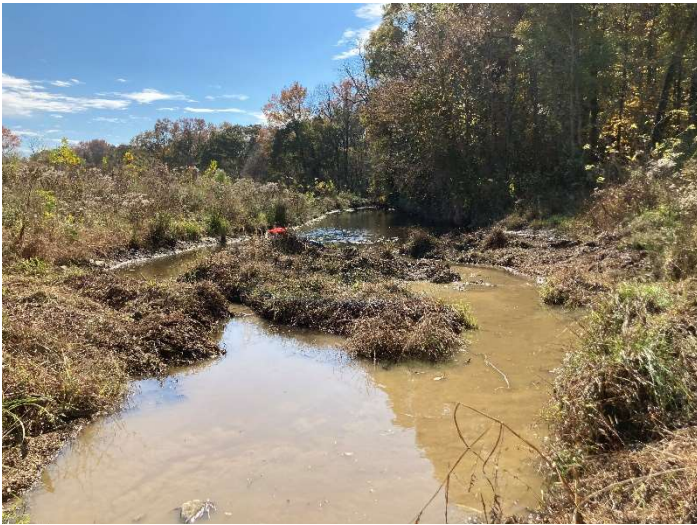
Meadow Branch, station 101+80 – Aggradation (11/02/2022)

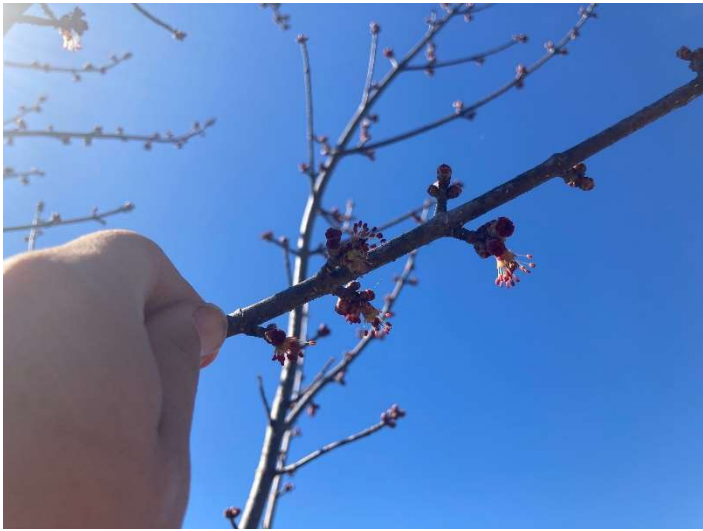
Start of the Growing Season - Red Maple Bud Burst -
(03/02/2022)

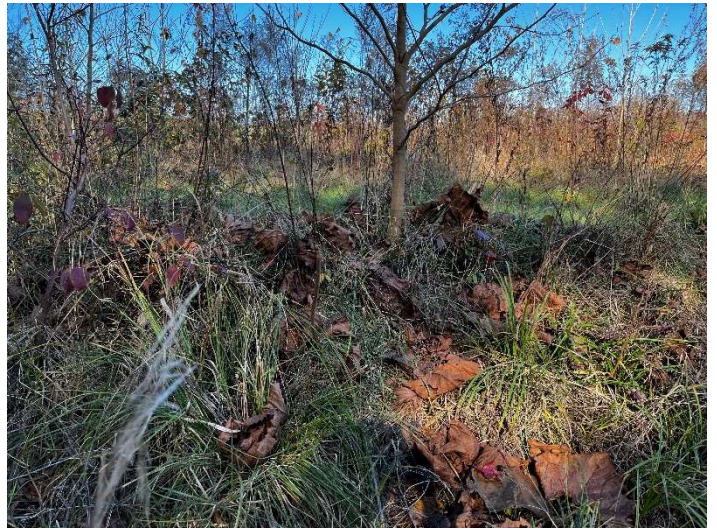
End of the Growing Season - Over 50% Leaf Drop -
(11/29/2022)

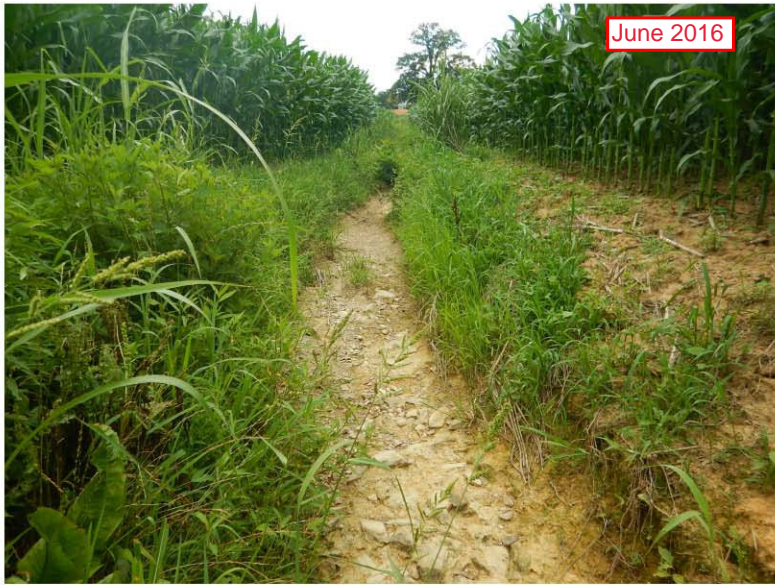
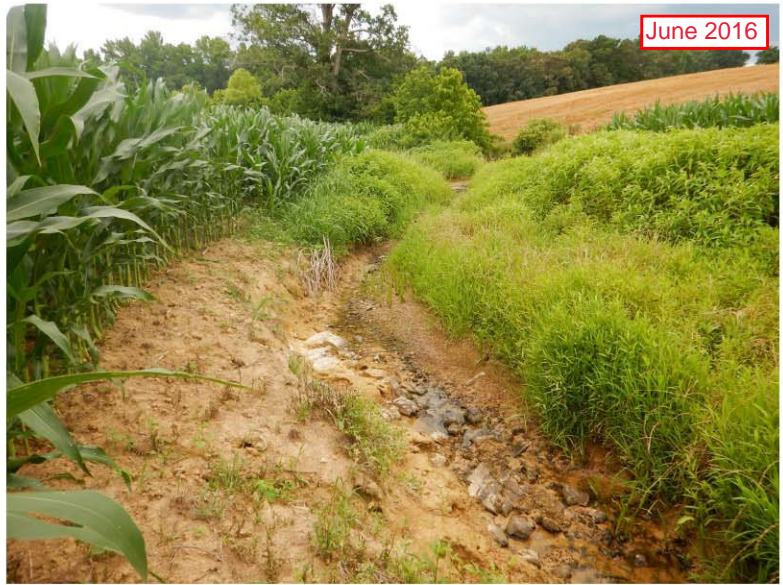
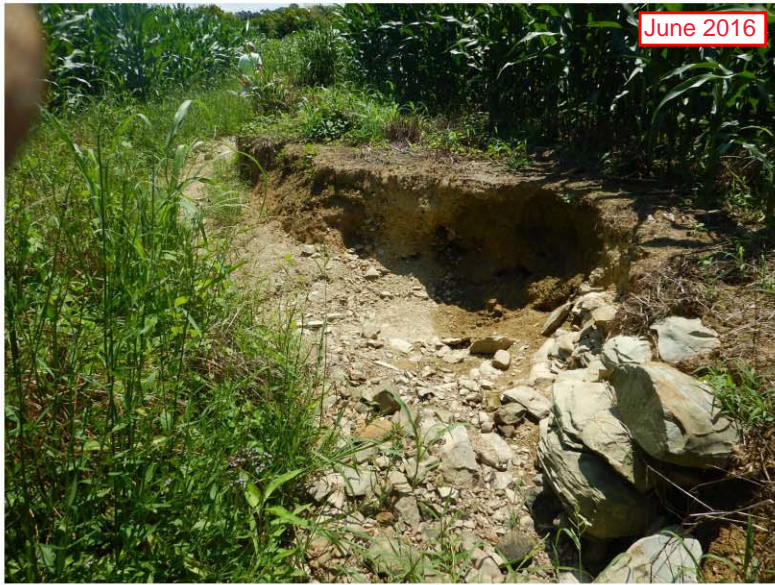
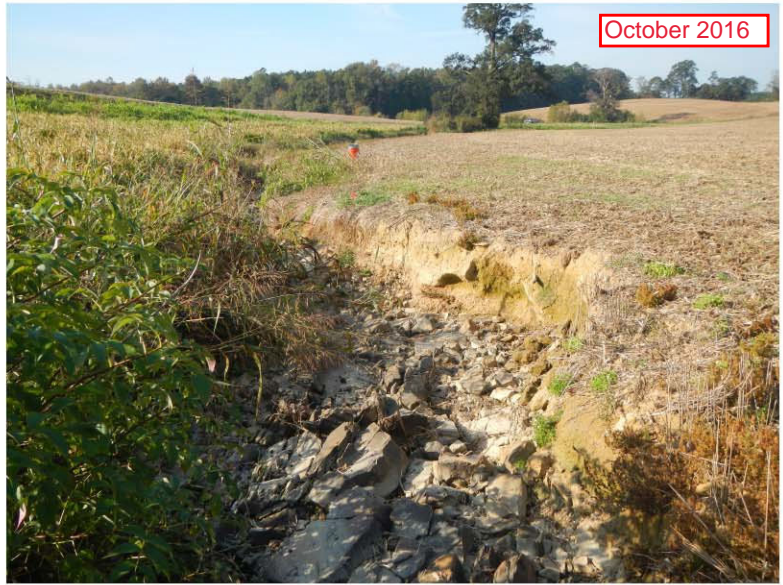
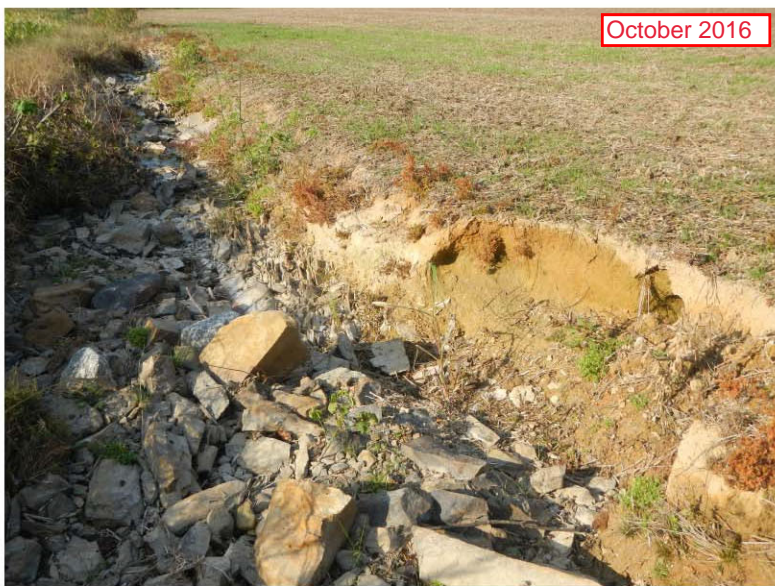
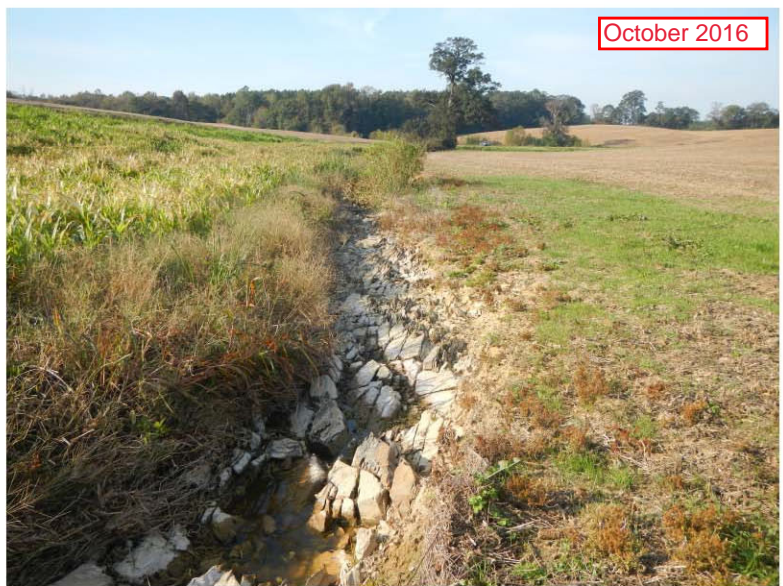
EF1 Historic Photo Log

- ii) Kim asked if Wildlands has pre-project photos that showed if the channel was flowing or dry. Aaron checked after the site meeting and found pre-construction photos of EF-1 from 2016 as shown in attached photo log.
