MONITORING YEAR 1 ANNUAL REPORT

DEEP MEADOW MITIGATION SITE

Union County, NC

DMS Project No. 97131

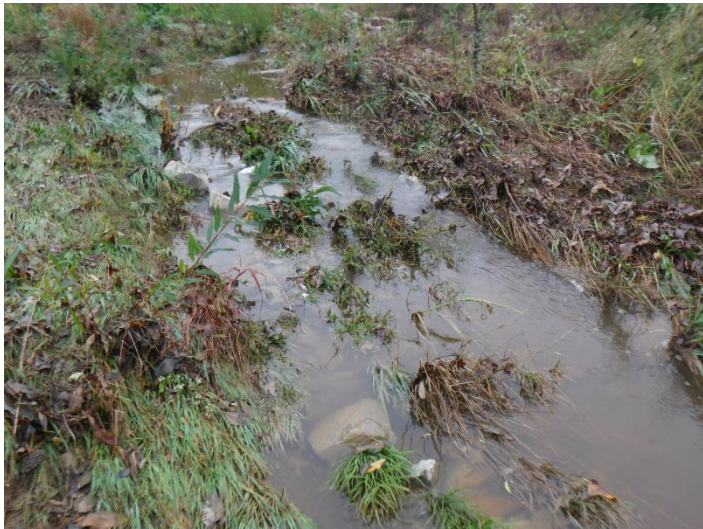
EF1 Vegetation in Channel at PP13 (11/13/2020)

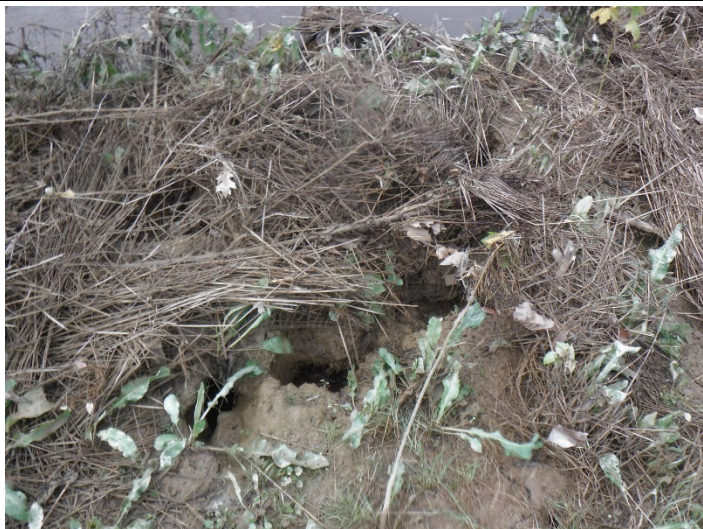
EF1 Issue: Bank Eroding behind structure 211+70- 212+00 (11/13/2020)

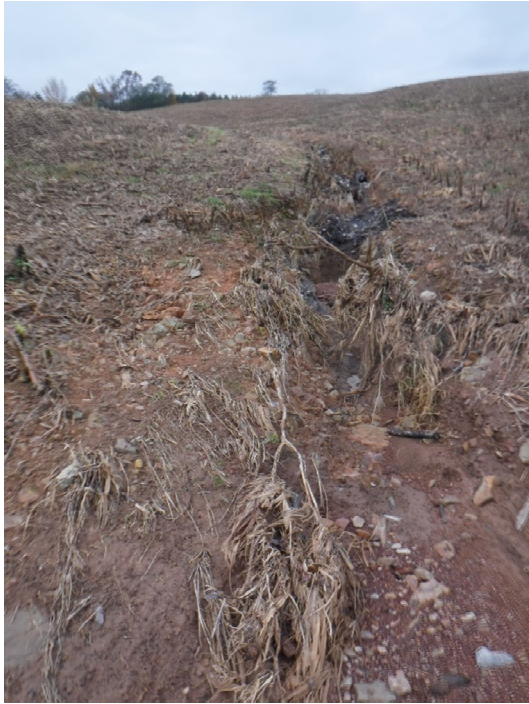
Scoured channel running from agricultural field into CE before flowing into Meadow Branch near station 107+50 (11/13/2020)

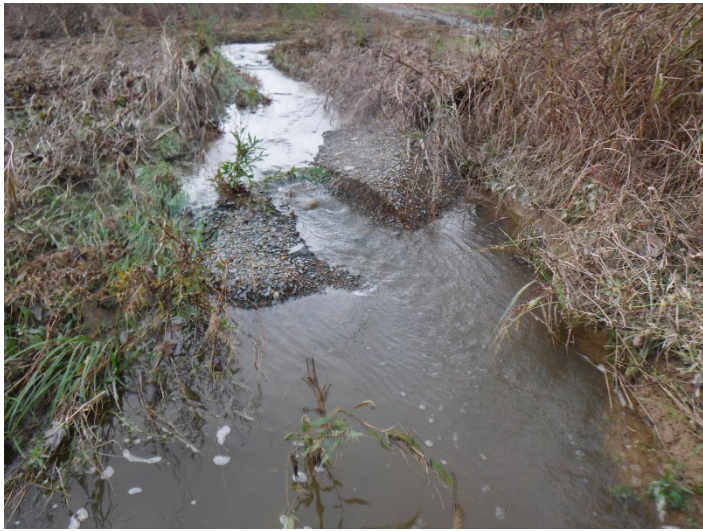
Issue: WF2 channel crossing being washed down stream causing aggradation (11/13/2020)

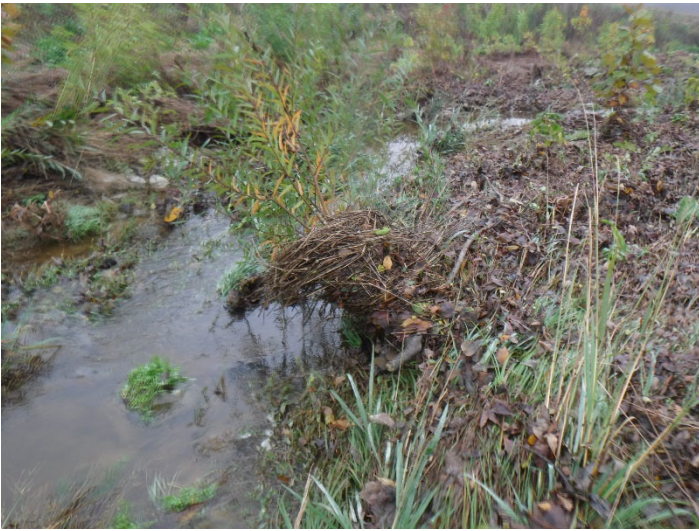
EF1 Wrackline (11/13/2020)

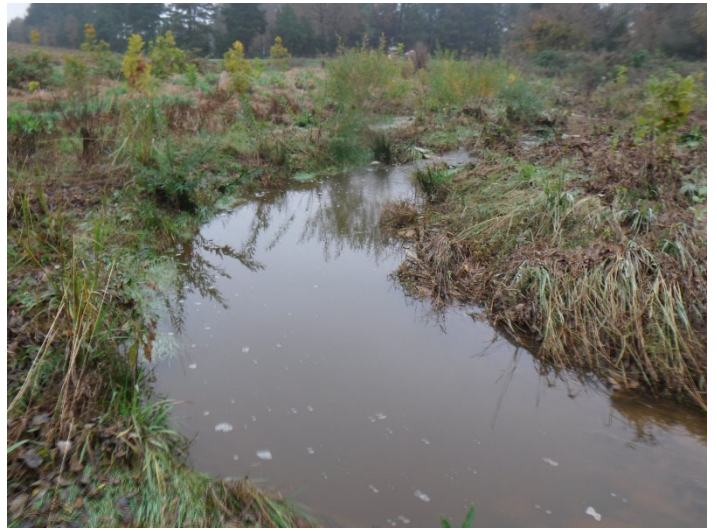
EF1 at bankfull (11/13/2020)

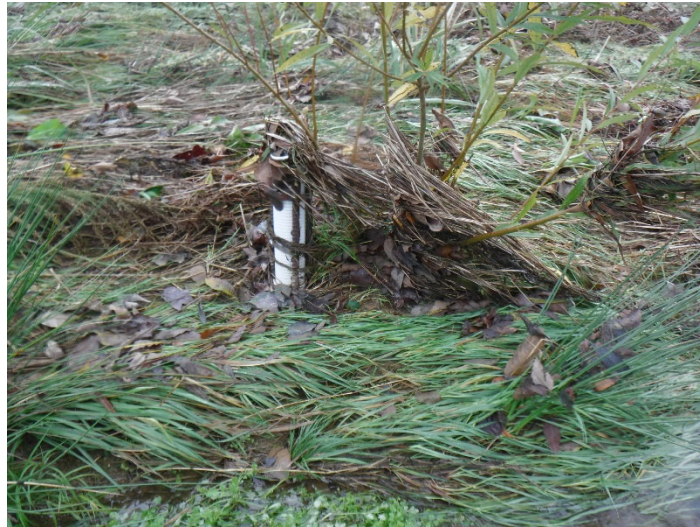
EF1 Crest Gage 2 Wrackline (11/13/2020)

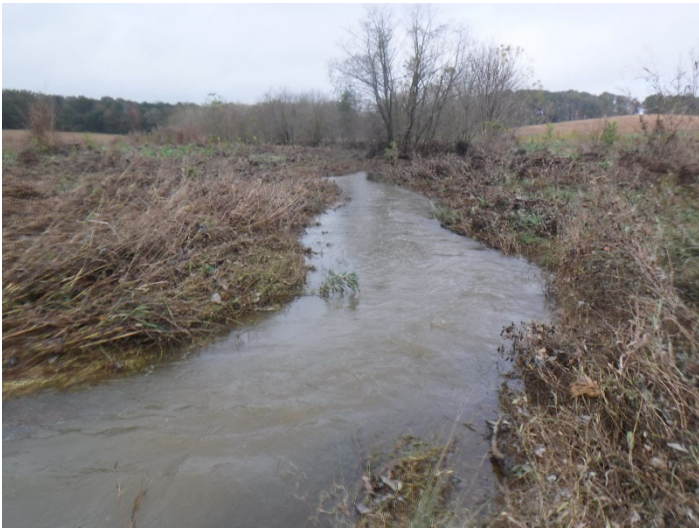
Meadow Branch at Bankfull (11/13/2020)

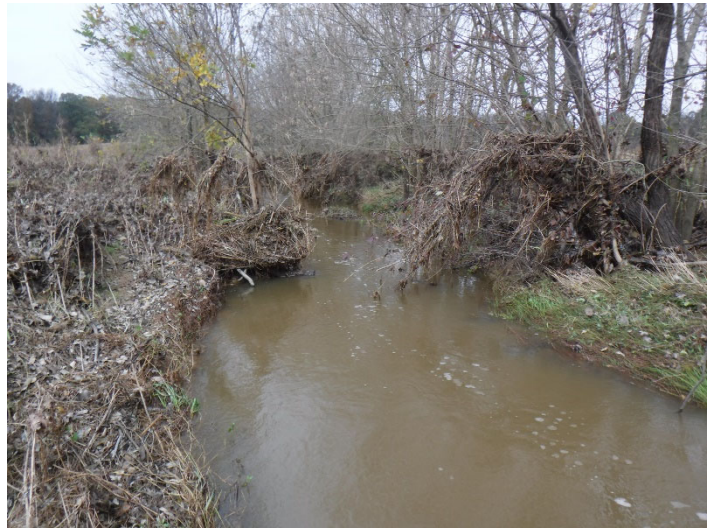
Meadow Branch wracklines (11/13/2020)

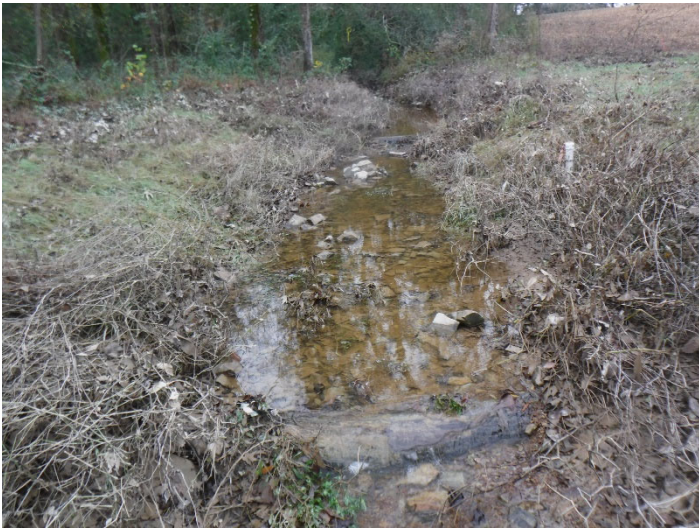
WF1 Stream Gage Wrackline (11/13/2020)

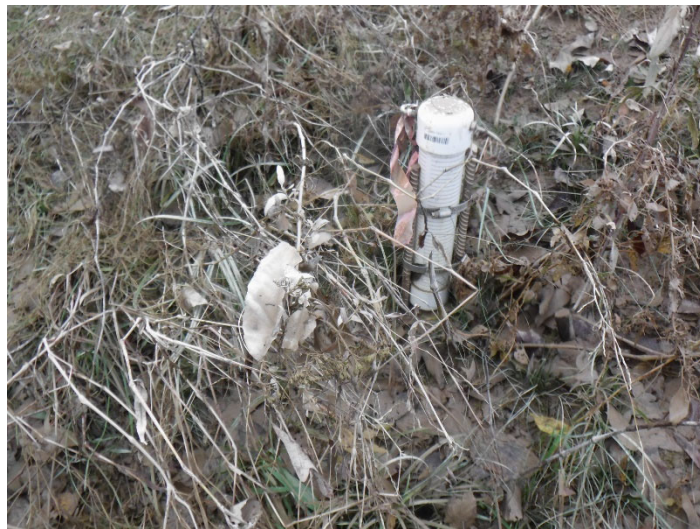
WF1 Crest Gage 1 Wrackline/ Sediment Deposit (11/13/2020)

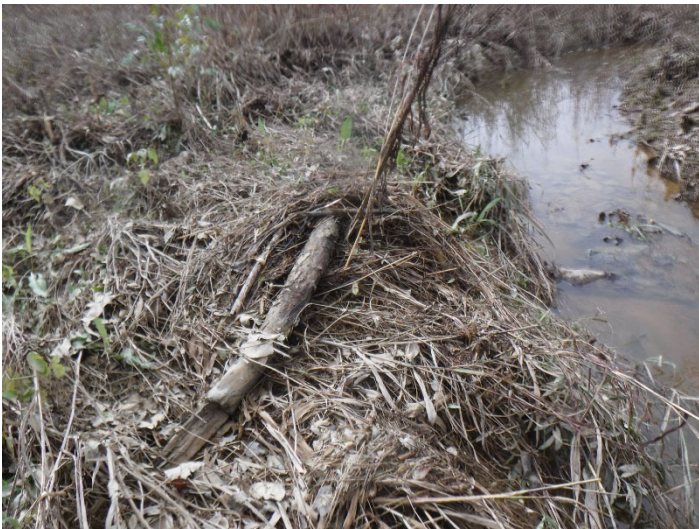
WF2 Wrackline (11/13/2020)

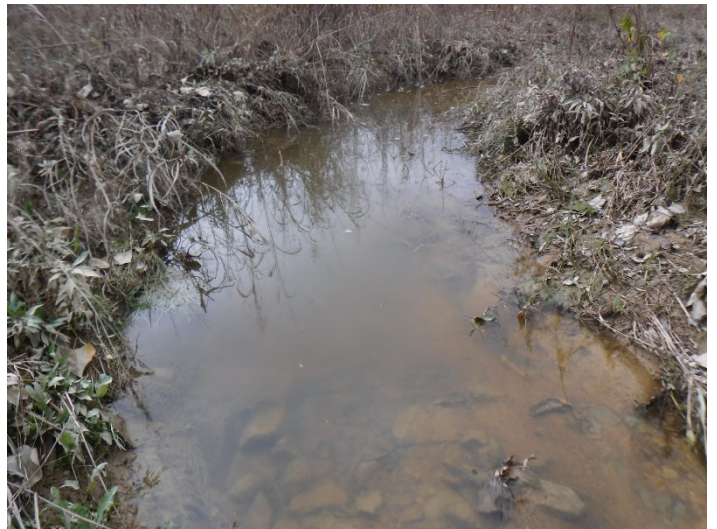
WF2 at Bankfull (11/13/2020)
