MONITORING YEAR 2 ANNUAL REPORT

DEEP MEADOW MITIGATION SITE

Union County, NC

DMS Project No. 97131

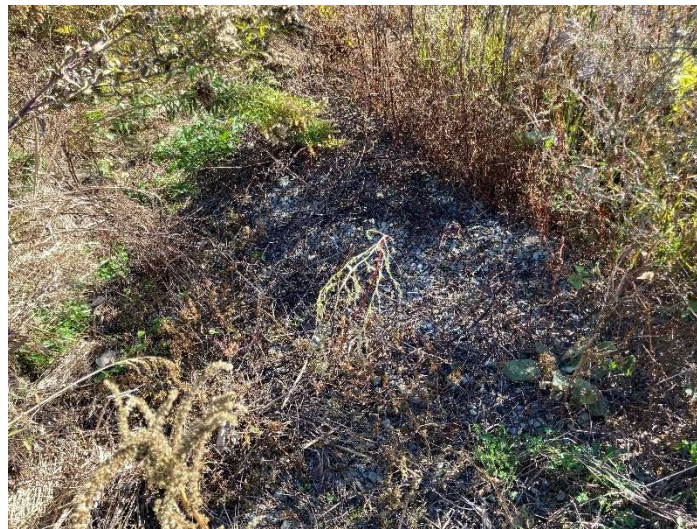
WF2: Aggradation in channel at 301+00 - 302+00 (11/09/2021)

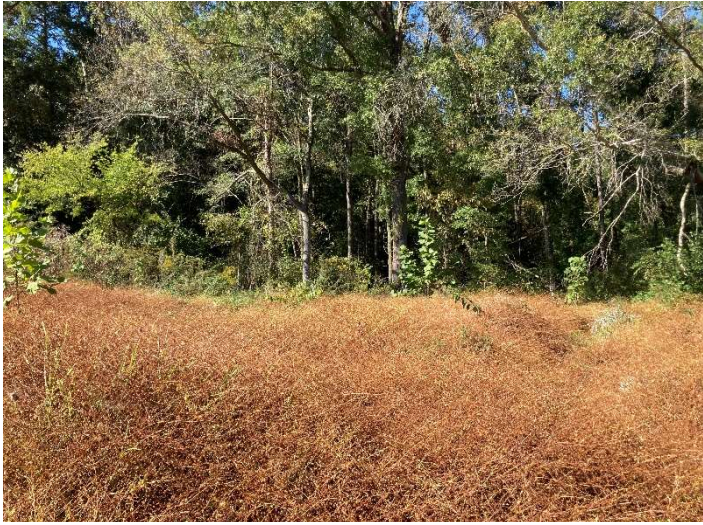
Meadow Branch: In-Stream vegetation at 116+00 (10/18/2021)
