# MONITORING YEAR 4 ANNUAL REPORT

## DEEP MEADOW MITIGATION SITE

Union County, NC  
Yadkin River Basin  
HUC 03040105

DMS Project No. 97131  
NC DEQ Contract No. 6887  
DWR Certification No. 18-0264  
USACE Action ID No. SAW-2012-01107  
Data Collection Period: January 2023 – November 2023

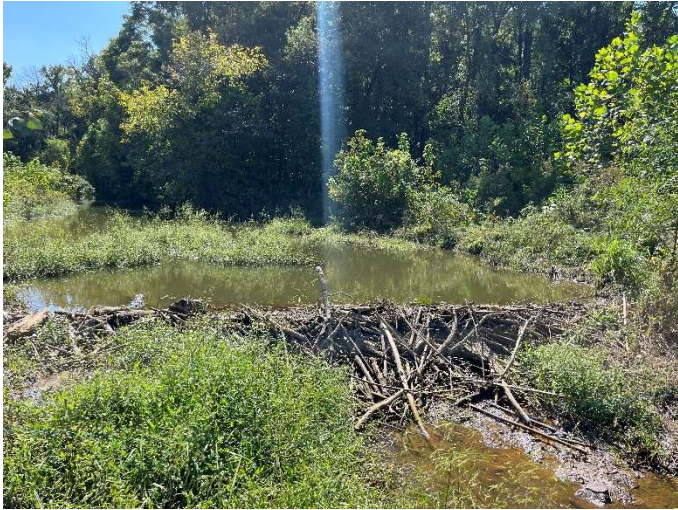
**Meadow Branch, station 101+80** – Recurring beaver dam and associated aggradation (9/29/2023)

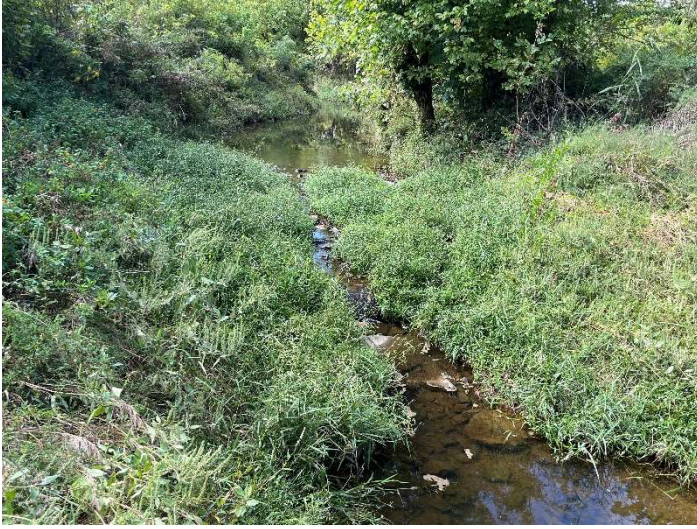
**Meadow Branch, station 121+15** – In-stream vegetation and associated aggradation (9/29/2023)

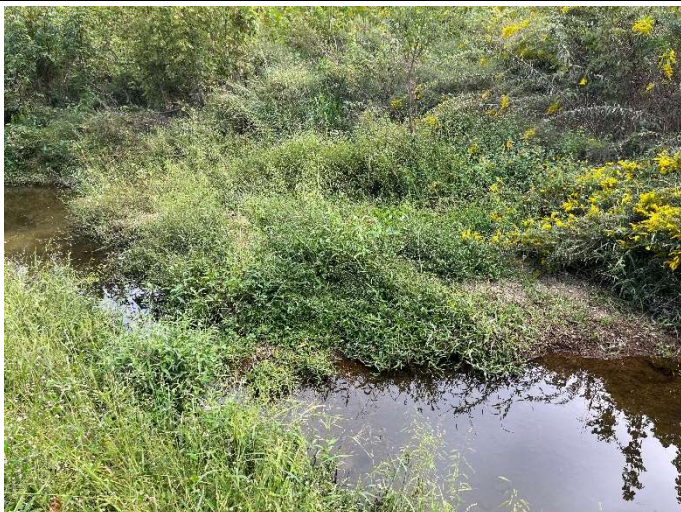
**Meadow Branch, station 124+50** – In-stream vegetation and associated aggradation (9/29/2023)

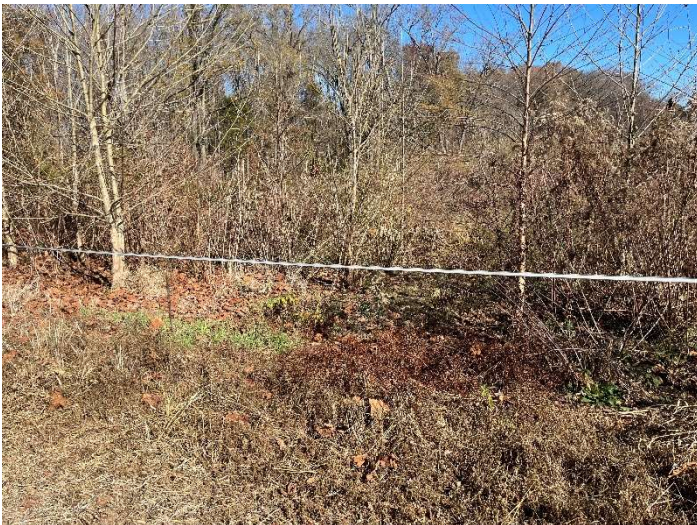
**Between Platted Corners 19 and 20 – Herbicidal overspray (11/28/2023)**

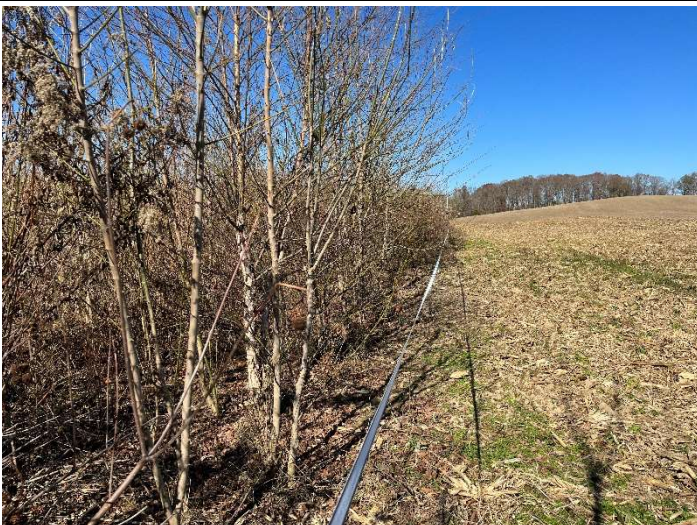
**Between Platted Corners 25 and 26 – Mowing and scalloping (11/28/2023)**

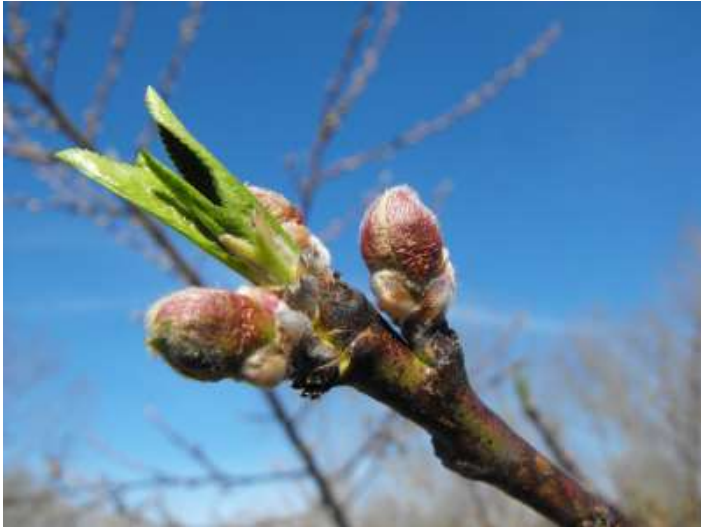
**Start of the Growing Season - Elderberry Bud Burst -**  
*(03/01/2023)*

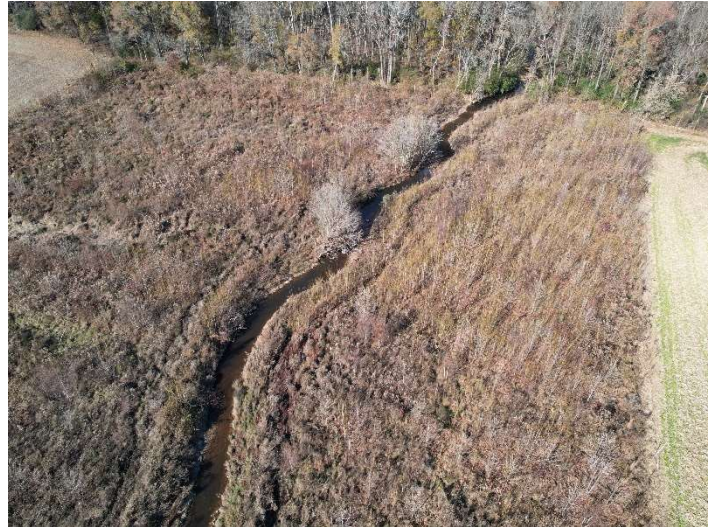
**End of the Growing Season - Over 50% Leaf Drop -**  
*(11/29/2023)*

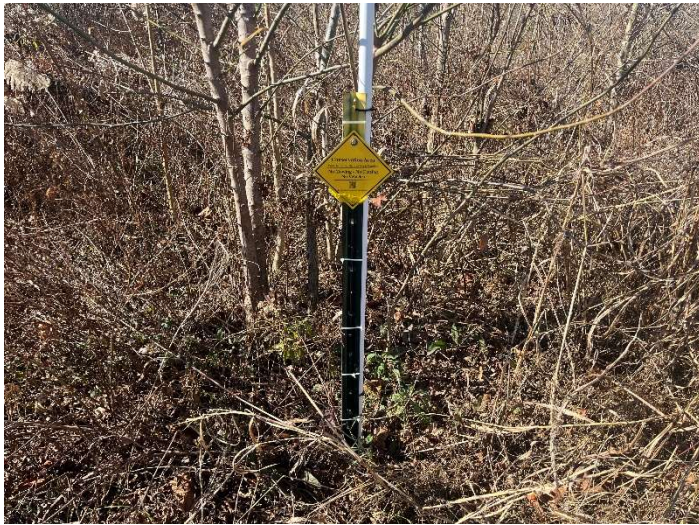
- The easement corners were adequately monumented with stamped aluminum caps. Most of the monument caps were buried and not visible.
- The easement corners were marked with metal posts (T-Posts & U-Channel) with attached easement signs. The marker posts at platted corners 36, 37 & 38 were missing along the main crossing area. Corner 12 was twisted, and the sign was misaligned. The easement signs at corners 8, 17 & 27 were damaged. PVC markers were damaged at corners 10, 17 and south of 22.

**Easement Corner 27 – New PVC marker and sign (11/29/2023)**

*Wildlands' response: Wildlands replaced missing and damaged signposts, PVC markers and easement signs in November 2023. New horse tape was pulled in areas where the tape was broken. Wildlands will continue to replace yellow plastic clips as the opportunity presents itself.*

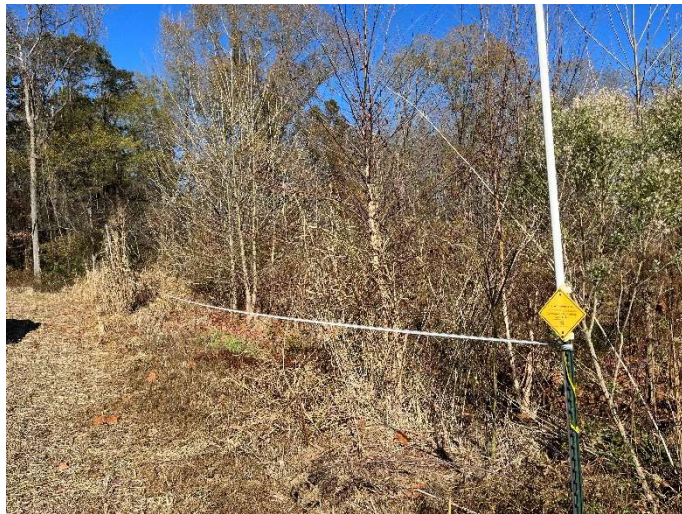
**Between Easement Corners 19 and 20 – New horse tape (11/29/2023)**

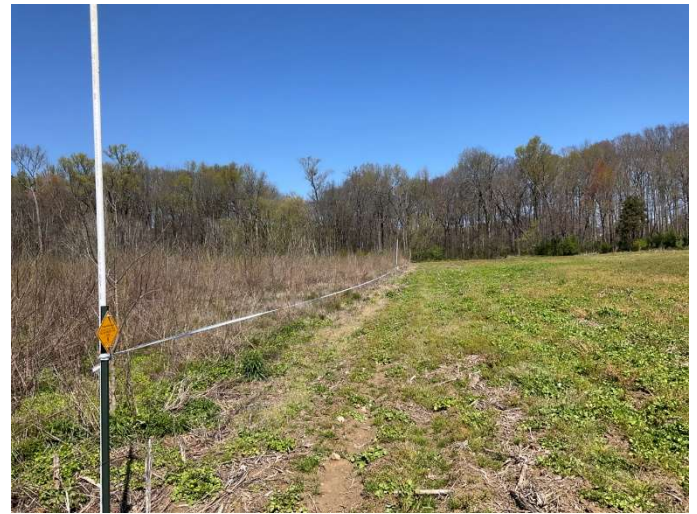
**Between Easement Corners 22 and 24 – New horse tape (11/29/2023)**

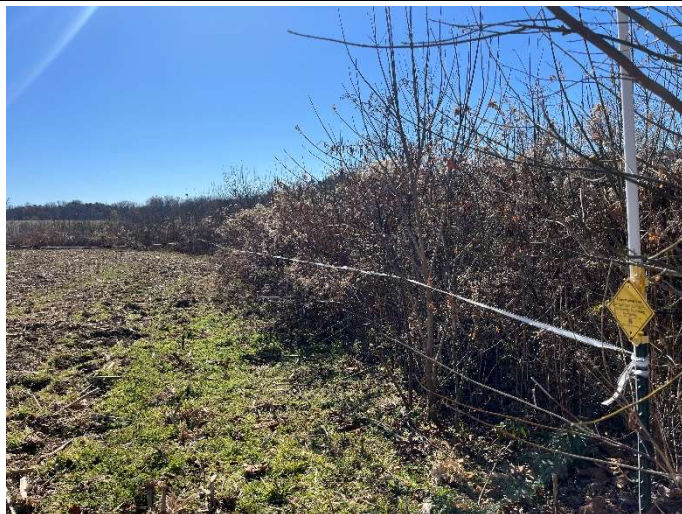
**Between Easement Corners 24 and 25 – New horse tape (11/29/2023)**

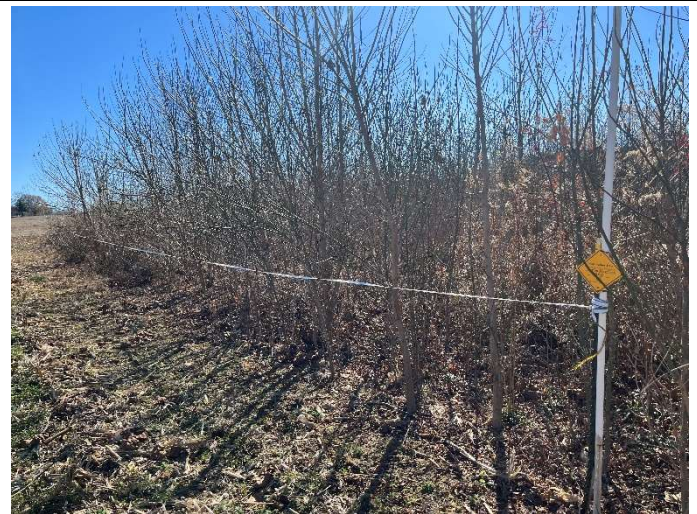
**Between Easement Corners 25 and 26 – New horse tape (11/29/2023)**

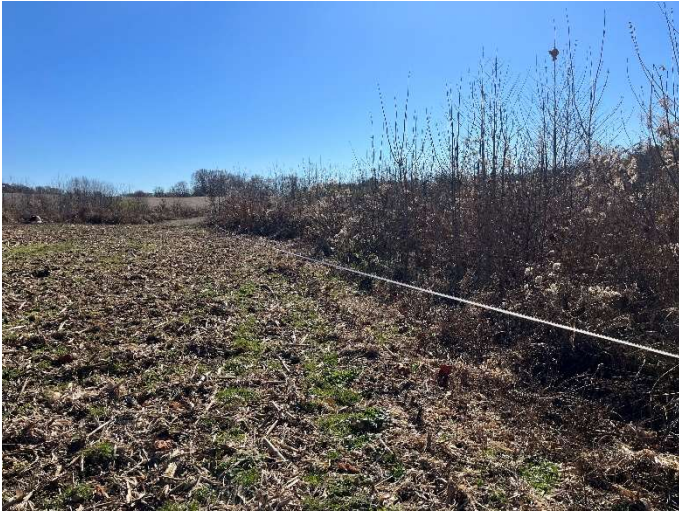
**Between Easement Corners 26 and 27 – New horse tape (11/29/2023)**
