MONITORING YEAR 6 ANNUAL REPORT FINAL

DEVIL'S RACETRACK MITIGATION SITE

Johnston County, NC
NCDEQ Contract 003989
DMS Project Number 95021
USACE Action ID Number 2012-00810
NCDWR Project Number 12-0747

Data Collection Period: March - November 2019
Draft Submission Date: December 20, 2019
Final Submission Date: February 20, 2020

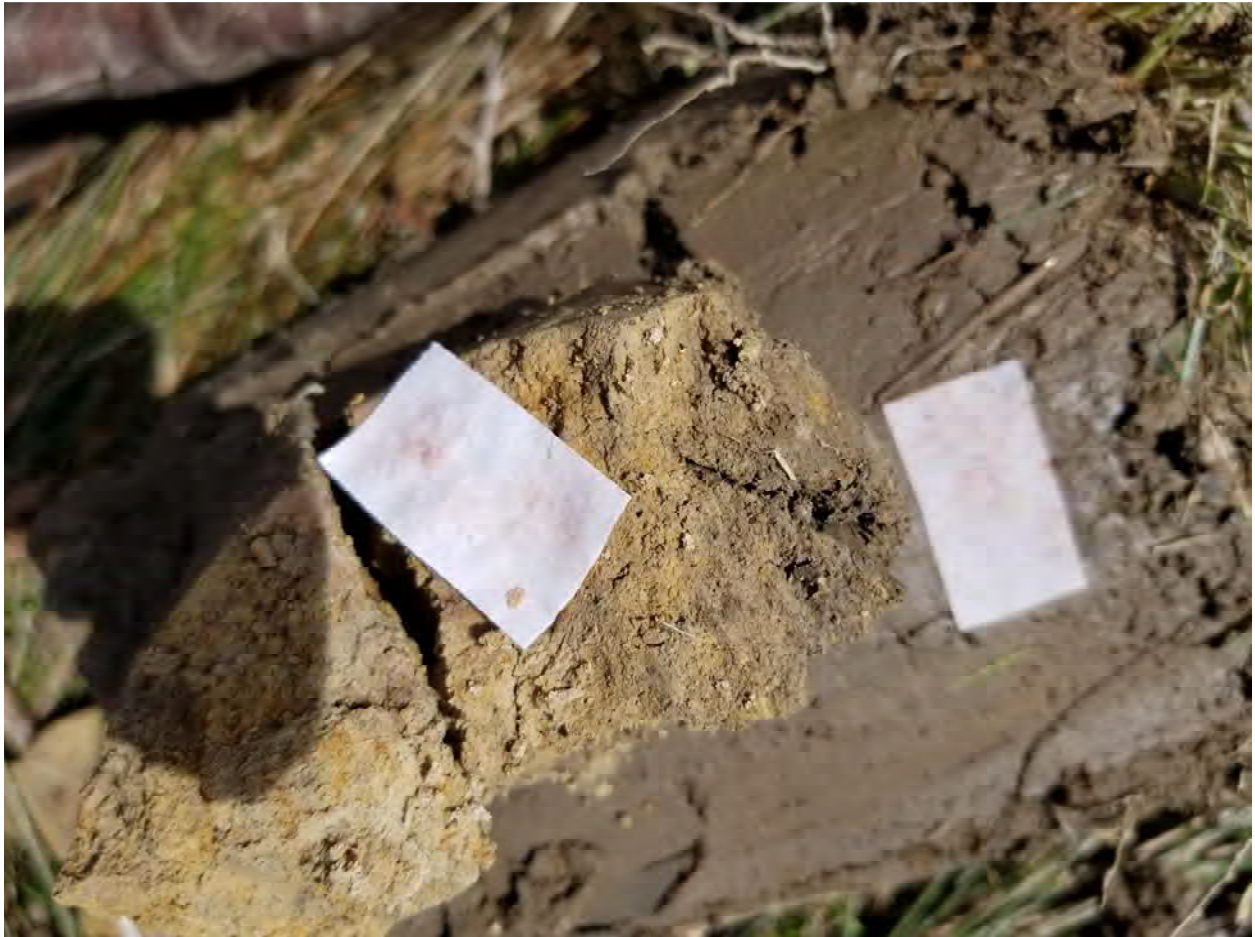
GW13 weak Positive α , α' -dipyridyl Surface and Subsurface

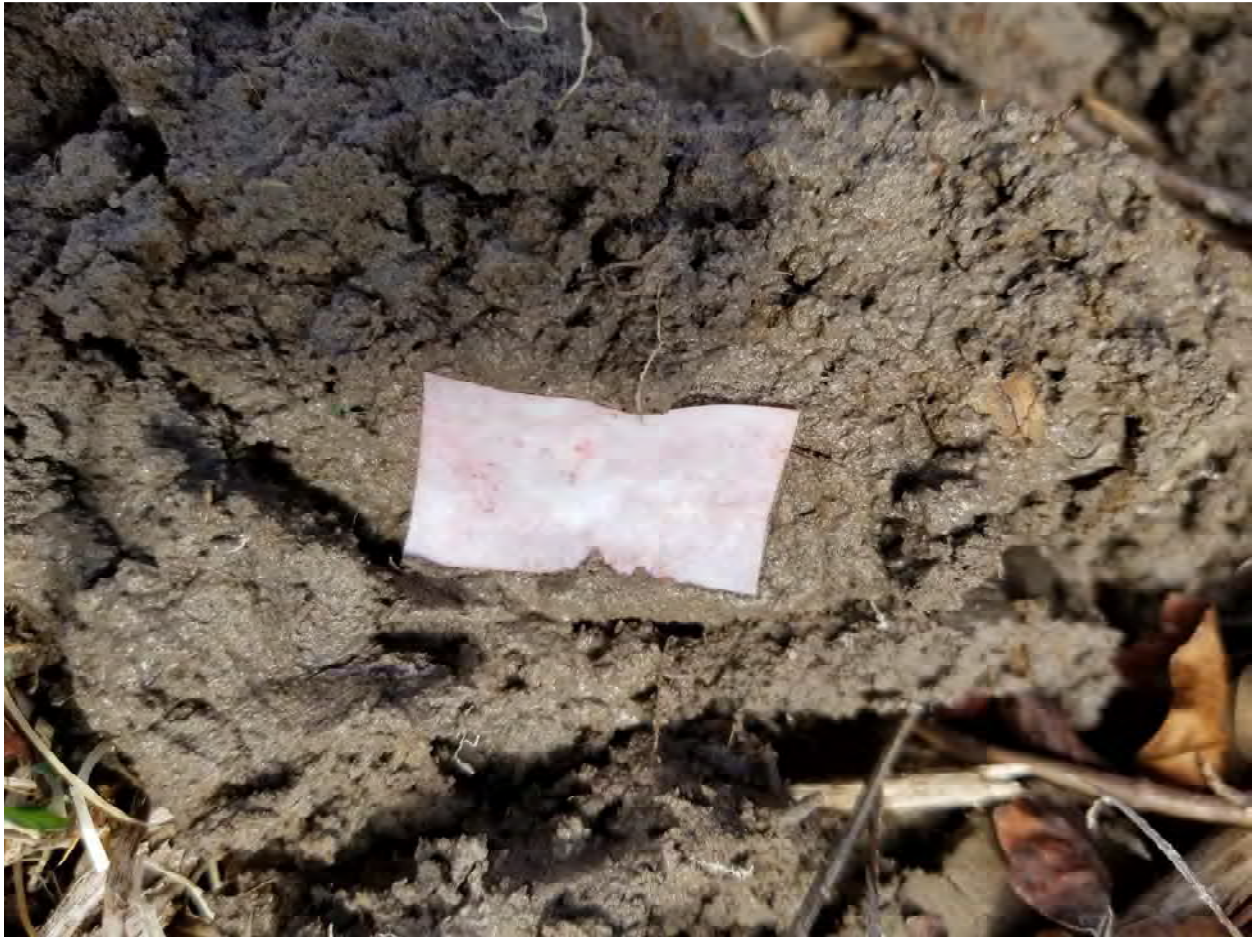
GW6 Positive α, α' -dipyridyl

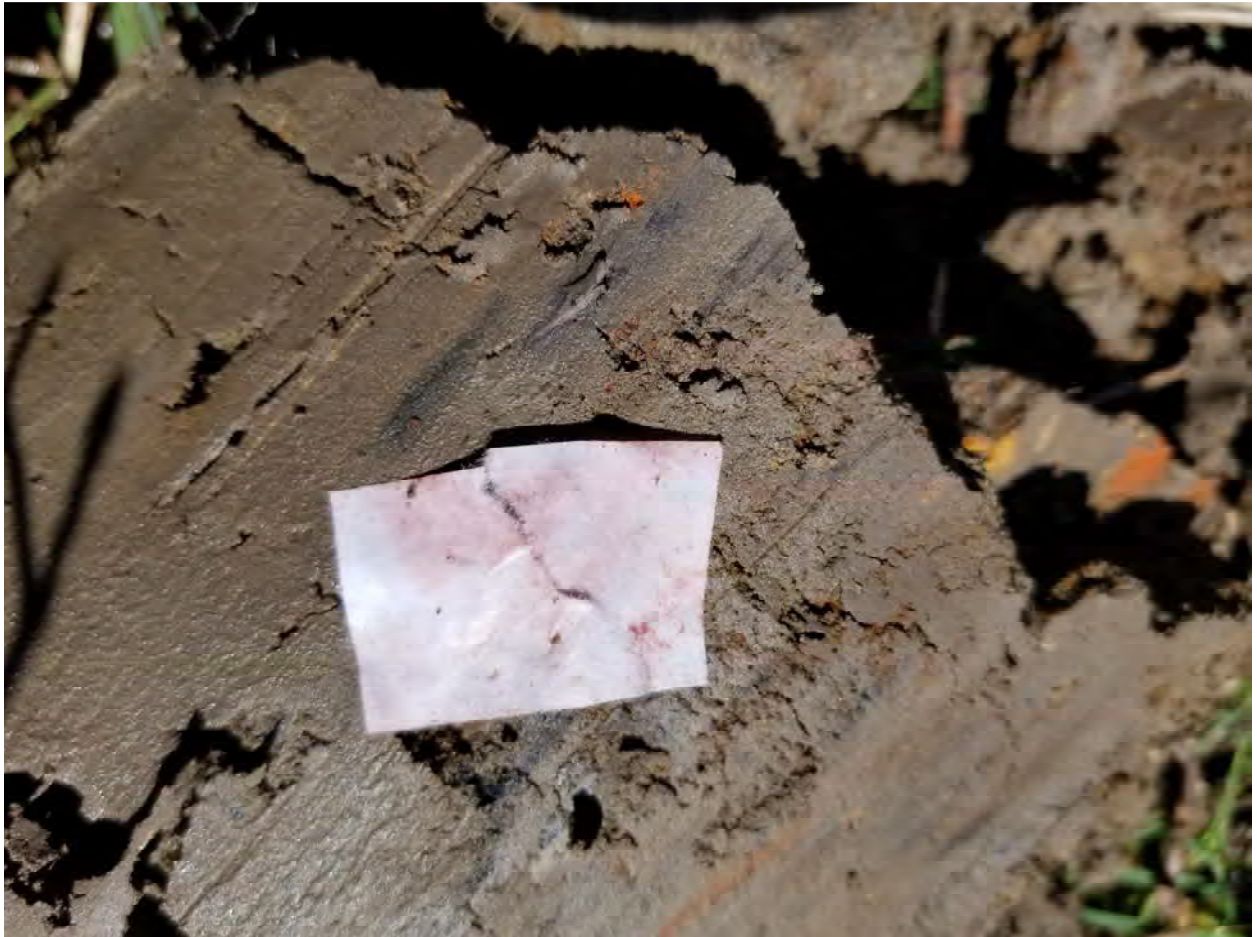
B10 subsurface Positive α, α' -dipyridyl
