# **MONITORING YEAR 7 ANNUAL REPORT FINAL**

## **DEVIL'S RACETRACK MITIGATION SITE**

Johnston County, NC  
NCDEQ Contract 003989  
DMS Project Number 95021  
USACE Action ID Number 2012-00810  
NCDWR Project Number 12-0747

Data Collection Period: January - November 2020  
Draft Submission Date: December 21, 2020  
Final Submission Date: February 17, 2021

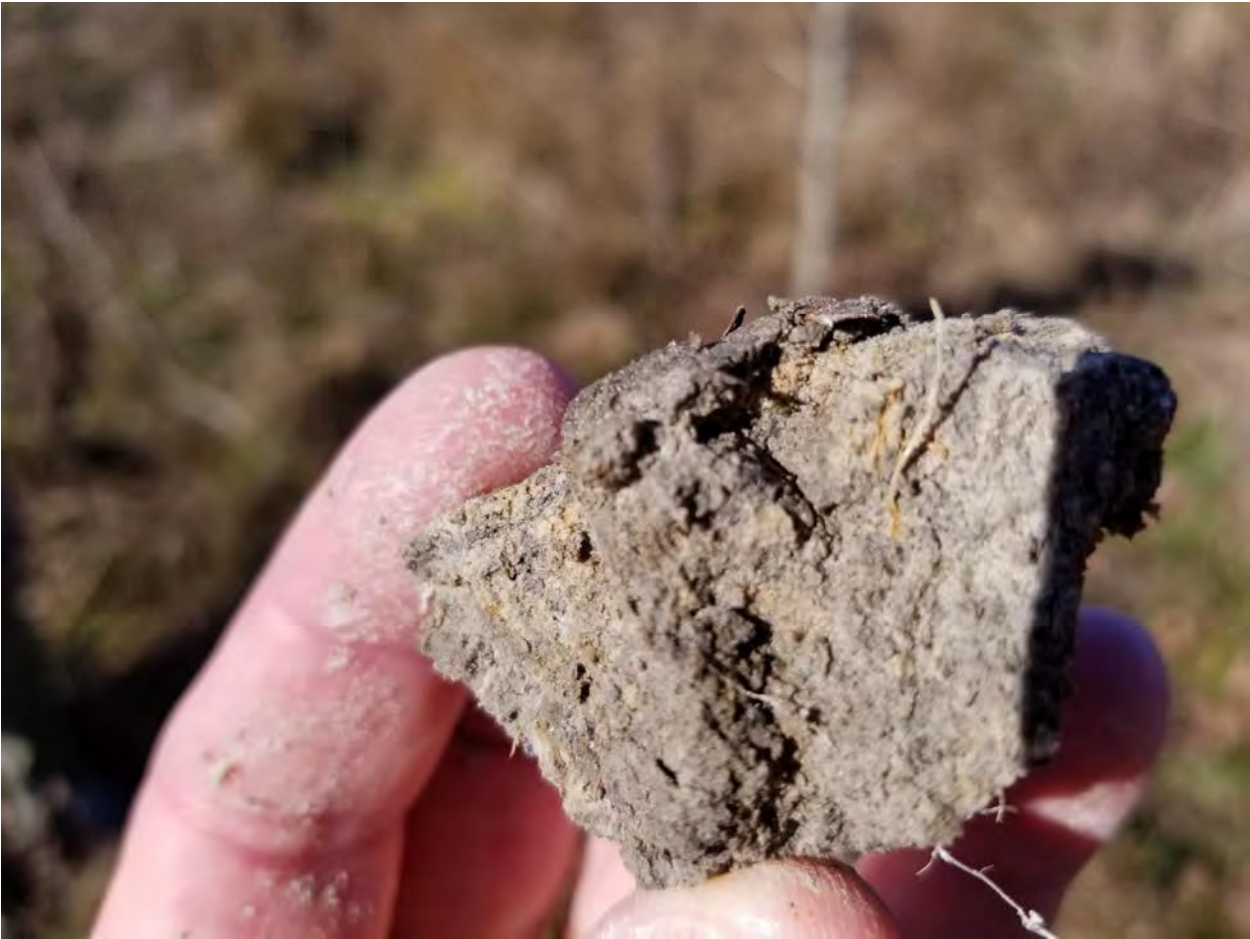
GW13 Oxidized Rhizospheres

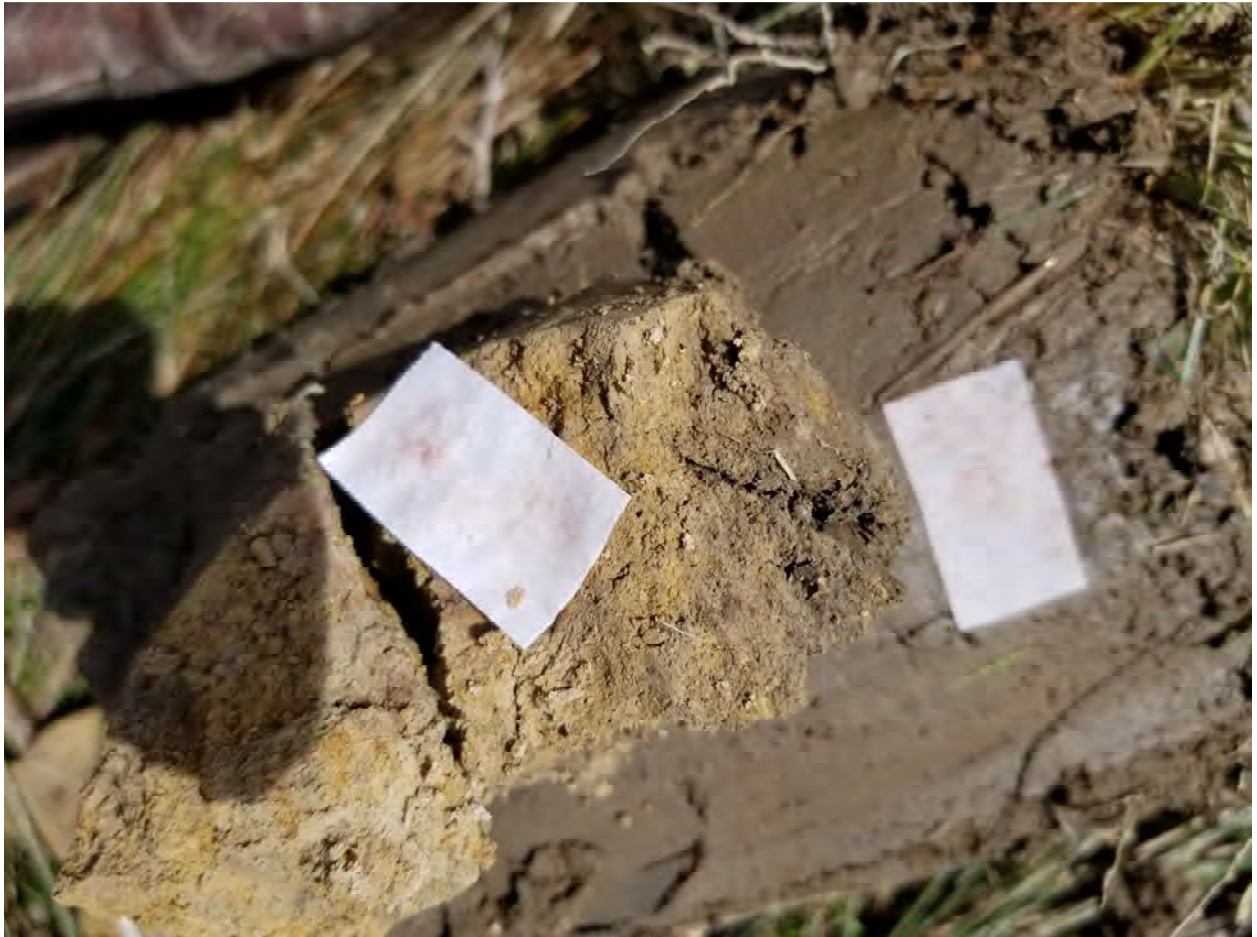
GW13 weak Positive  $\alpha$ ,  $\alpha'$ -dipyridyl Surface and Subsurface

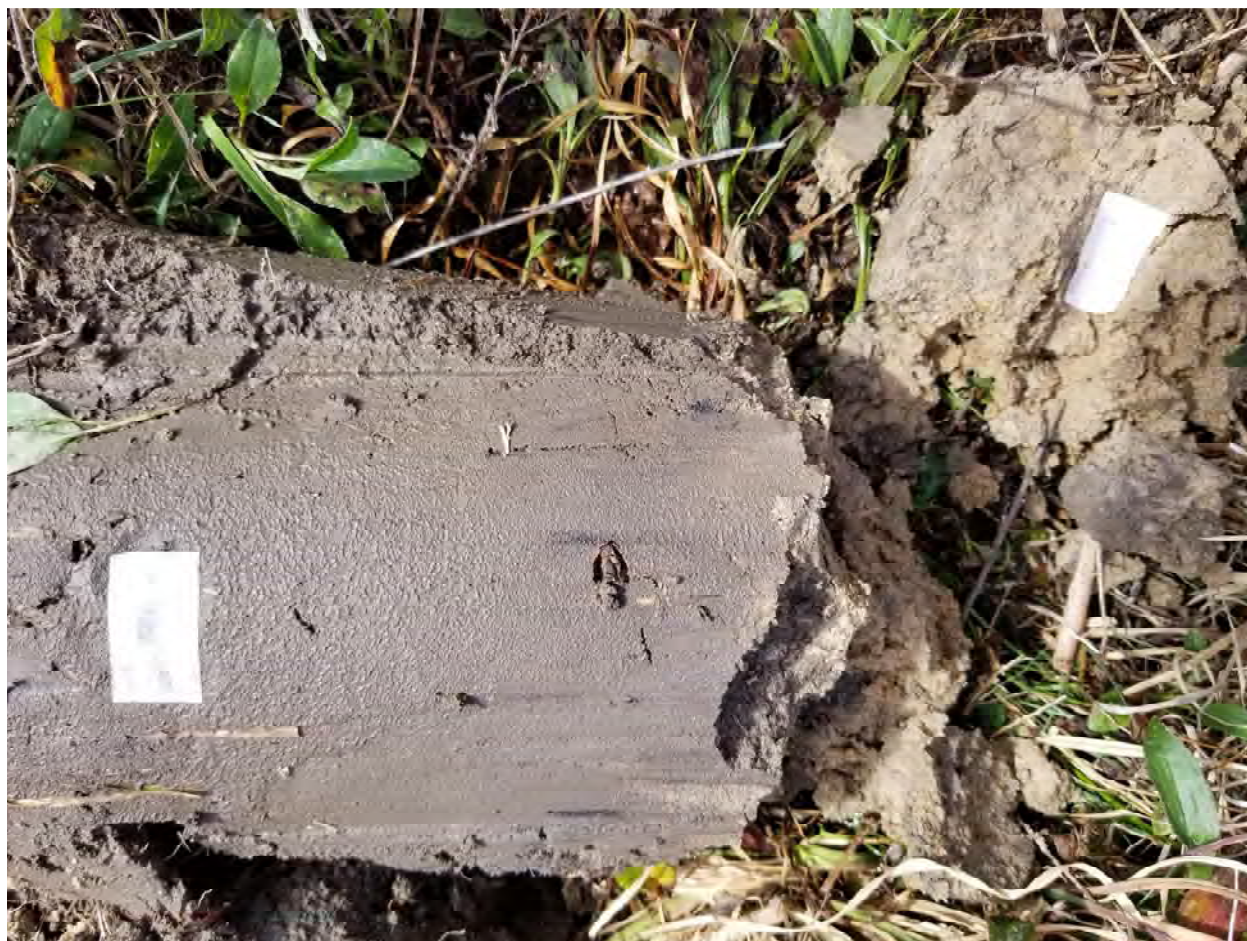
GW35 #2 Positive  $\alpha$ ,  $\alpha'$ -dipyridyl (hard to see due to bright sunlight)

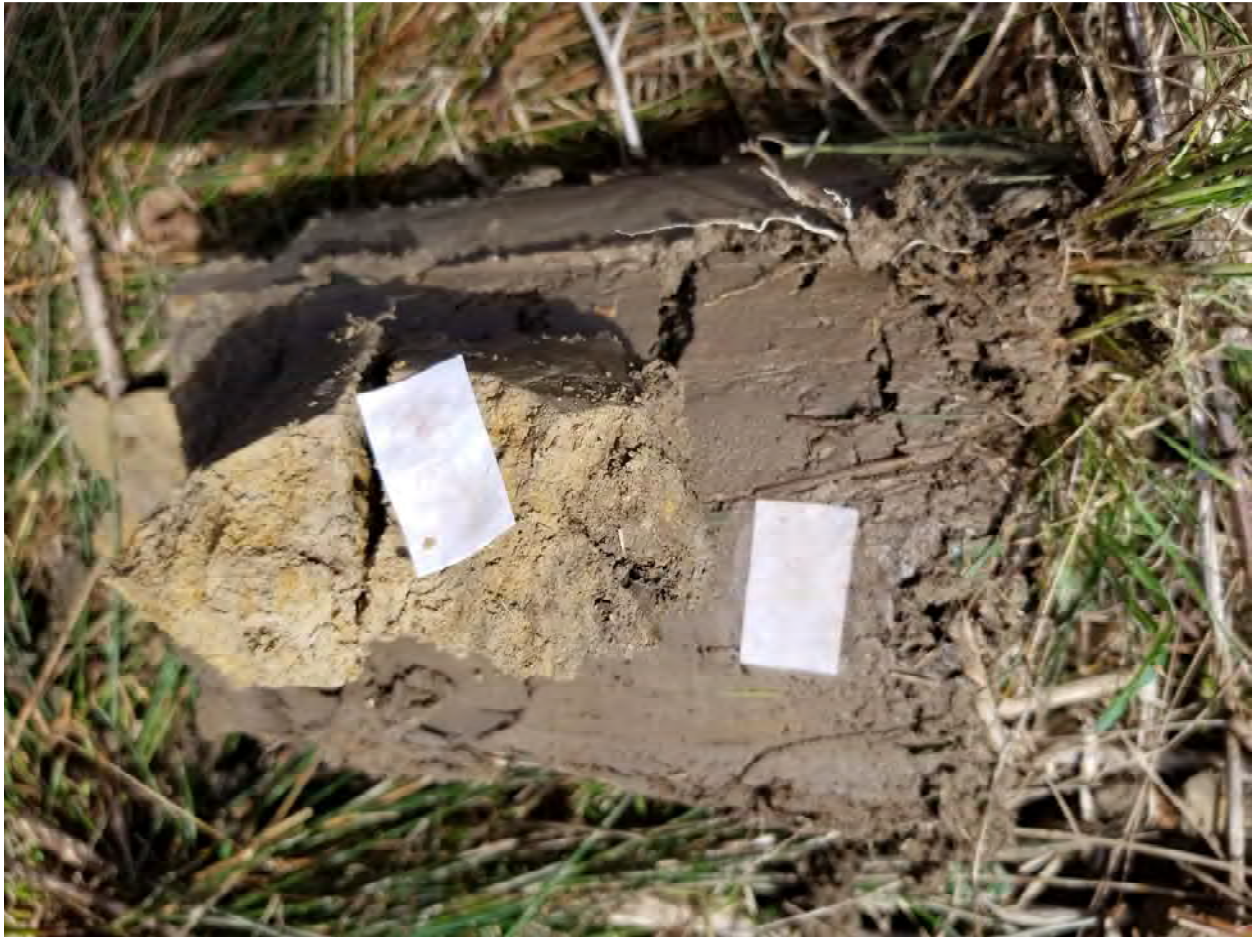
GW14 Weak Positive  $\alpha$ ,  $\alpha'$ -dipyridyl surface and subsurface

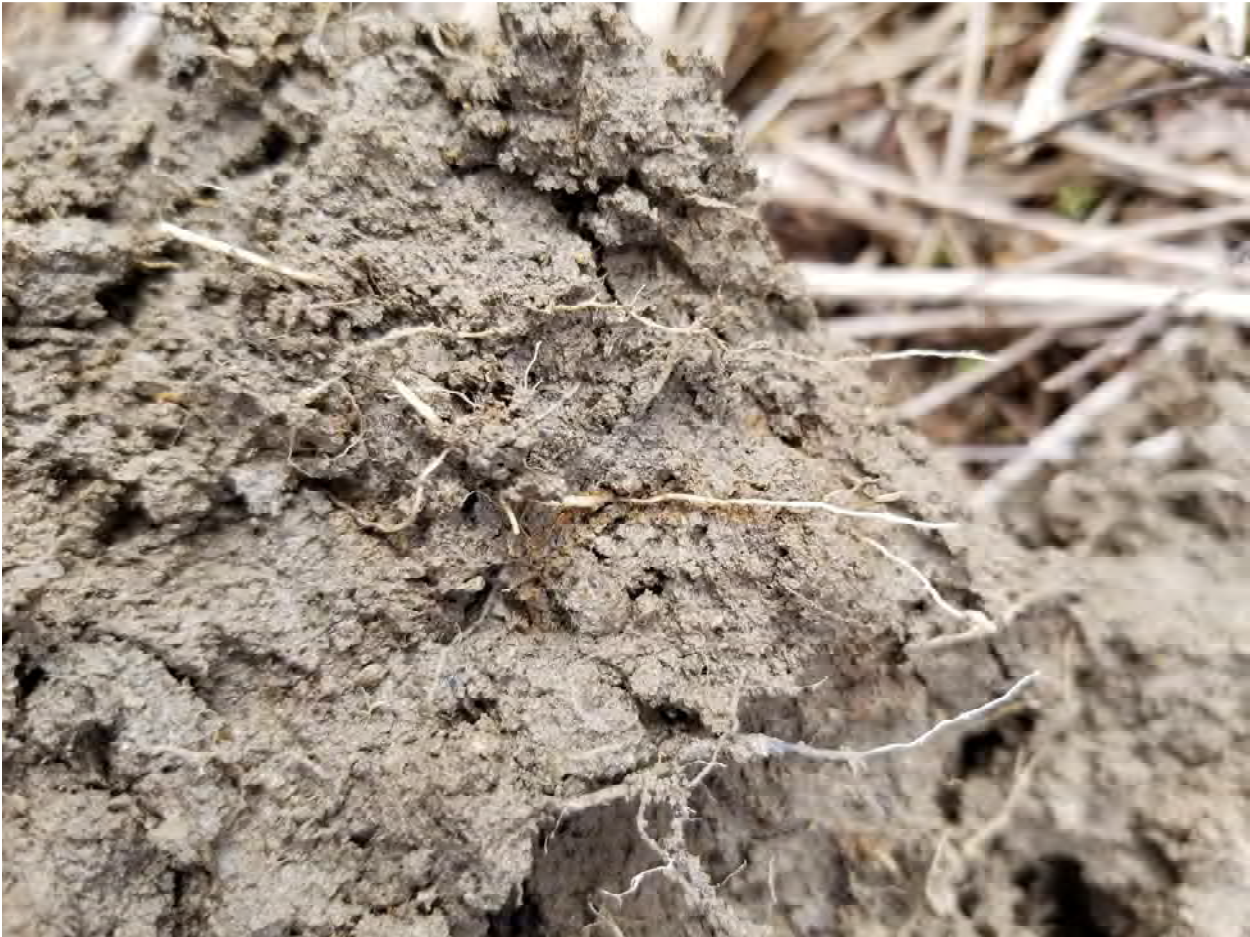
B2 Oxidized Rhizospheres

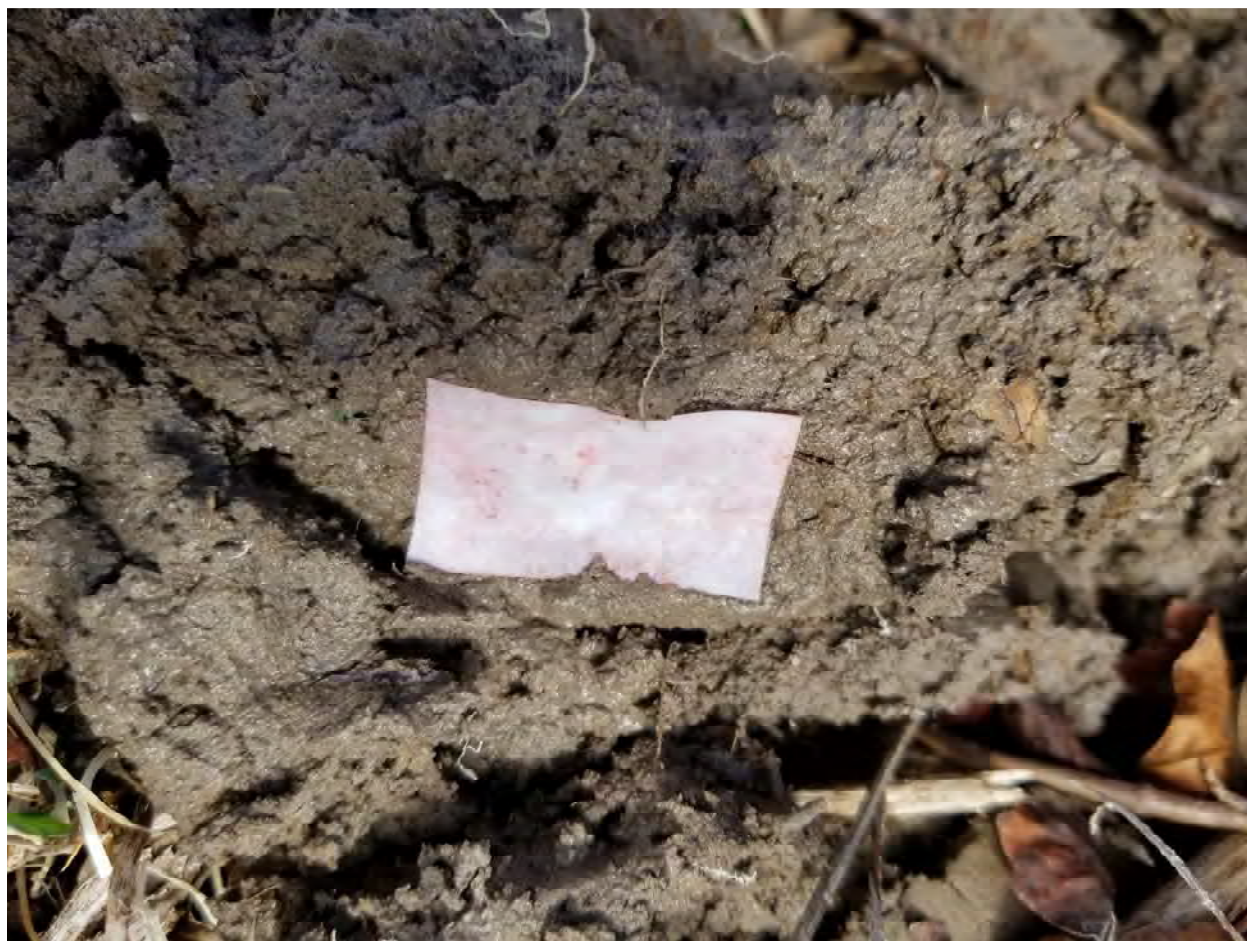
GW6 Positive  $\alpha, \alpha'$ -dipyridyl

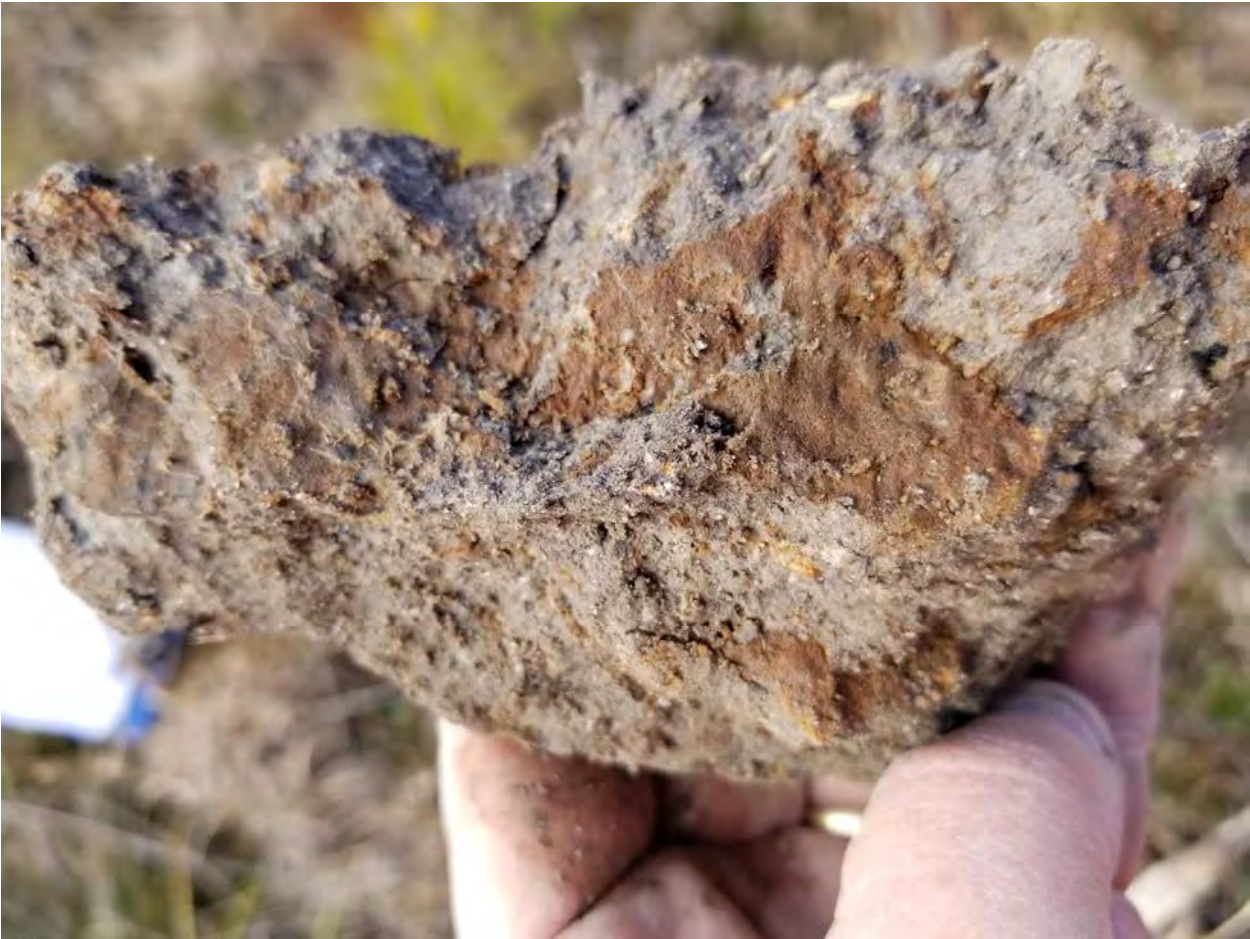
GW5 pedface soft masses

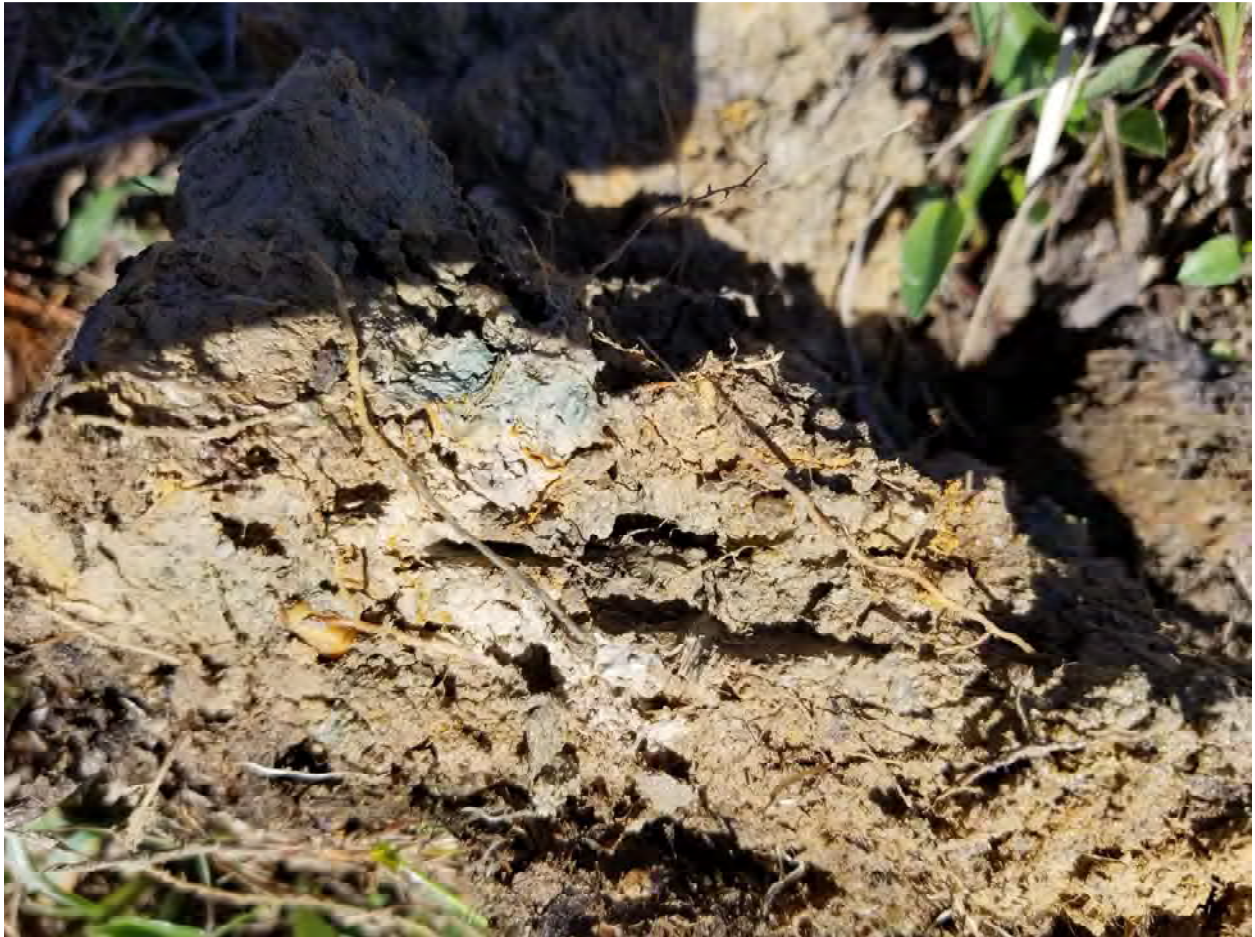
GW30 surface #2 Oxidized rhizospheres and Pore Linings

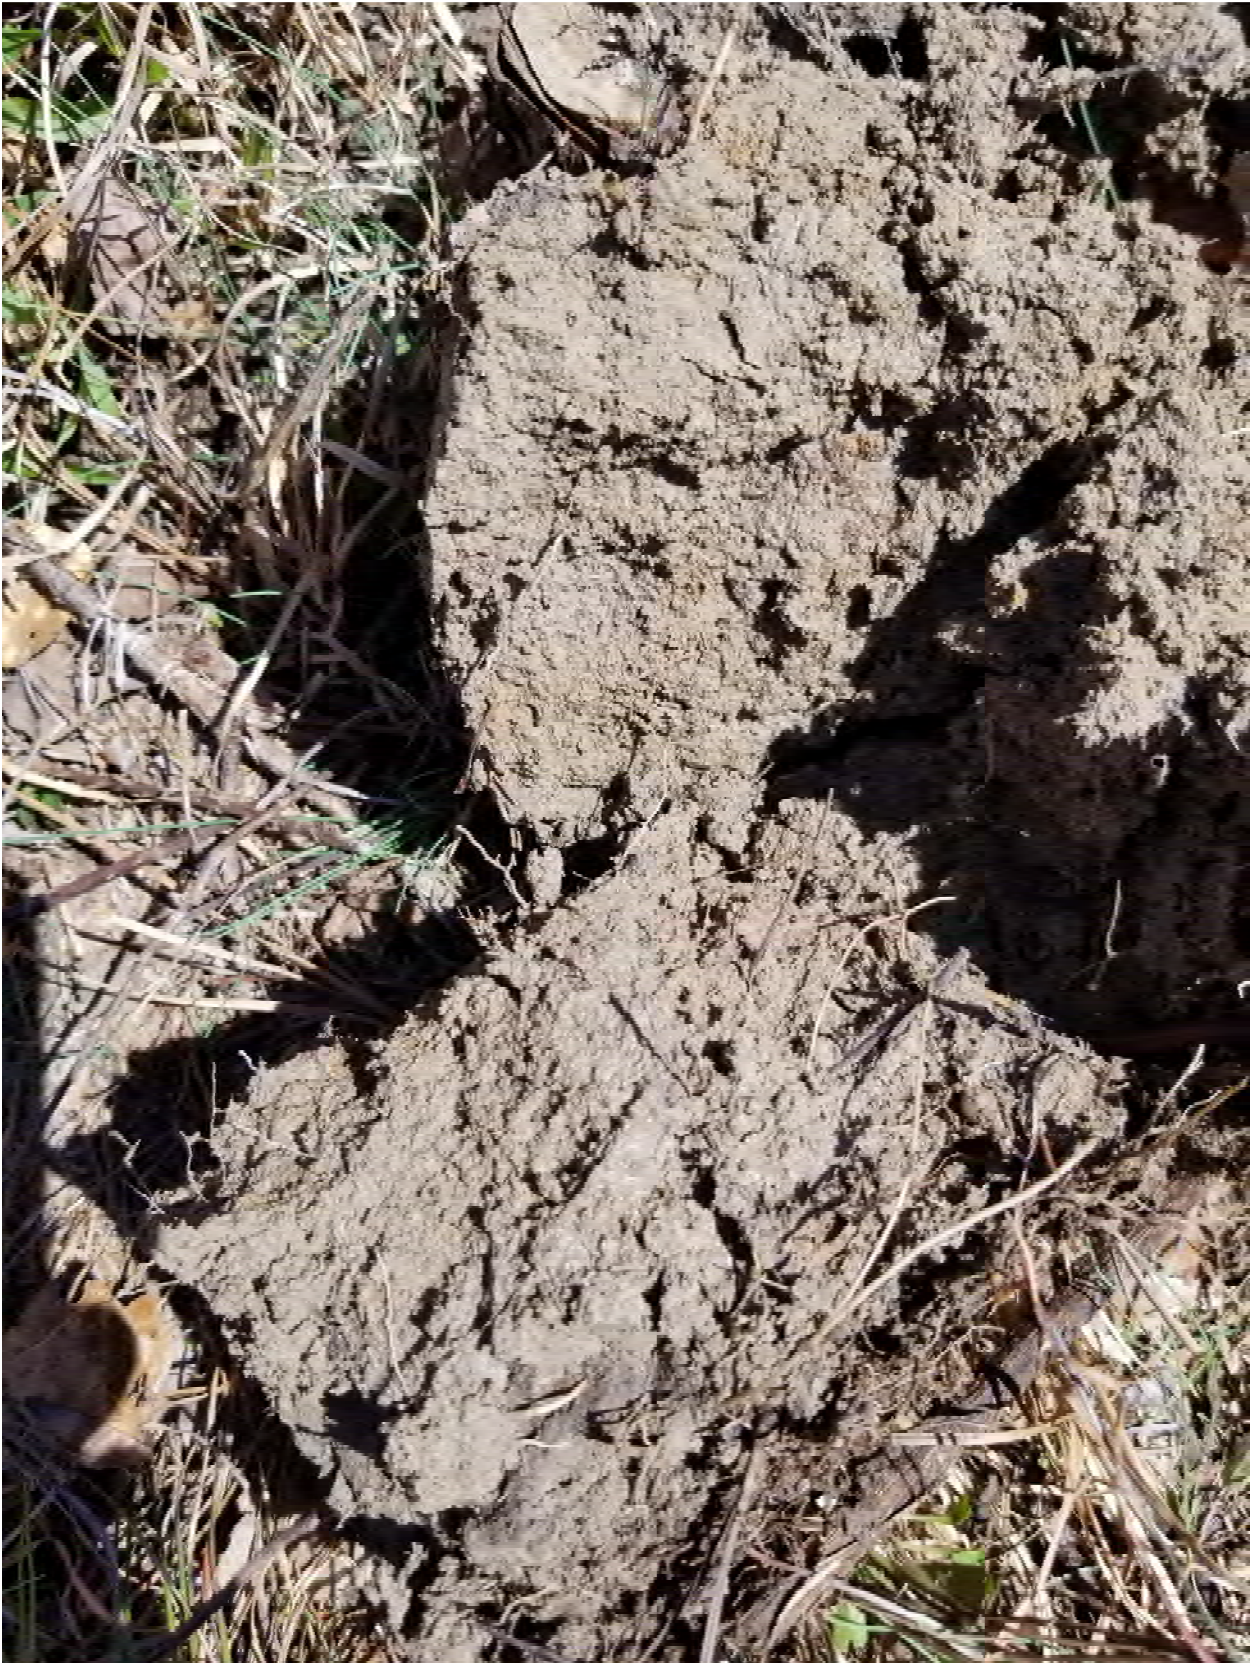
GW20 surface

- (4) The elongated area south of GW20. This area contains hydric soils, but is slightly elevated above adjacent areas that are meeting aquic conditions but the ditch along the eastern property line is likely preventing adequate hydrology that would cause aquic conditions.

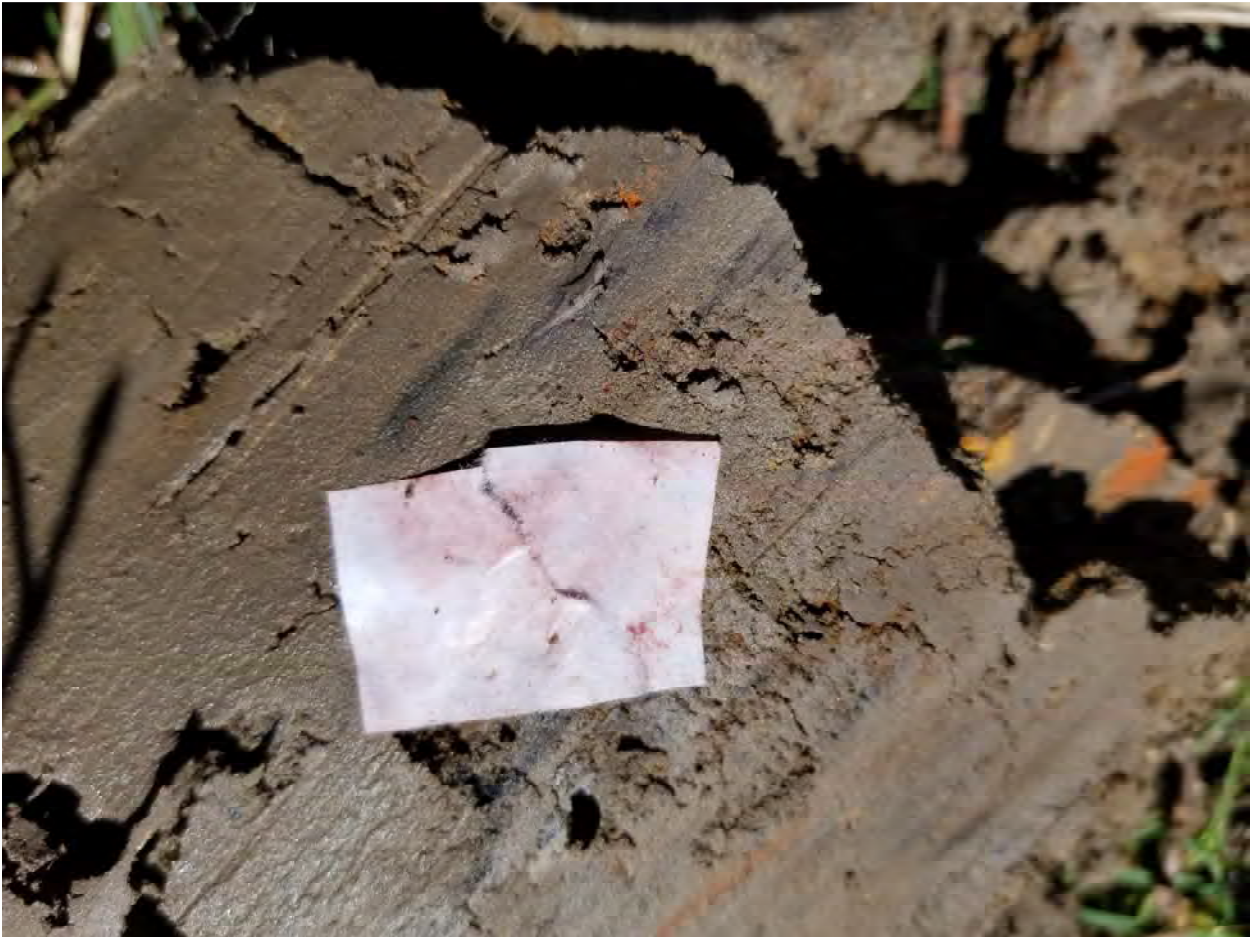
B10 subsurface Positive  $\alpha, \alpha'$ -dipyridyl

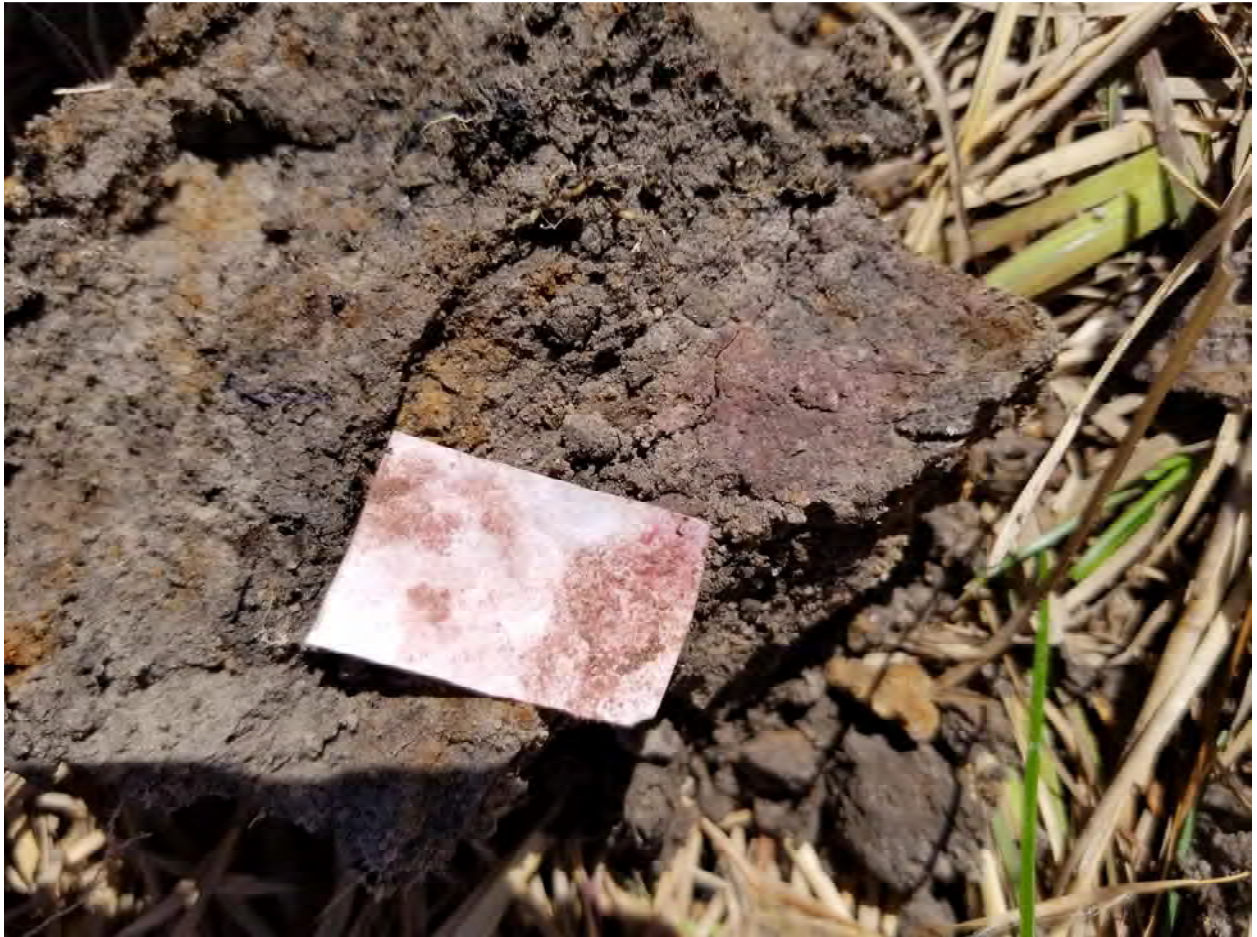
B11 subsurface Positive  $\alpha, \alpha'$ -dipyridyl
