MONITORING YEAR 1 ANNUAL REPORT

January 2023

DOUBLE H FARMS MITIGATION SITE

Alleghany County, NC
DEQ Contract No. 7608
DMS Project No. 100082

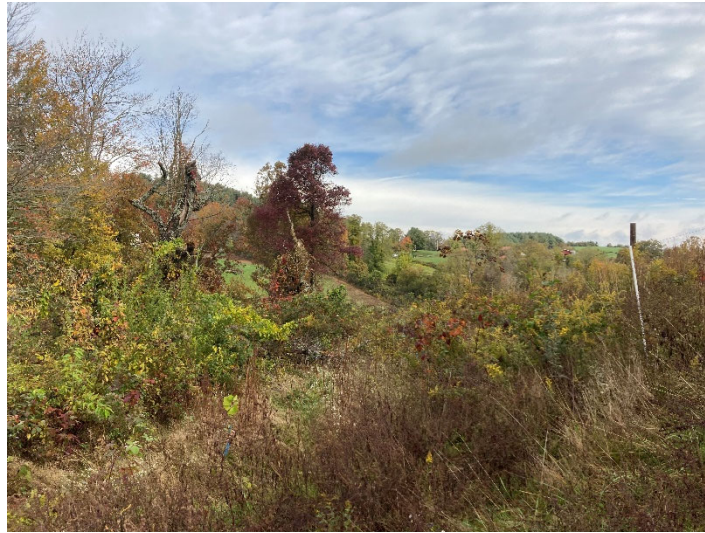
UT6 – Invasive Treatment Along EII channel (10/12/2022)

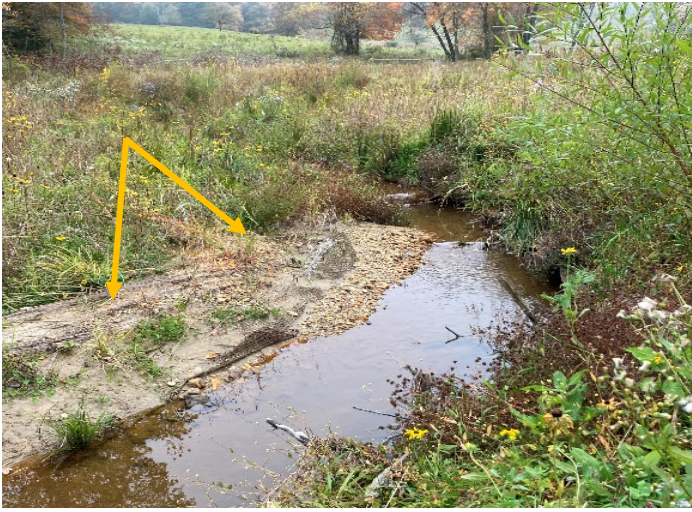
UT to Crab Creek Point Bar Deposition – (10/14/2022)

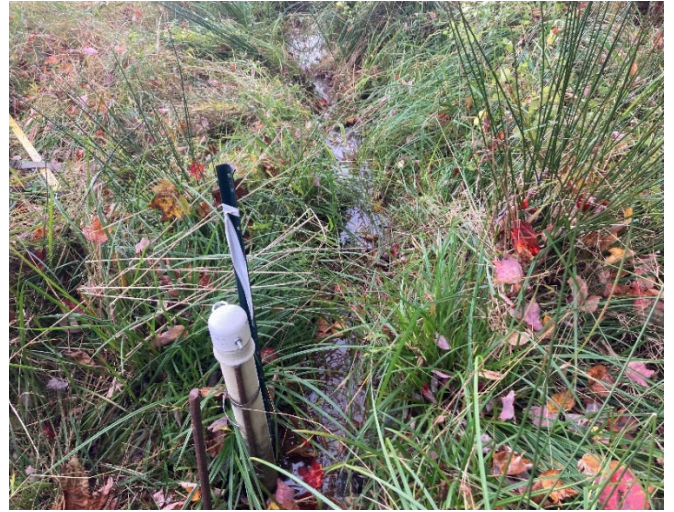
UT1A R1 Start of Stream Flow – (10/14/2022)

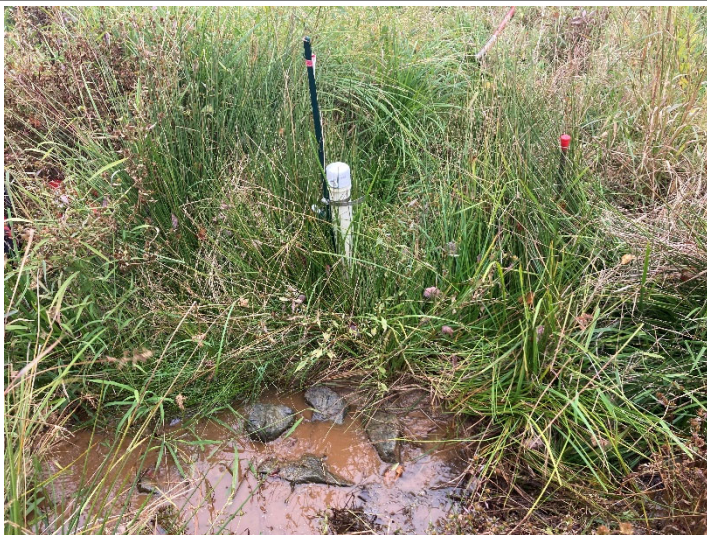
UT1A R1 Top of Bank CG3 In-stream Location – (10/14/2022)

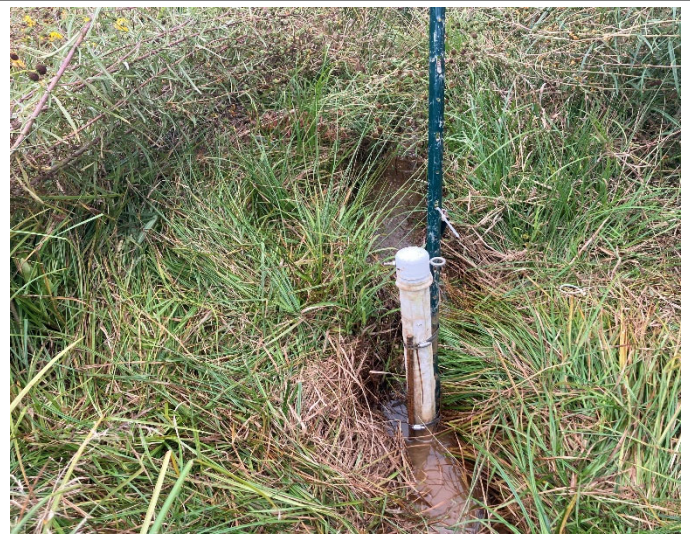
UT1A R1 CG3 Relocated In-stream – (10/14/2022)

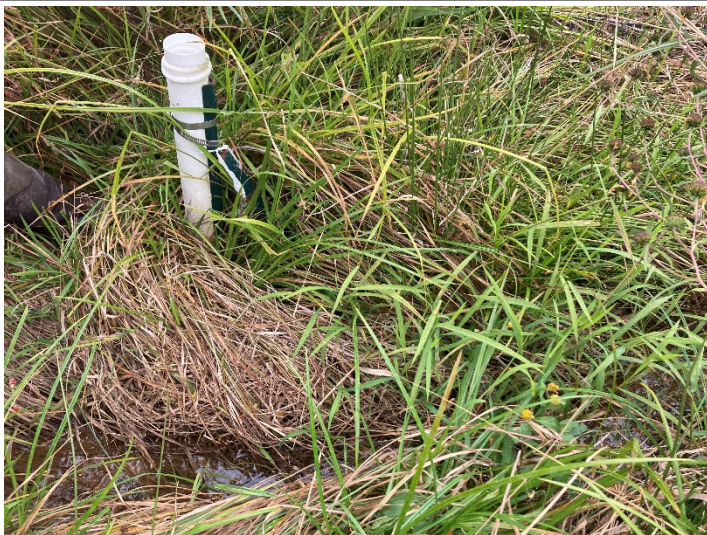
UT4 R1 Top of Bank CG2 Location – (10/14/2022)

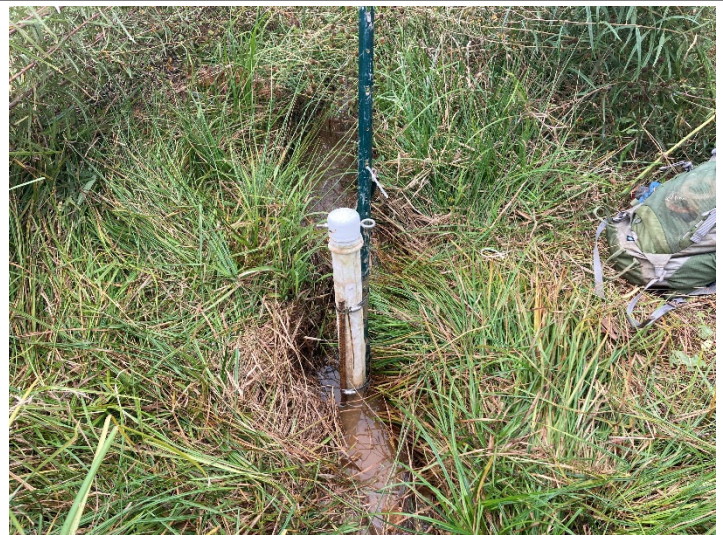
UT4 R1 CG2 Relocated In-stream – (10/14/2022)
