MONITORING YEAR 2 ANNUAL REPORT FINAL

DOUBLE H FARMS MITIGATION SITE

Alleghany County, NC
DEQ Contract No. 7608
DMS Project No. 100082

DOUBLE H FARMS MITIGATION SITE
Monitoring Year 2 Annual Report

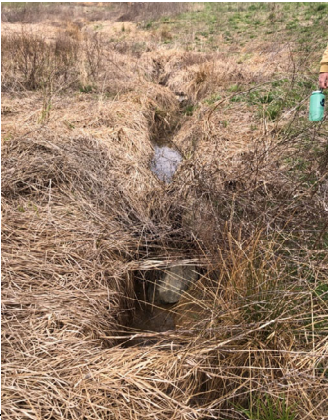
404+30	piping sill and channel incising above culvert	reduce drop over structure, lay back bank, re-build riffle

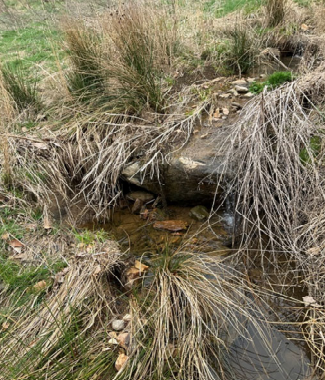
UT4 R2	409+60	piping sill	reduce drop over structure, lay back bank, re-build riffle

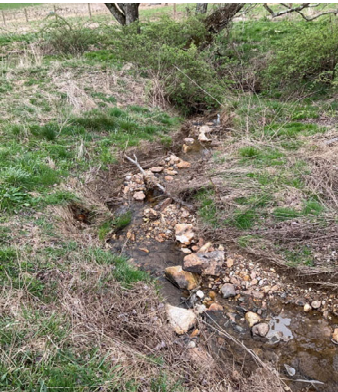
411+70	channel incising	add structures

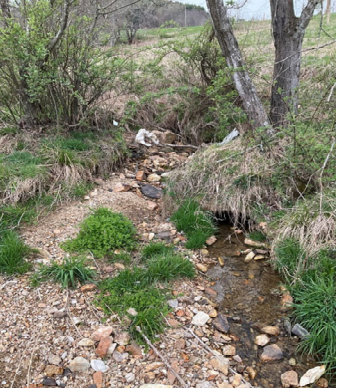
412+60	channel incising	add structures

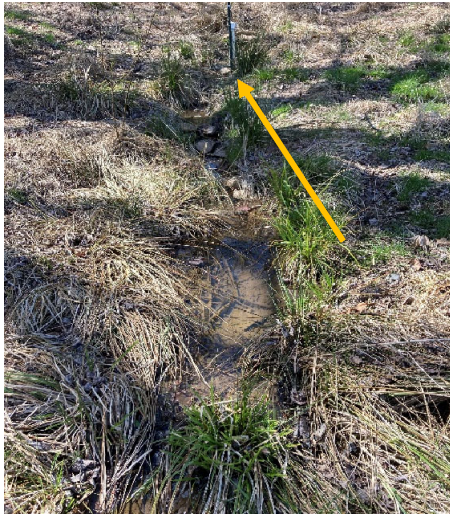
UT1A R1 Start of Stream Flow below wetland seep, looking upstream – (04/05/2023)

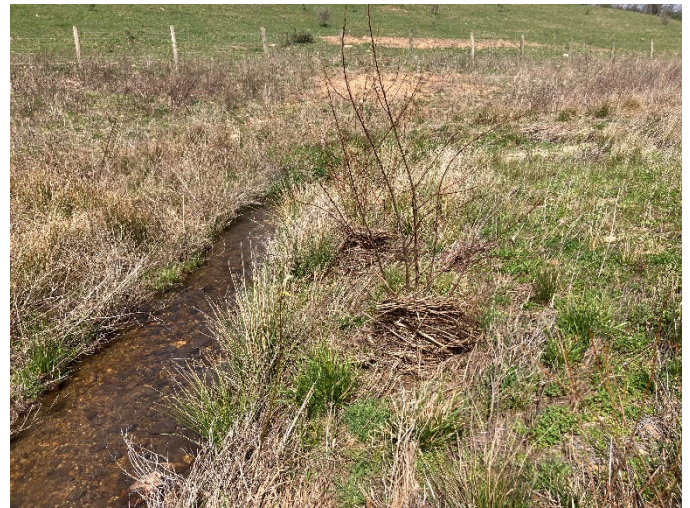
UT to CC Wrackline – (04/05/2023)

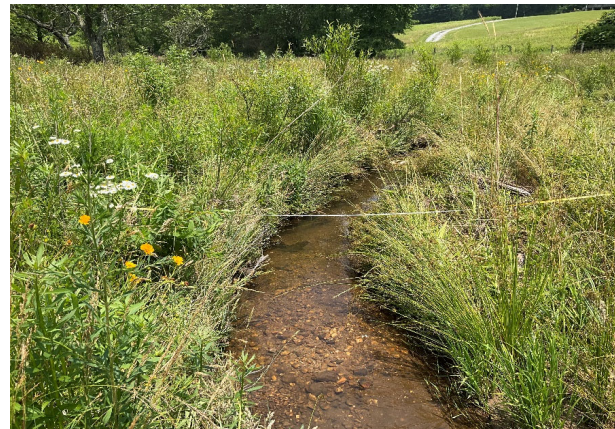
Cross-Section 7 - UT to Crab Creek R2

7.9	x-section area (ft.sq.)
8.8	width (ft)
0.9	mean depth (ft)
1.7	max depth (ft)
10.1	wetted perimeter (ft)
0.8	hydraulic radius (ft)
9.7	width-depth ratio

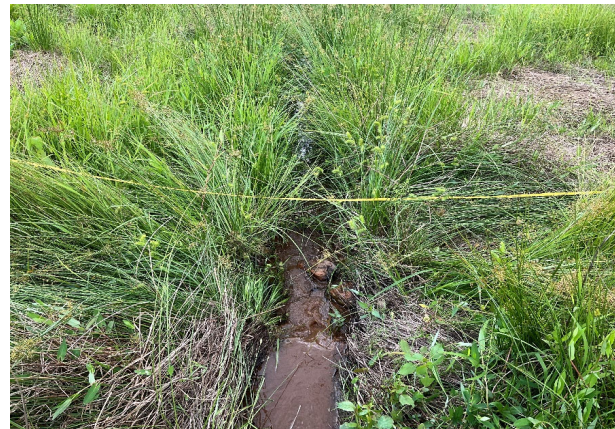
Cross-Section 8 - UT5 R2

1.4	x-section area (ft.sq.)
5.1	width (ft)
0.3	mean depth (ft)
0.6	max depth (ft)
5.5	wetted perimeter (ft)
0.3	hydraulic radius (ft)
18.4	width-depth ratio
30.0	W flood prone area (ft)
5.8	entrenchment ratio
1.1	low bank height ratio

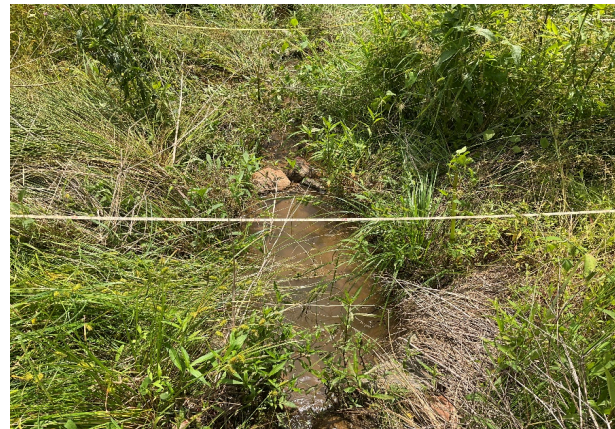
Cross-Section 9 - UT4 R1

5.2	x-section area (ft.sq.)
6.6	width (ft)
0.8	mean depth (ft)
1.7	max depth (ft)
7.8	wetted perimeter (ft)
0.7	hydraulic radius (ft)
8.3	width-depth ratio

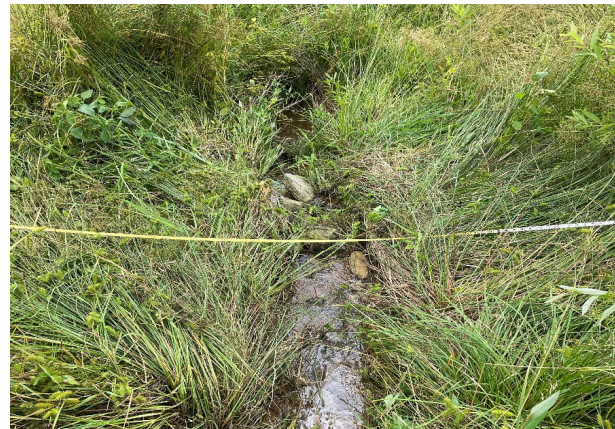
Cross-Section 10 - UT4 R1

1.3	x-section area (ft.sq.)
4.9	width (ft)
0.3	mean depth (ft)
0.7	max depth (ft)
5.3	wetted perimeter (ft)
0.2	hydraulic radius (ft)
18.9	width-depth ratio
24.8	W flood prone area (ft)
5.1	entrenchment ratio
< 1.0	low bank height ratio

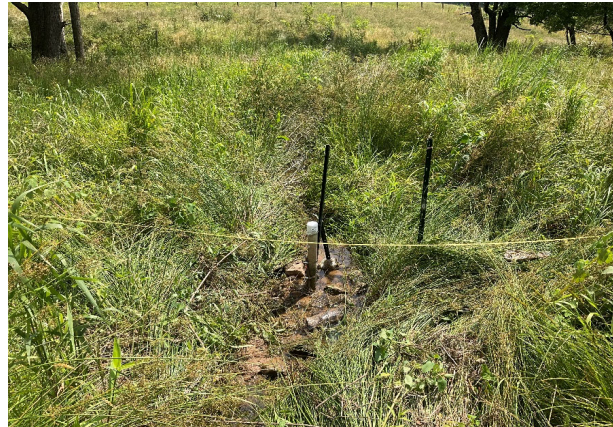
Cross-Section 11 - UT4 R2

2.5	x-section area (ft.sq.)
5.8	width (ft)
0.4	mean depth (ft)
0.9	max depth (ft)
6.3	wetted perimeter (ft)
0.4	hydraulic radius (ft)
13.3	width-depth ratio
31.8	W flood prone area (ft)
5.5	entrenchment ratio
< 1.0	low bank height ratio

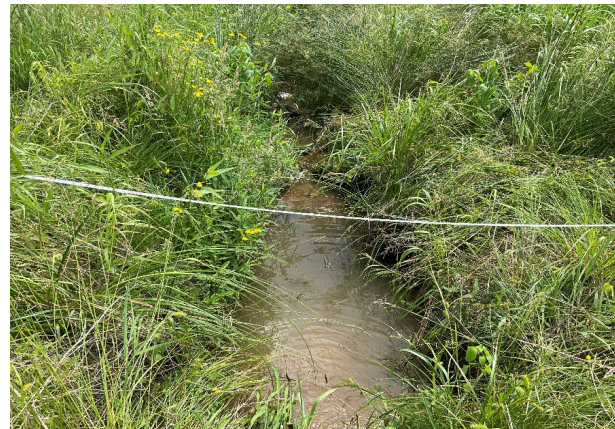
Cross-Section 12 - UT4 R2

9.2	x-section area (ft.sq.)
6.4	width (ft)
1.4	mean depth (ft)
2.6	max depth (ft)
9.1	wetted perimeter (ft)
1.0	hydraulic radius (ft)
4.5	width-depth ratio

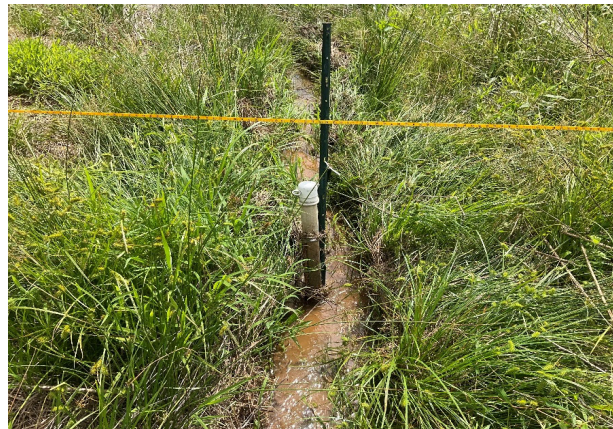
Cross-Section 13 - UT1A R1

2.0	x-section area (ft.sq.)
5.8	width (ft)
0.3	mean depth (ft)
0.9	max depth (ft)
6.4	wetted perimeter (ft)
0.3	hydraulic radius (ft)
16.7	width-depth ratio
29.7	W flood prone area (ft)
5.2	entrenchment ratio
1.1	low bank height ratio

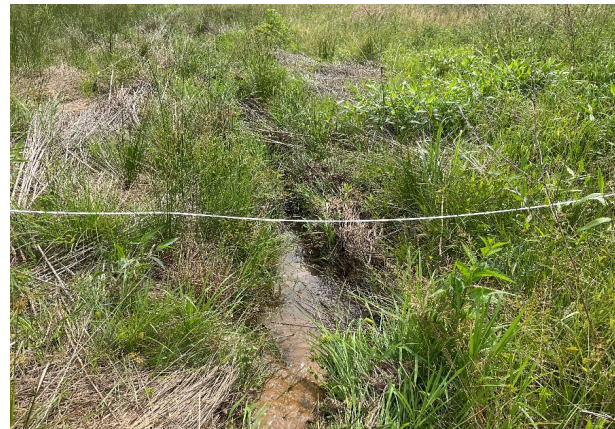
Cross-Section 14 - UT1A R1

5.7	x-section area (ft.sq.)
5.6	width (ft)
1.0	mean depth (ft)
1.9	max depth (ft)
7.3	wetted perimeter (ft)
0.8	hydraulic radius (ft)
5.6	width-depth ratio
