**DUKE SWAMP WETLAND AND STREAM
RESTORATION PROJECT**
ANNUAL MONITORING REPORT FOR 2011 (YEAR 4)

Contract Number D06065-A

Prepared by: Michael Baker Engineering, Inc.

December 2011

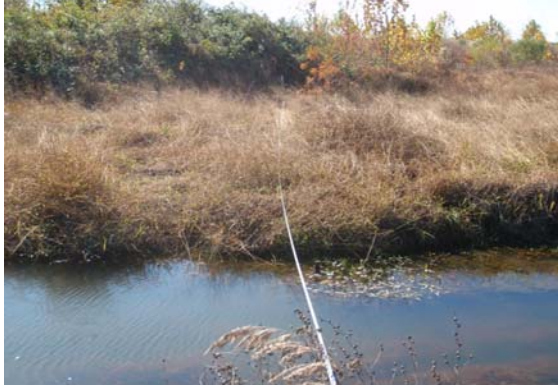
Permanent Cross-section 1, Station 13+30
 (Year 4 Data - Collected November 2011)

Looking at the Left Bank

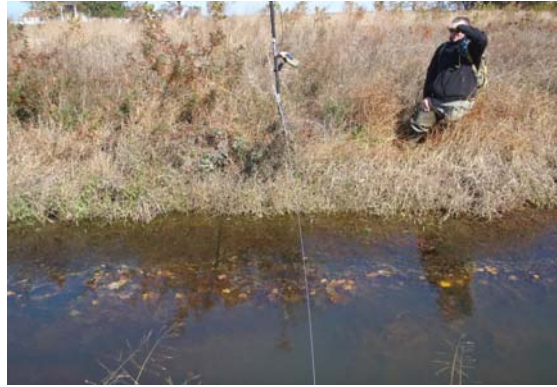
Looking at the Right Bank

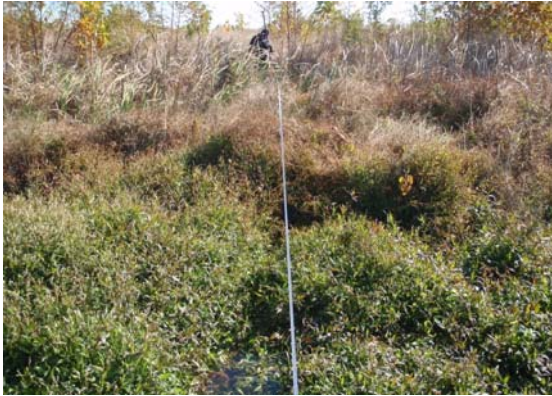
Permanent Cross-section 3, Station 20+27
 (Year 4 Data - Collected November 2011)

Looking at the Left Bank

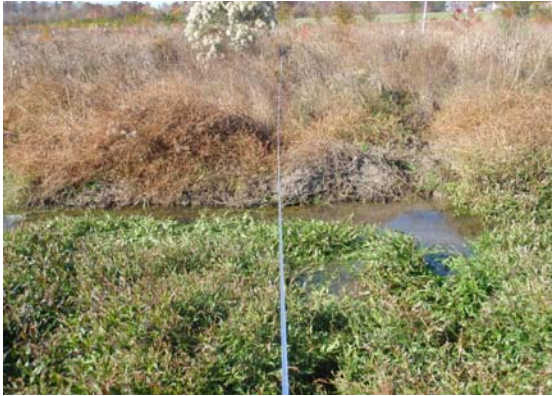
Looking at the Right Bank

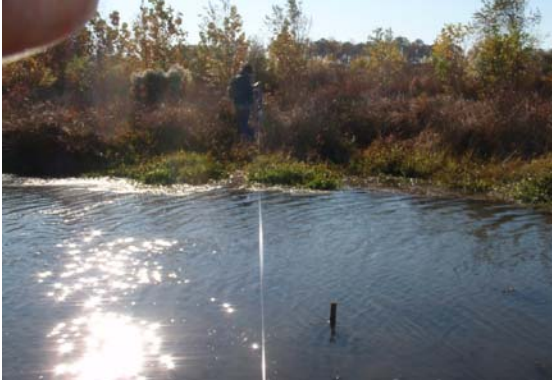
Permanent Cross-section 6, Station 37+13
 (Year 4 Data - Collected November 2011)

Looking at the Left Bank

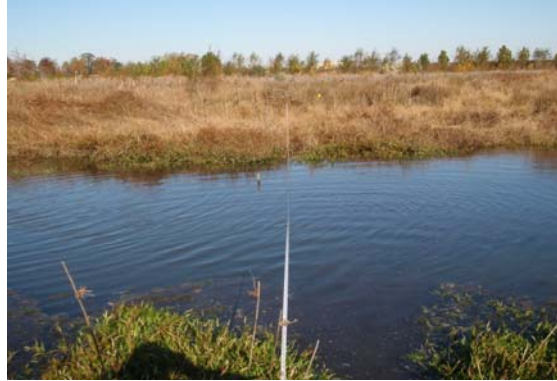
Looking at the Right Bank

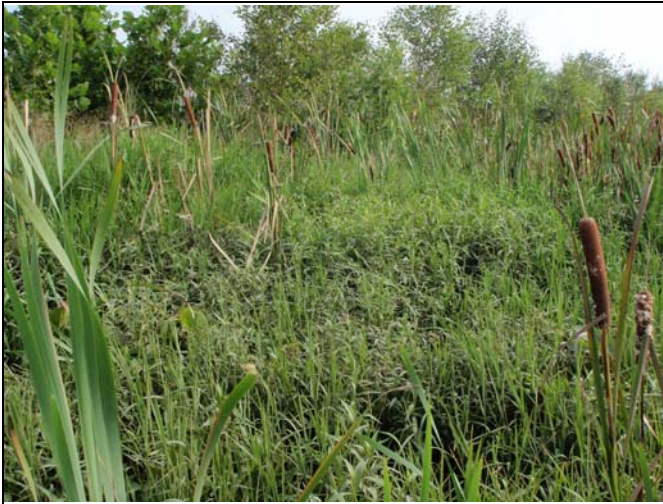
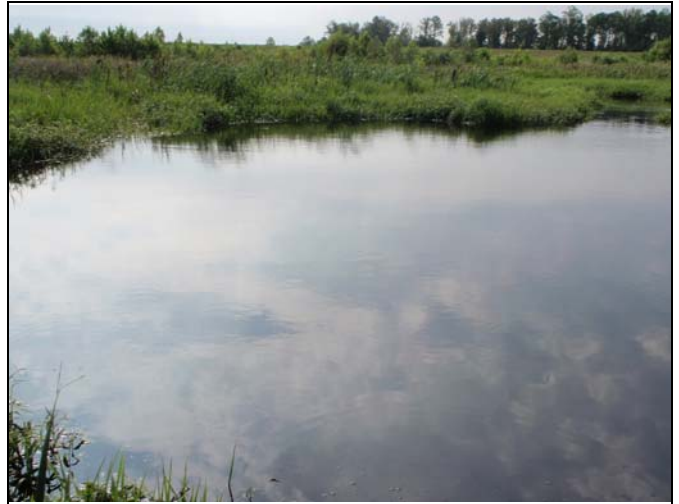
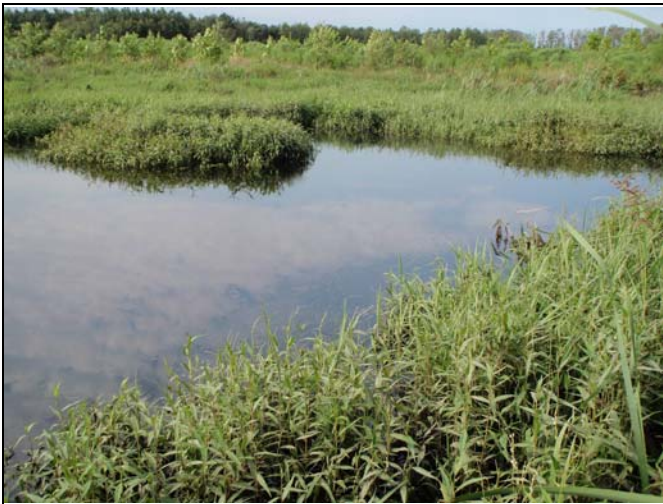
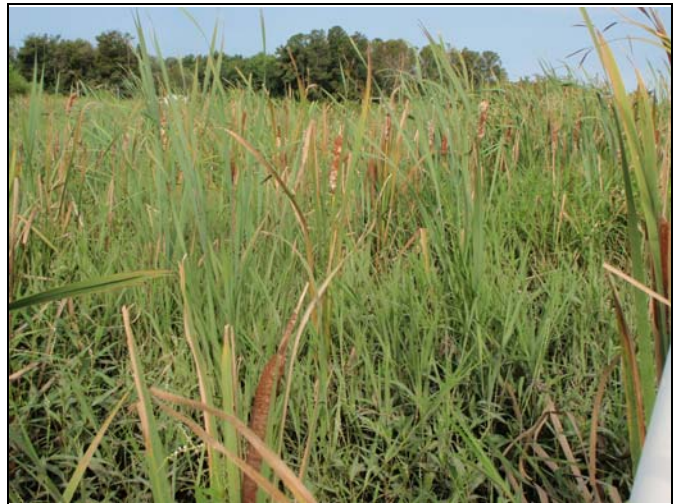
The area between station 38+00 and 40+00 has undergone subsidence on the right floodplain. The settling has allowed below bankfull flows to permanently flood the right floodplain near AW4, vegetation plot 10 and cross-section 7. The floodplain elevation of cross-section 7 has decreased since as-built conditions, but it has remained stable since Year 1 data collection. The subsided area between stations 38+00 and 40+00 has also remained stable and no significant changes have been noted. This area will continue to be closely observed during Year 5 and prior to project closeout and any significant changes will be reported.
