**Dye Branch II
Stream Restoration
NCEEP Project Number: 92255
Monitoring Year 2
Monitoring Contract Number: 004523
2012 Final Report**

**Submitted to
North Carolina Ecosystem Enhancement Program
North Carolina Department of Environment and Natural Resources
November 2012**

Dye Branch II Stream Restoration 2012 Monitoring Report (MY 2)

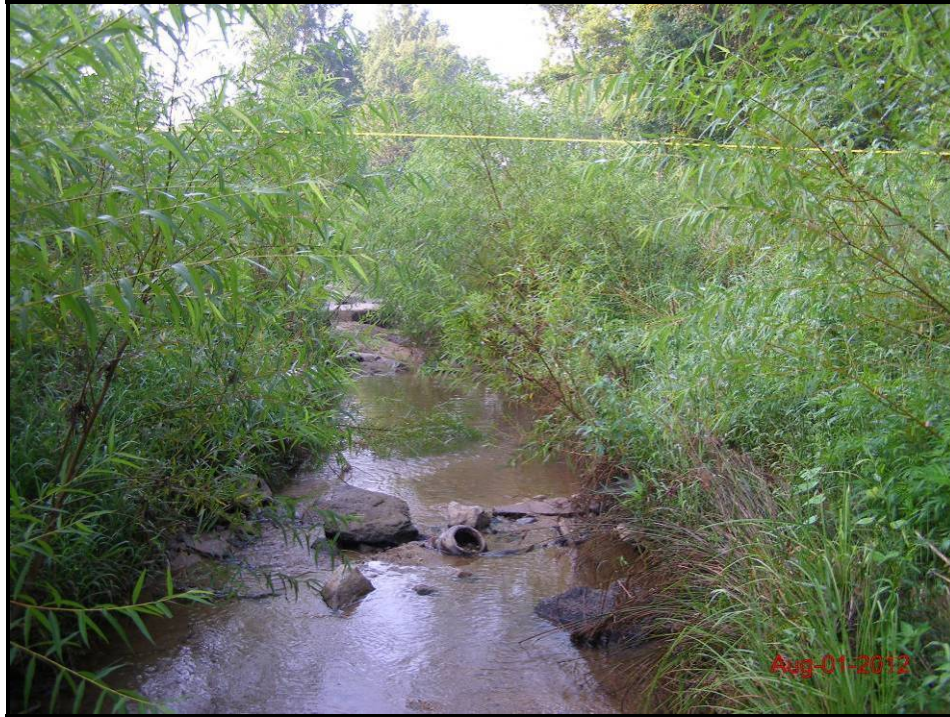
Dye Branch Downstream Reach – Cross-Section 8 – Riffle
Downstream
Monitoring Year 2 – August 1, 2012

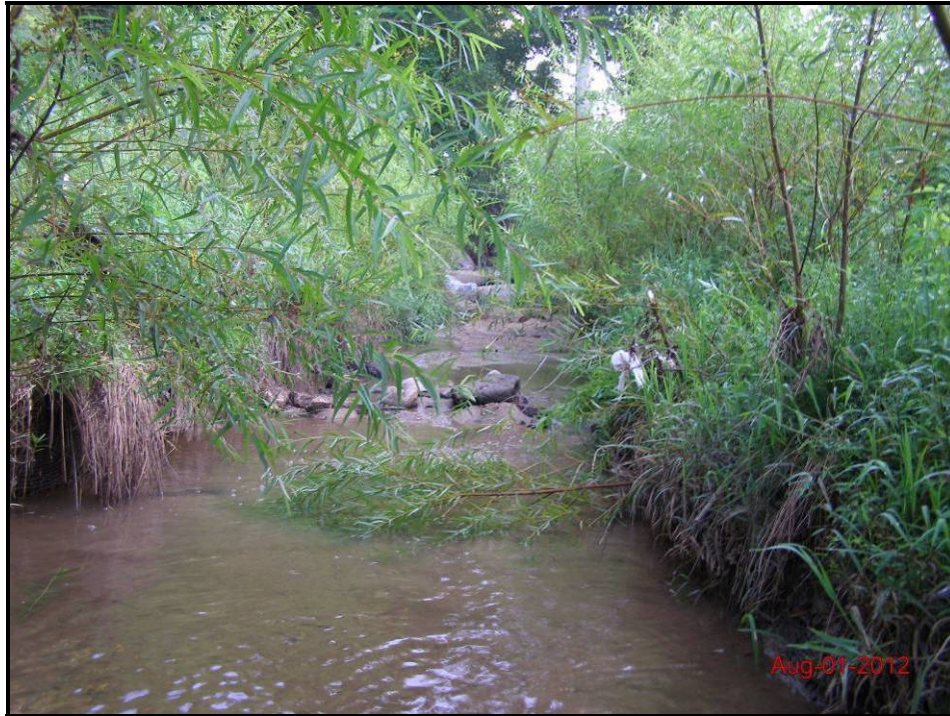
Dye Branch Downstream Reach – Cross-Section 8 – Riffle
Upstream
Monitoring Year 2 – August 1, 2012

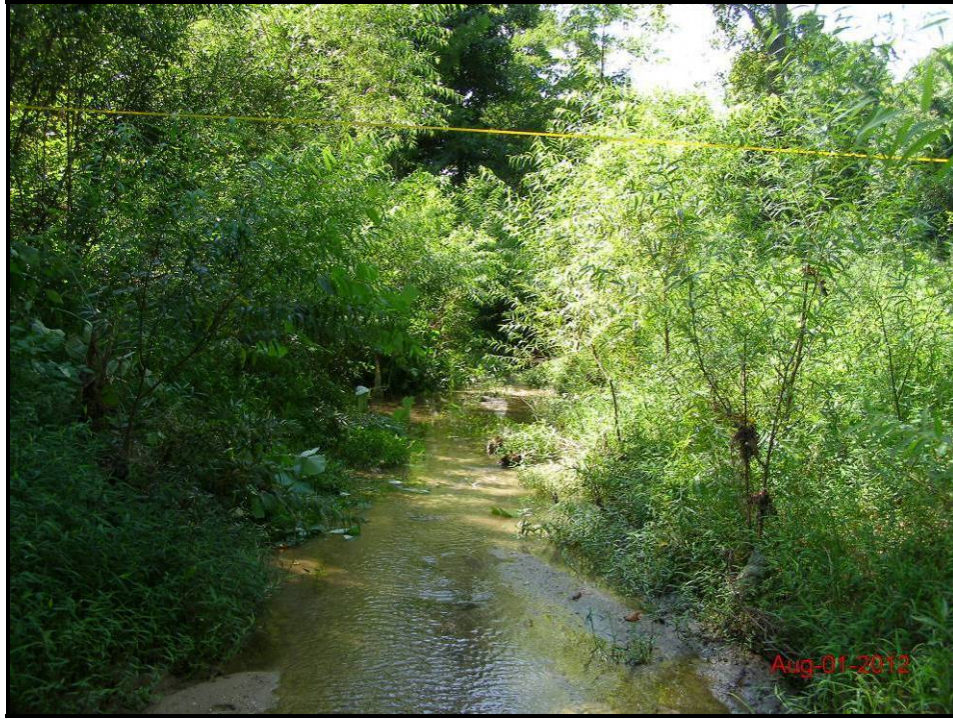
Dye Branch Downstream Reach – Cross-Section 9 – Pool
Downstream
Monitoring Year 2 – August 1, 2012

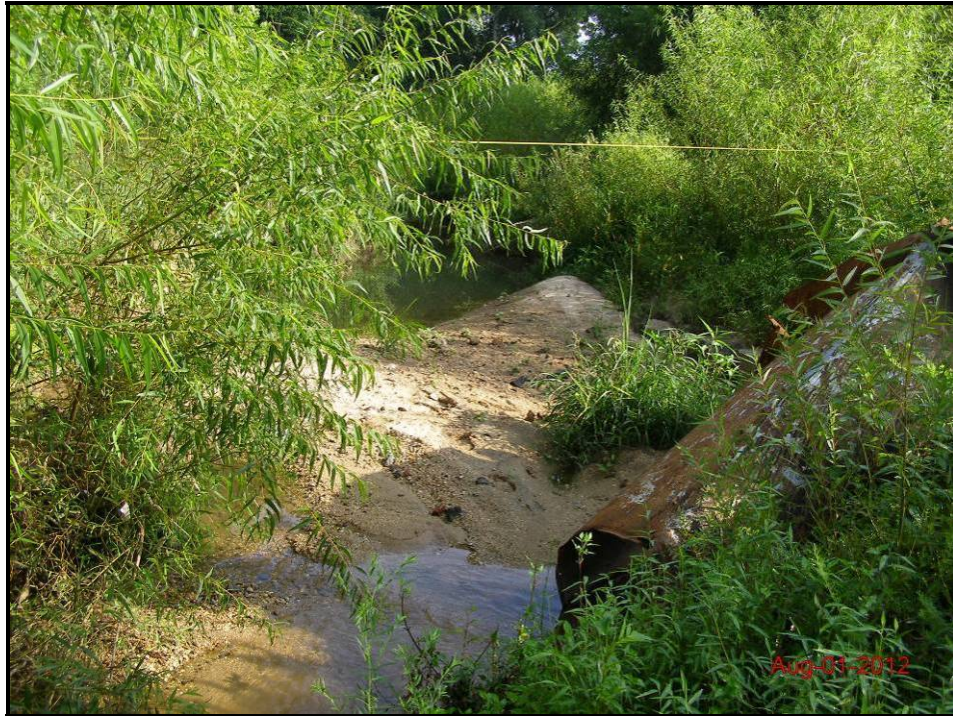
Dye Branch Downstream Reach – Cross-Section 9 – Pool
Upstream
Monitoring Year 2 – August 1, 2012

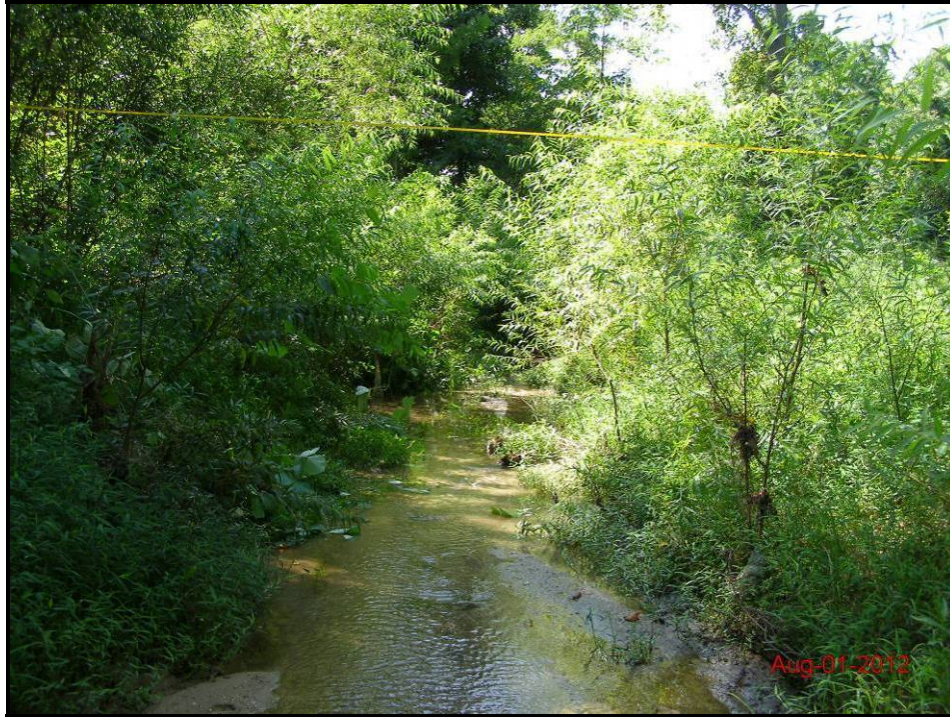
Dye Branch Downstream Reach – Cross-Section 10 – Riffle
Downstream
Monitoring Year 2 – August 1, 2012
