East Buffalo Creek Mitigation Project

Year 4 Monitoring Report - Final Graham County, North Carolina

Monitoring Firm: Michael Baker
Engineering, Inc. (Baker)
Monitoring Firm POC: Micky Clemmons

Prepared for: NCDENR – Division of
Mitigation Services
DMS Project Manager: Paul Wiesner

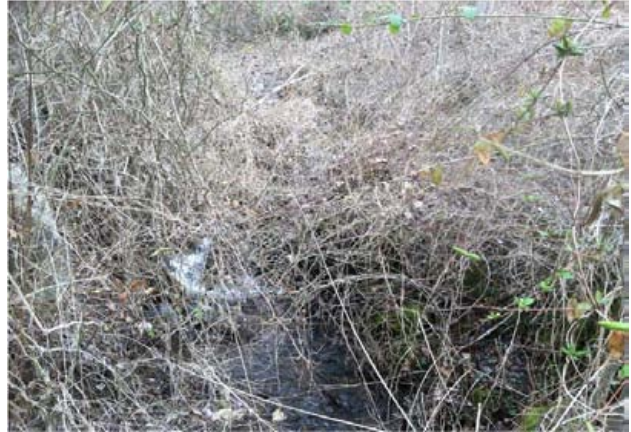
Photo 2. Dead multiflora above driveway in VPA2.

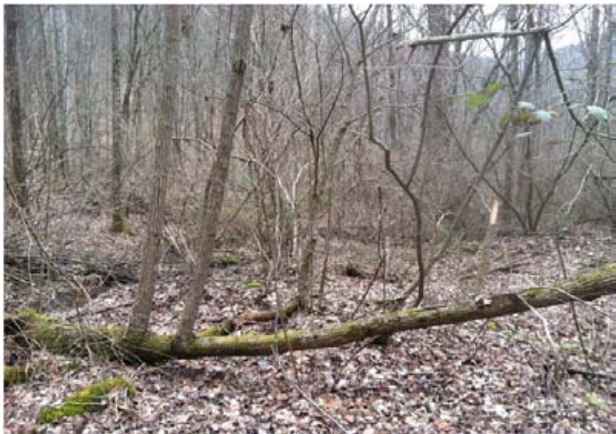
Invasive/Exotic Populations	See Plan View	<i>Rosa multiflora</i> , and <i>Ligustrum sinense</i> : significantly reduced but still persisting after treatment in some areas. We are continuing to show these areas and will continue to treat these areas to kill surviving invasives.	Photo 3

Photo 3. Reduced invasive density in VPA3.

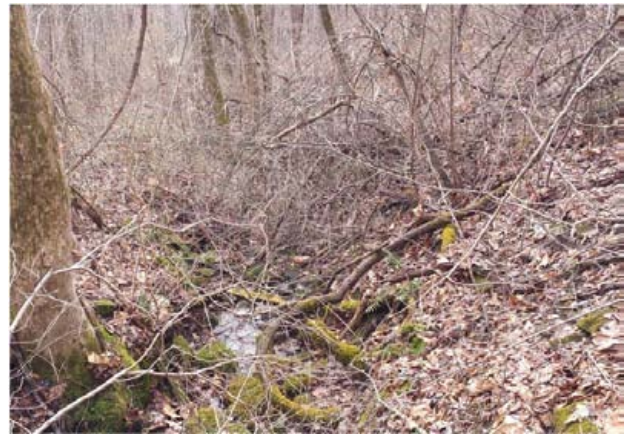
Photo 4. Dead multiflora within VPA2.
