**East Tarboro Canal Stream Restoration Project  
Edgecombe County  
North Carolina**

**CU: 03020103  
SCO# 030603101  
EEP Project No. 123**

**Year 1 Monitoring Report  
January 22, 2009**

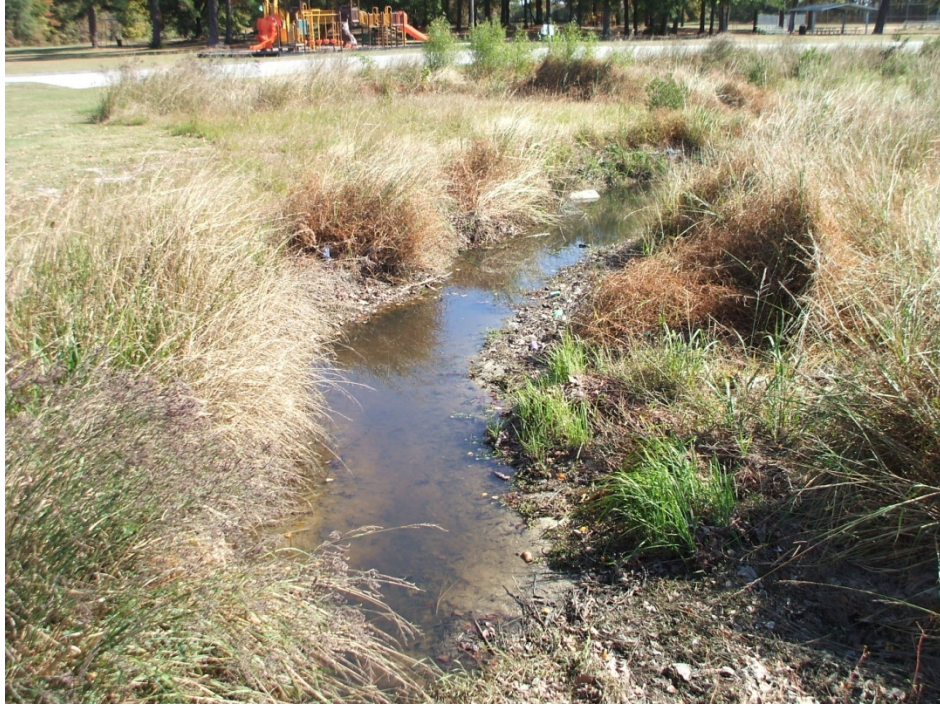
Photo Station 5. Beginning of Reach 2 Downstream

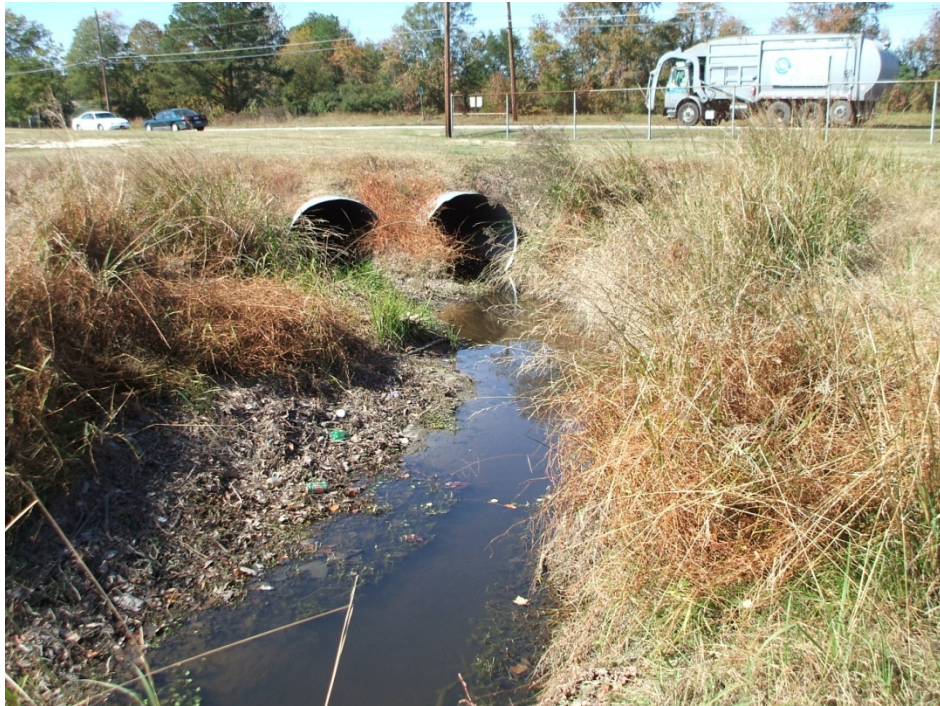
Photo Station 6. Beginning of Reach 2 Upstream

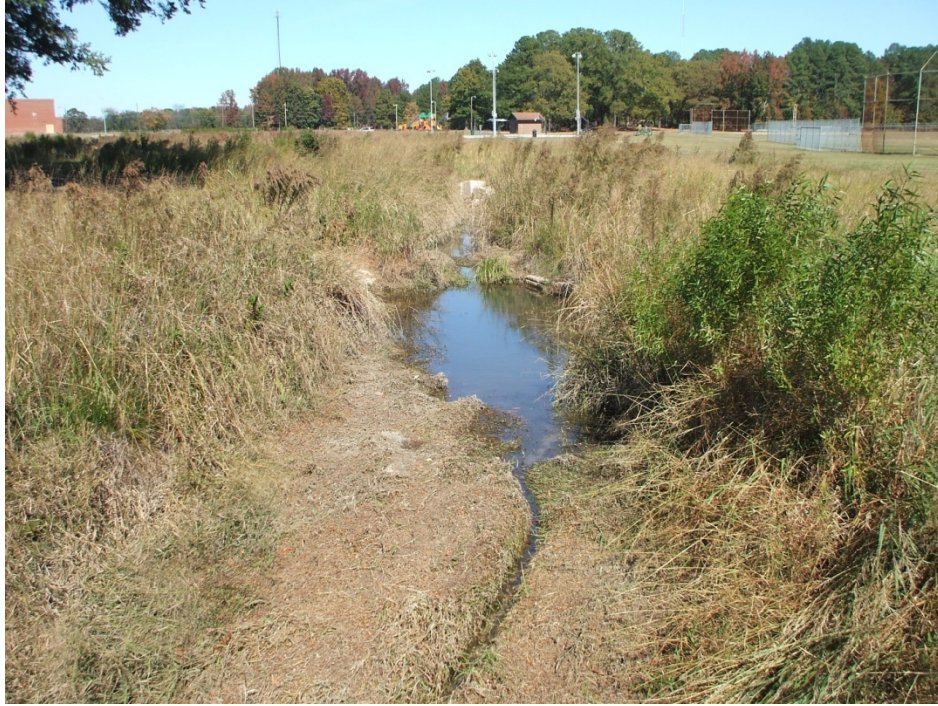
Photo Station 7. Wilson Street Crossing Upstream

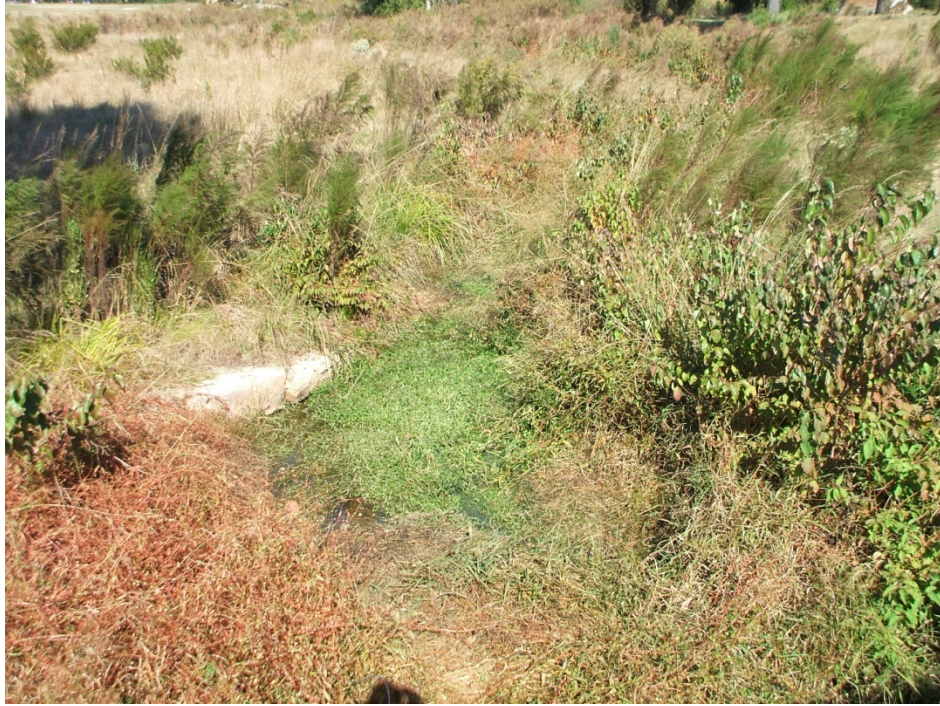
Photo Station 11. Reach 2 End of Project

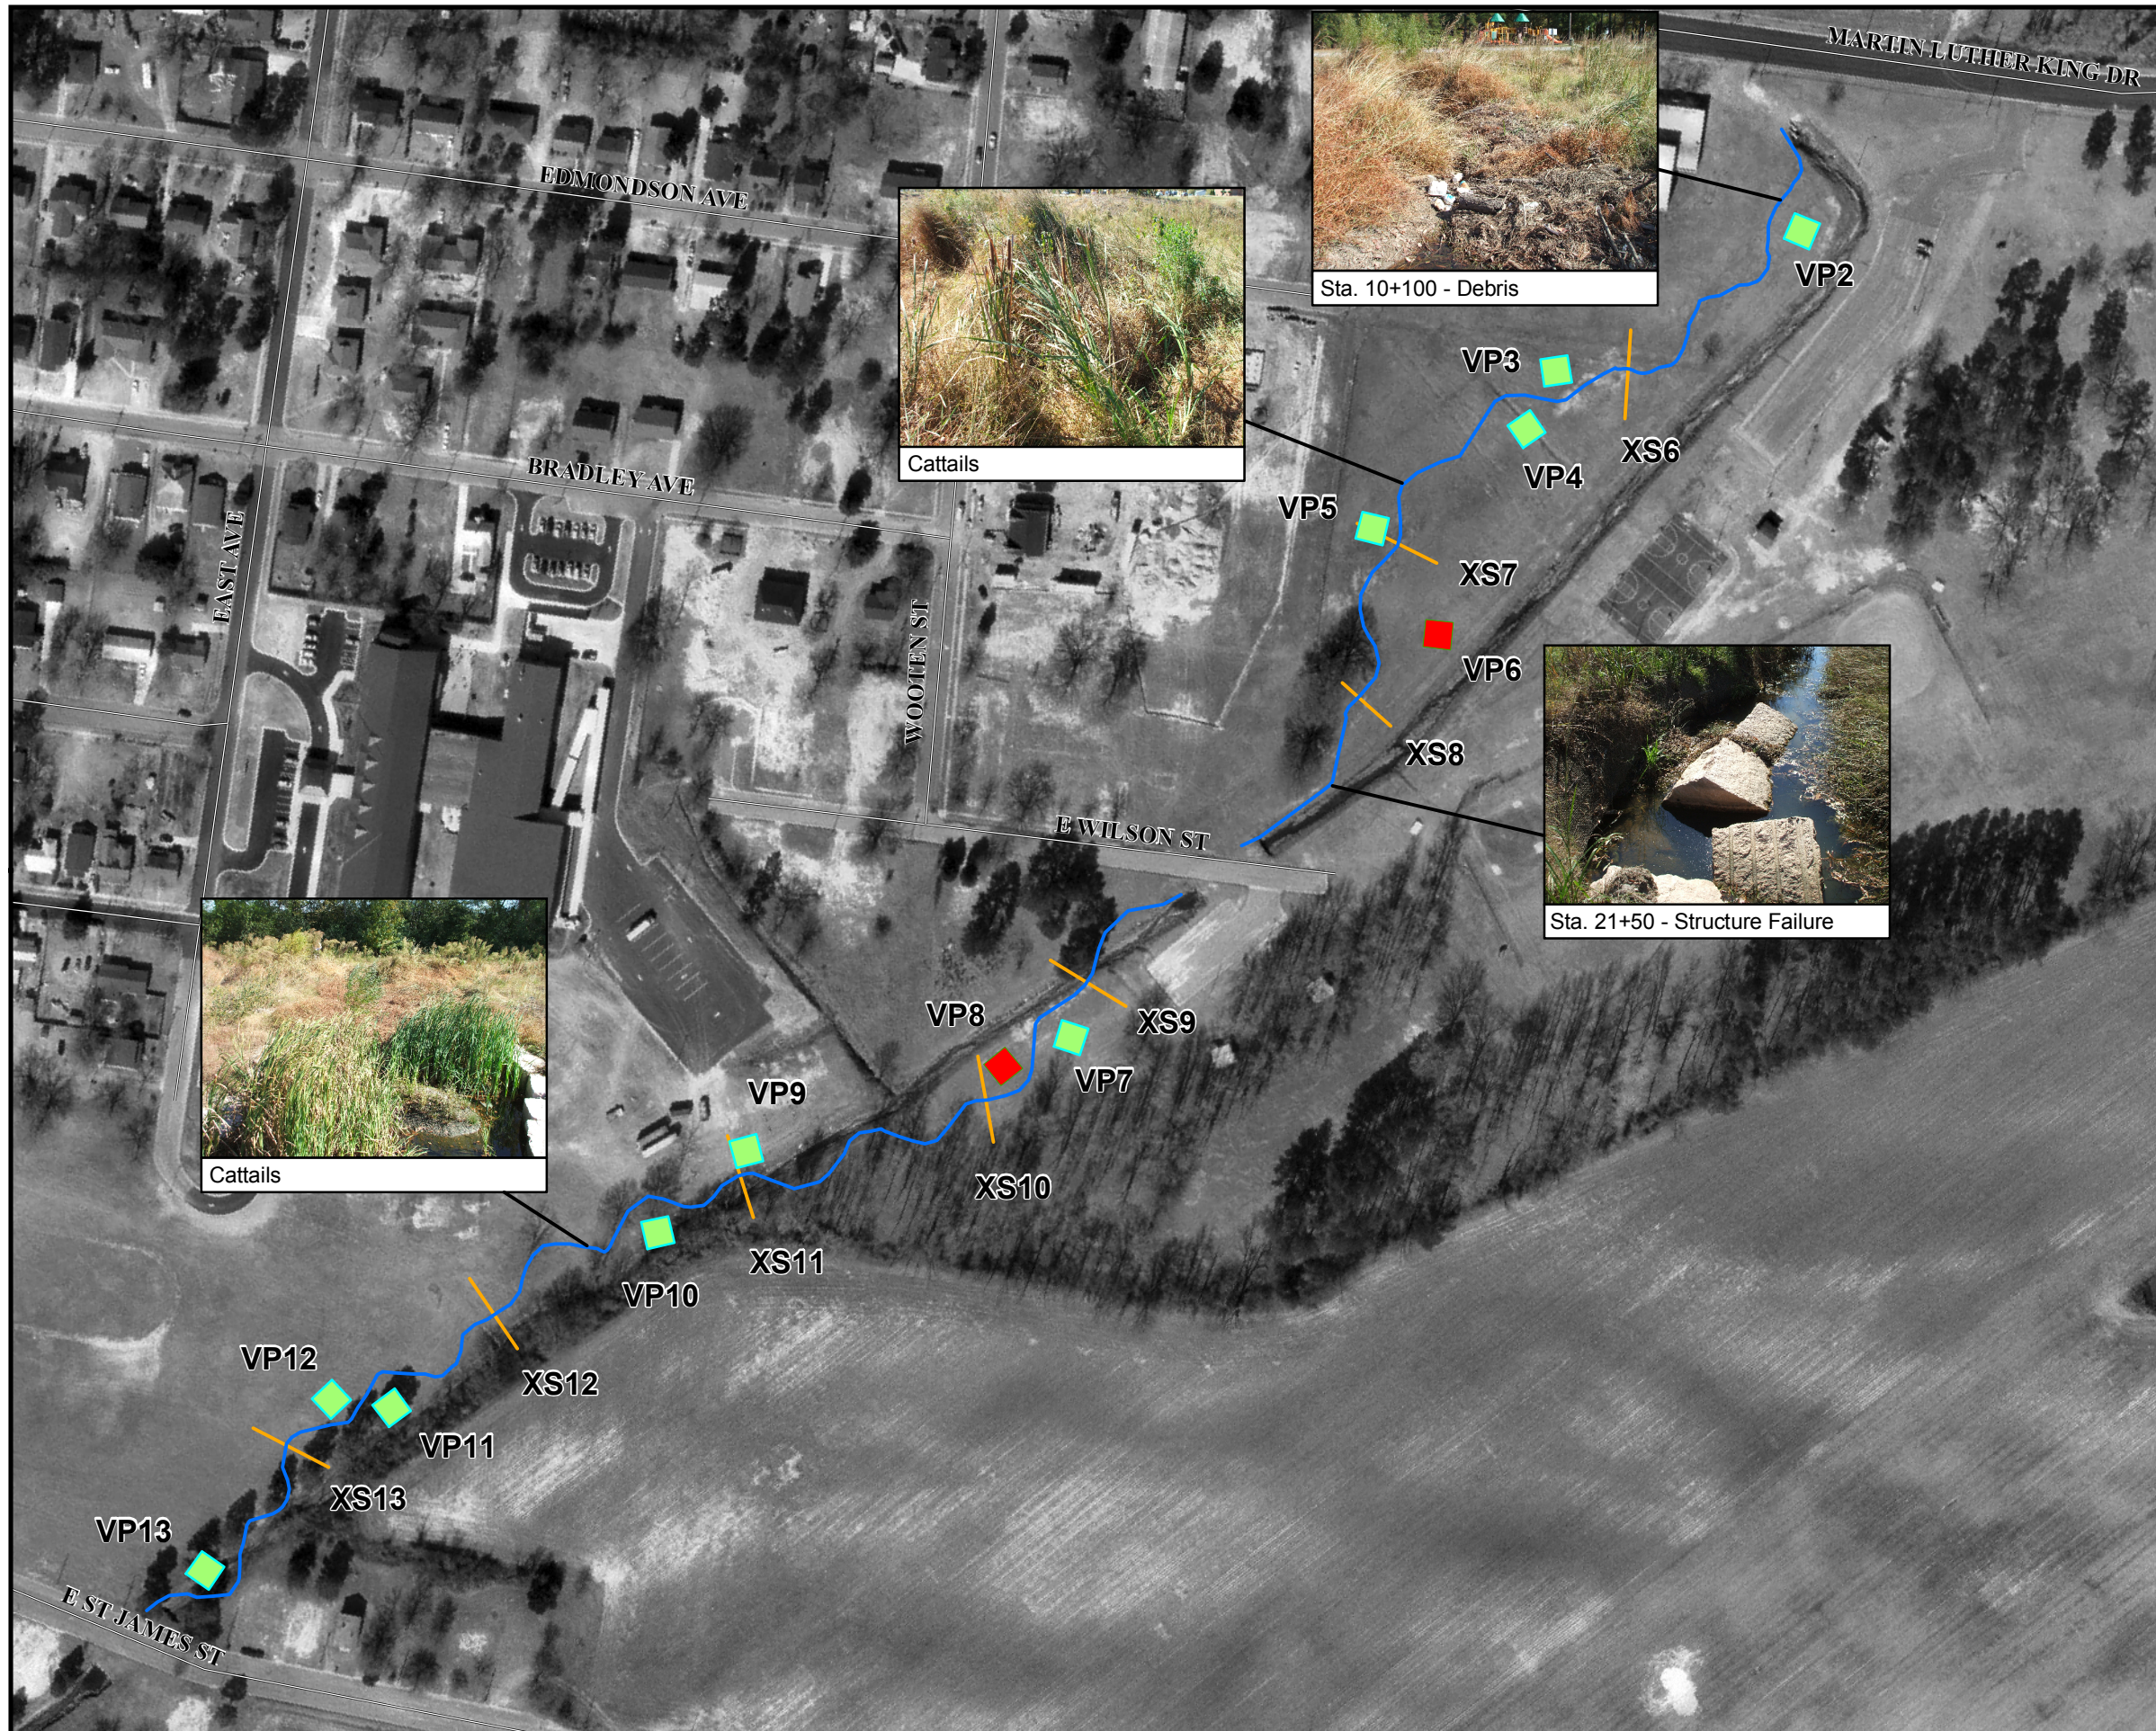
Current Conditions Plan View  
Reach 2

- Rock Vein Structure Failure at Station 21+50
- Invasive and exotic vegetation found throughout the stream channel of Reach 2

<b>Exhibit Table B.1 Stream Problem Areas East Tarboro Canal Stream Restoration Site EEP Project No. 123</b>				
<b>Feature Issue</b>	<b>Reach</b>	<b>Station Number</b>	<b>Suspected Cause</b>	<b>Photo Number</b>
Aggradation	Reach 1	20+25	Sediment from upstream	SP1
Aggradation	Reach 2	10+50	Sediment from upstream	N/A
Debris	Reach 2	10+100	N/A	SP2
Structure Failure	Reach 2	21+50	Poor Installation	SP3

RK&K recommends that the rock vein at station 21+50 (Photo B.3 SP3) be removed and replaced immediately to prevent more damage to the stream in this area. It is also recommended that all exotic species found within the stream channel be treated with herbicide.
