Elk Branch Restoration Project

Year 5 ~~Half~~Monitoring Report

Mitchell County, North Carolina

Monitoring Firm: Michael Baker Engineering, Inc. (Baker)

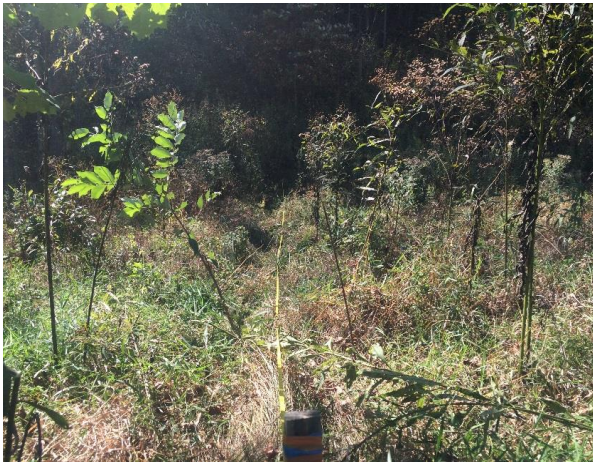
Photo 7: XS-4 facing right bank

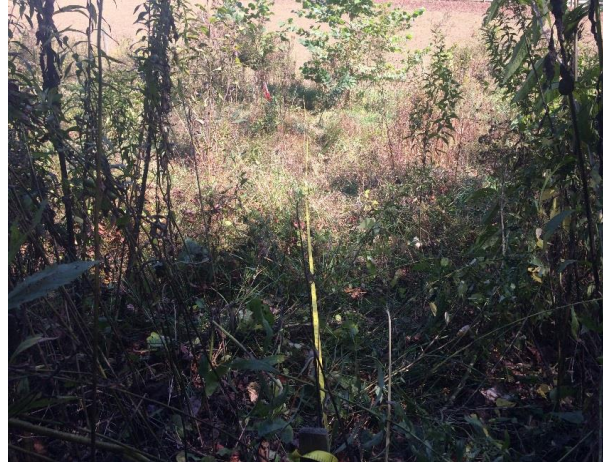
Photo 8: XS-4 facing left bank

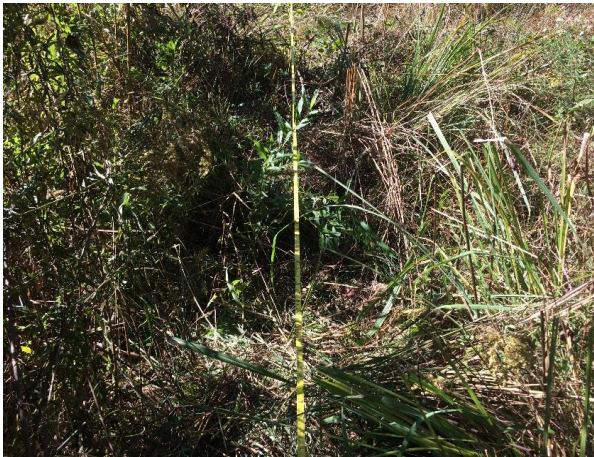
Photo 1: XS-1 facing right bank

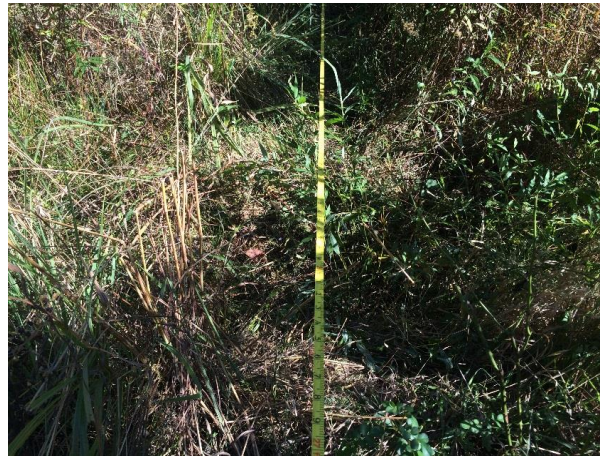
Photo 2: XS-1 facing left bank

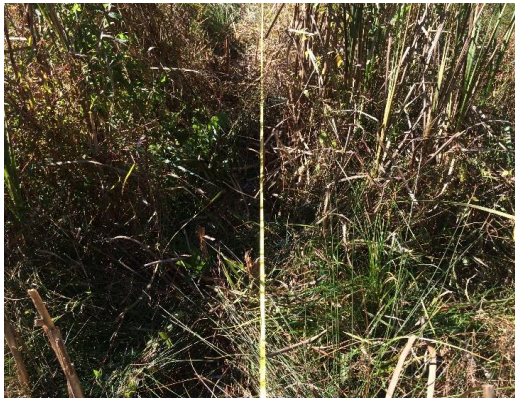
Photo 3: XS-2 facing right bank

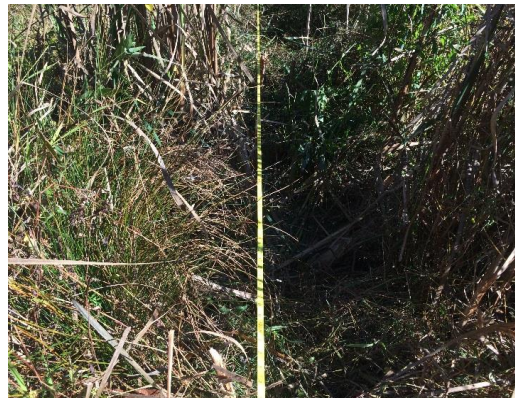
Photo 4: XS-2 facing left bank at channel

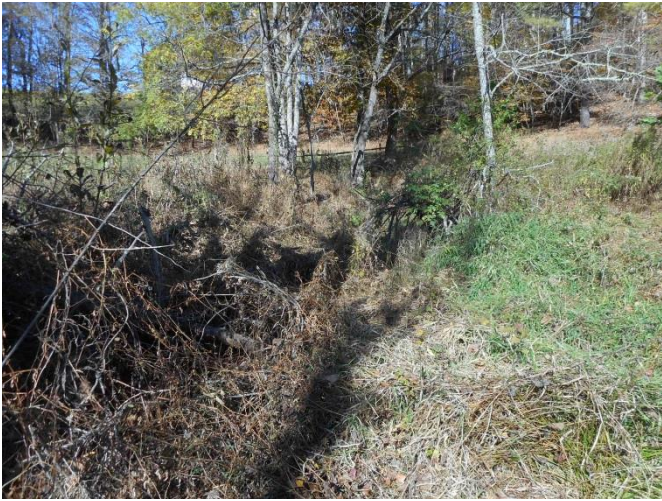
Photo Point 1: looking upstream

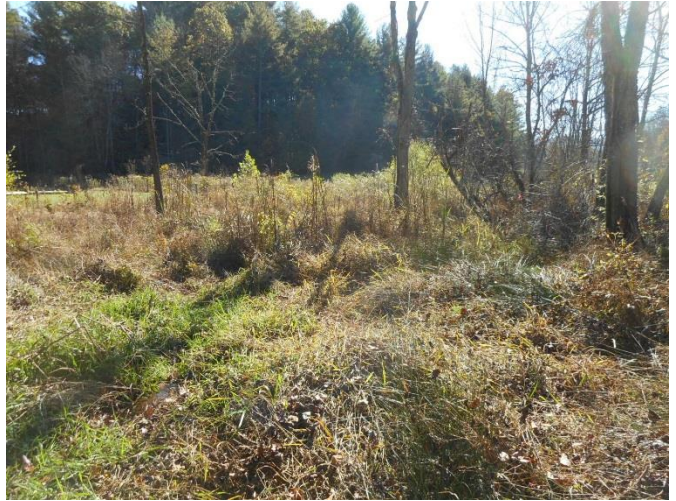
Photo Point 1: looking downstream

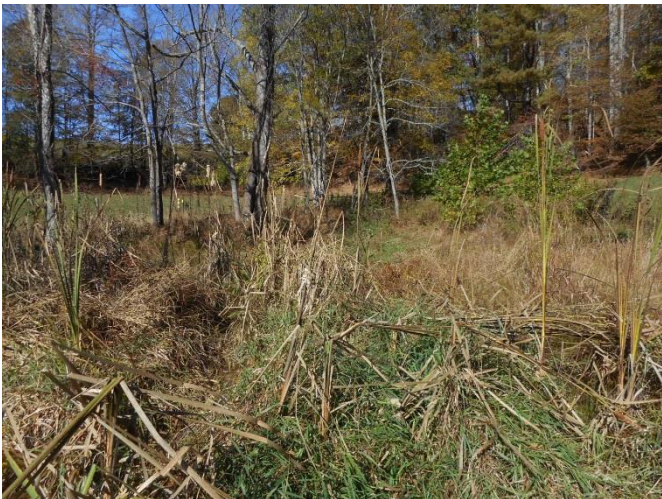
Photo Point 2: looking upstream

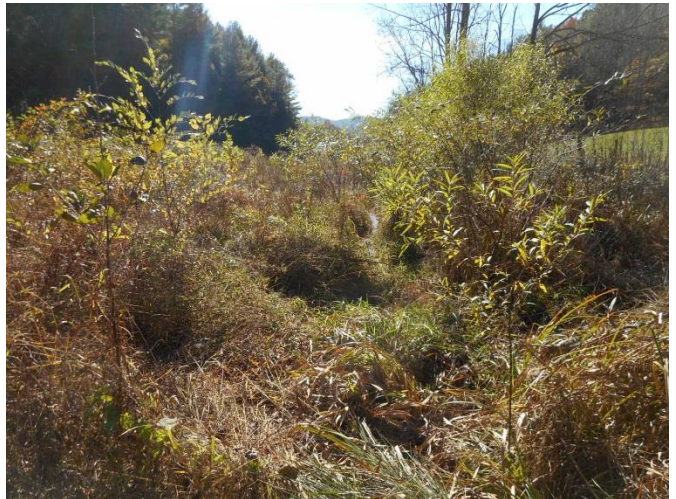
Photo Point 2: looking downstream

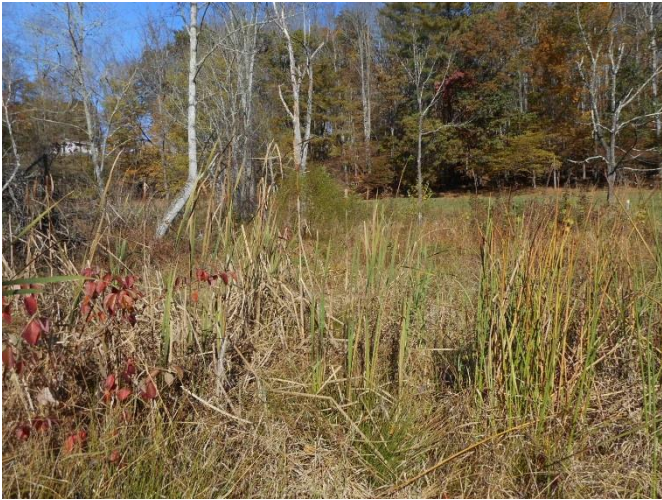
Photo Point 3: looking upstream

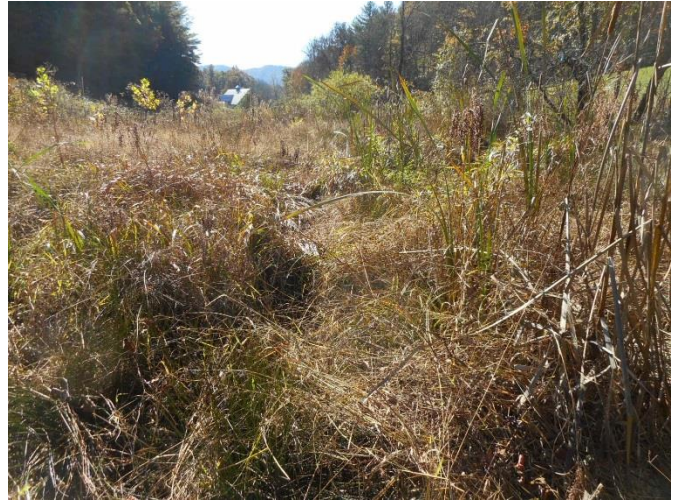
Photo Point 3: looking downstream

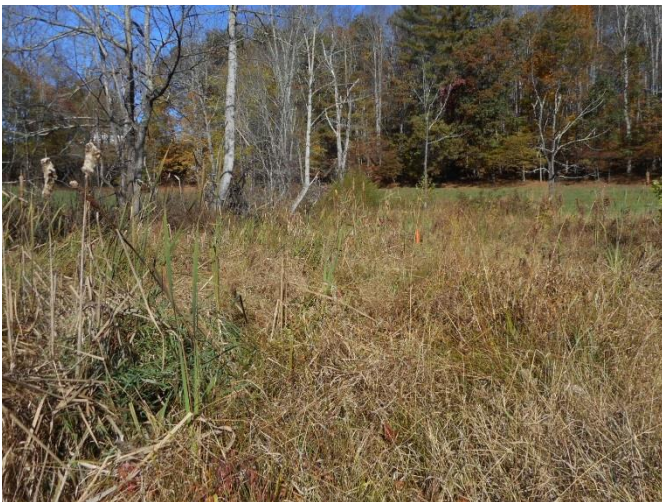
Photo Point 4: looking upstream

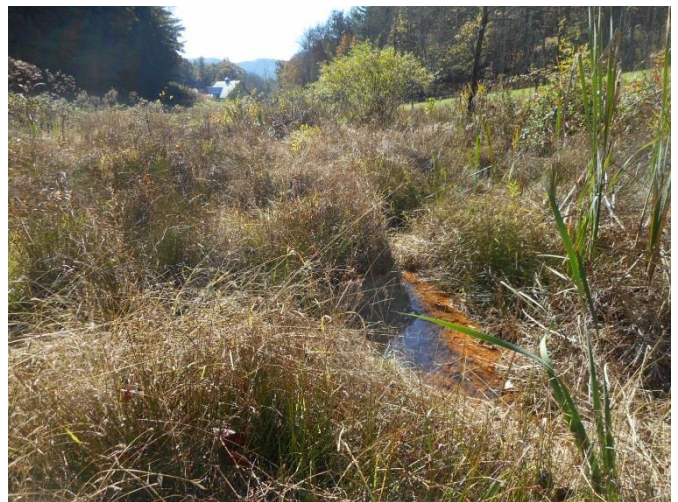
Photo Point 4: looking downstream

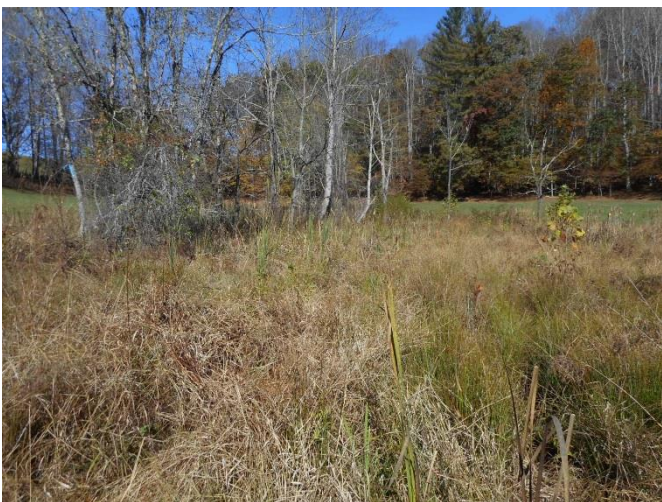
Photo Point 5: looking upstream

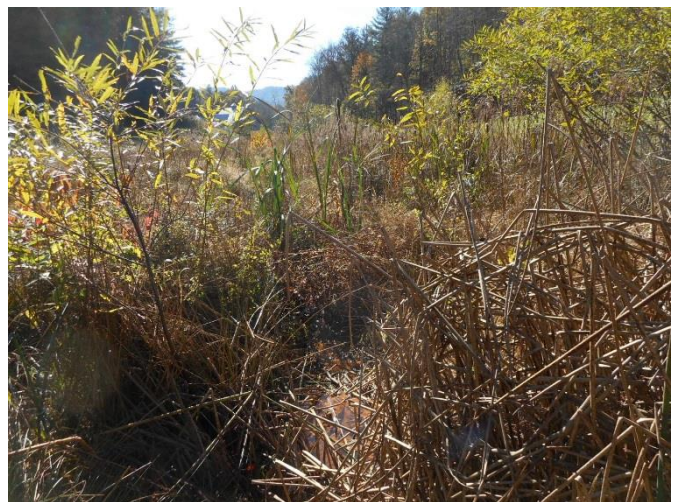
Photo Point 5: looking downstream

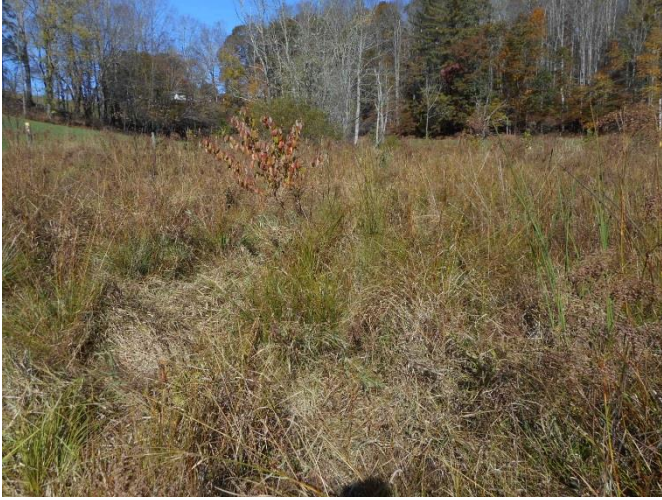
Photo Point 6: looking upstream

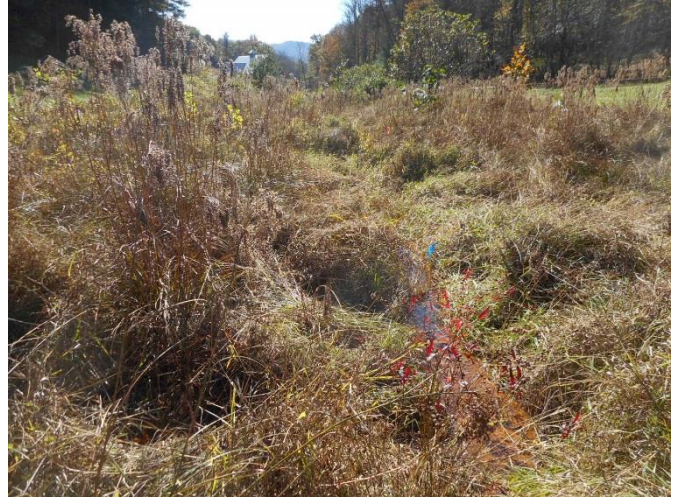
Photo Point 6: looking downstream

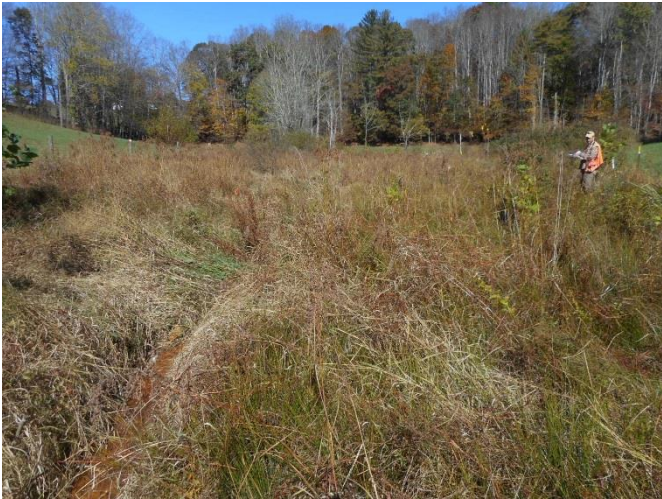
Photo Point 7: looking upstream

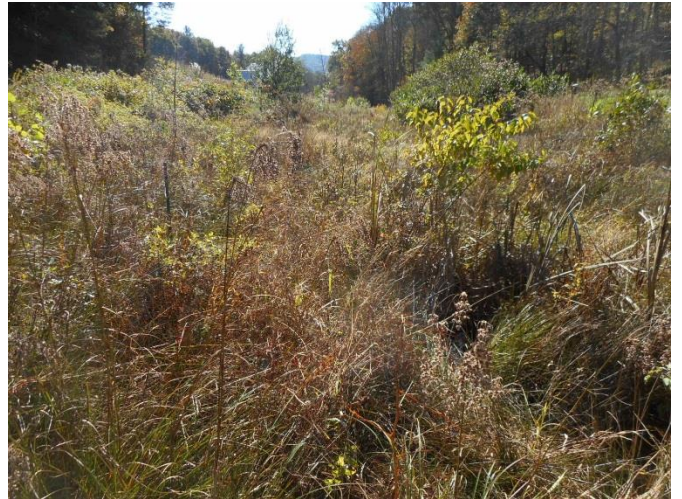
Photo Point 7: looking downstream

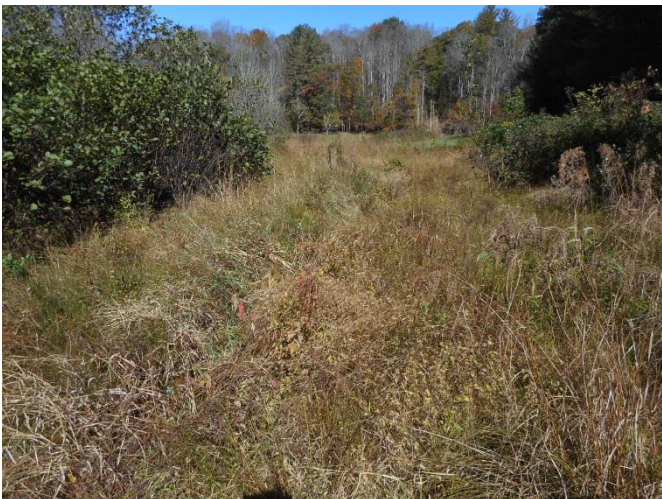
Photo Point 8: looking upstream

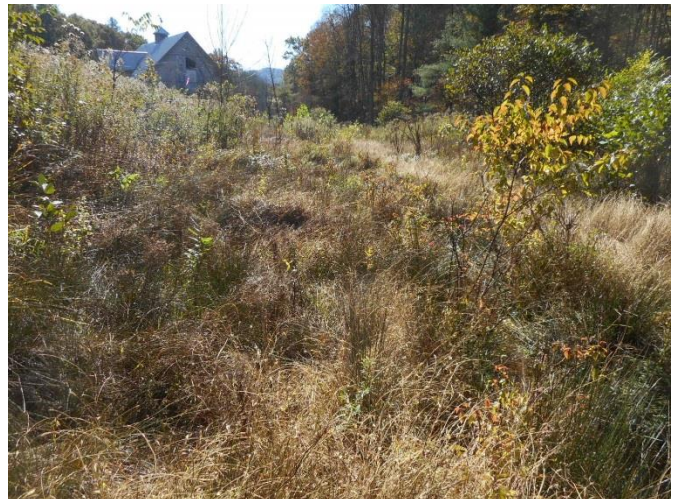
Photo Point 8: looking downstream

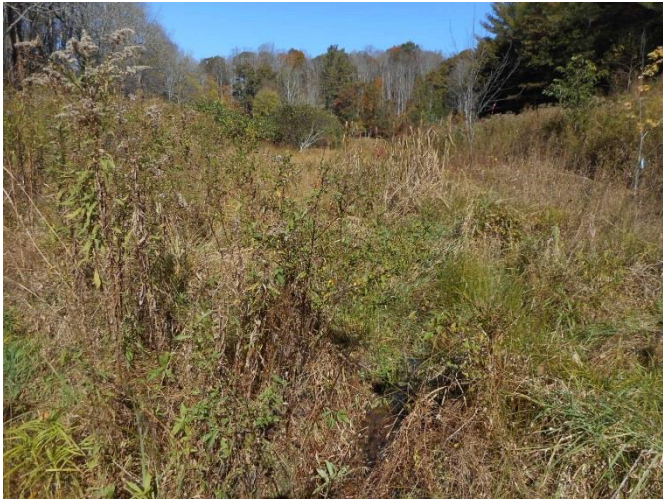
Photo Point 9: looking upstream

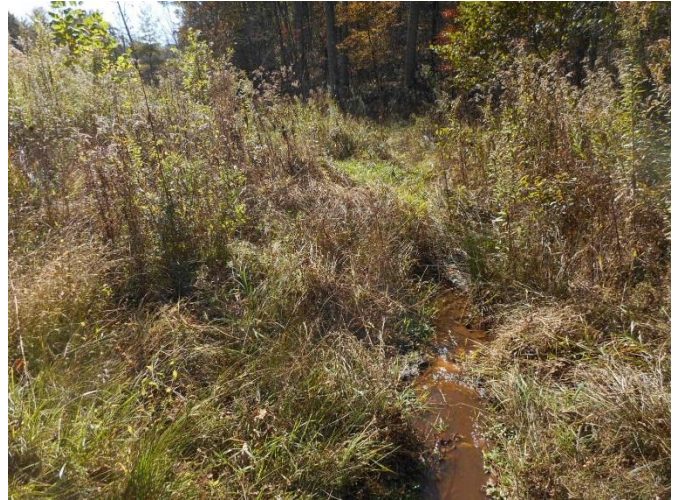
Photo Point 9: looking downstream

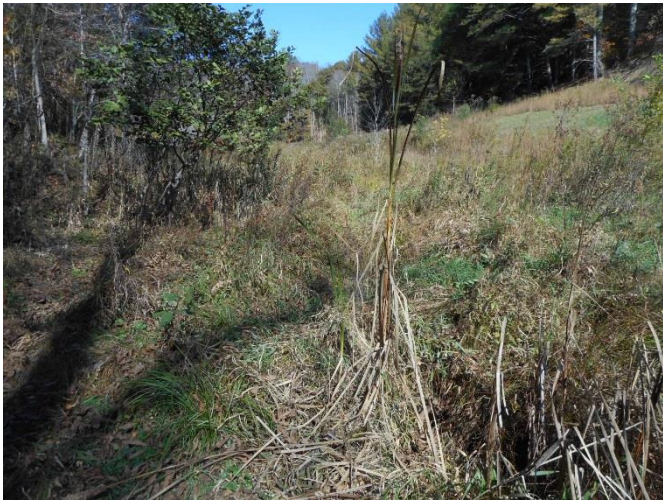
Photo Point 10: looking upstream

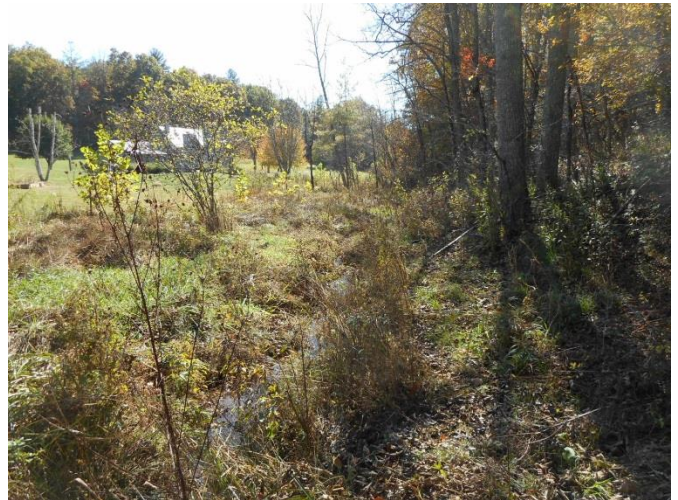
Photo Point 10: looking downstream

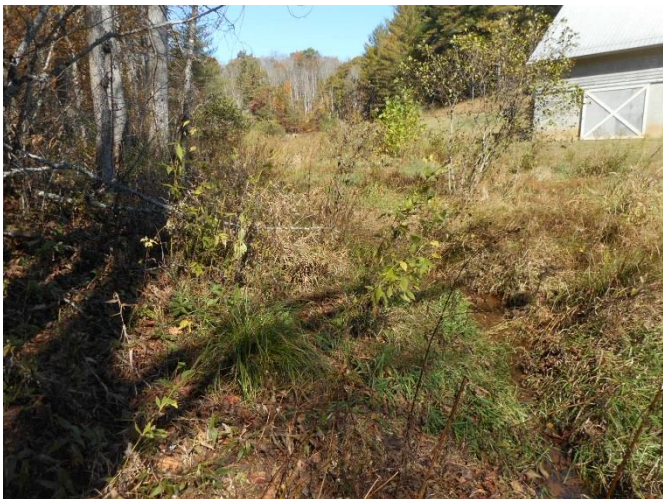
Photo Point 11: looking upstream

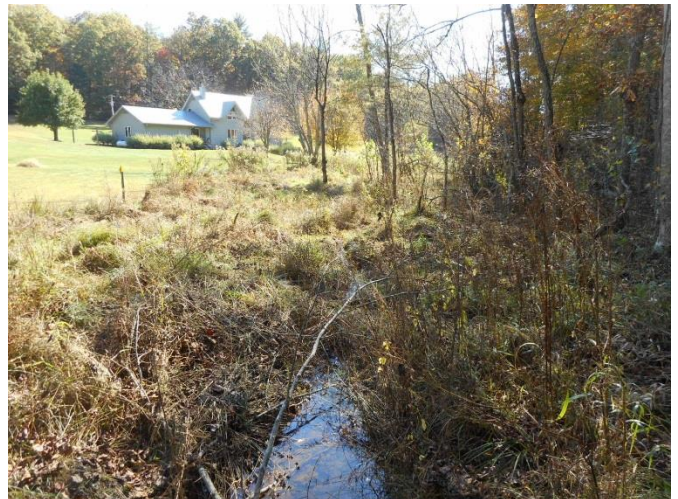
Photo Point 11: looking downstream

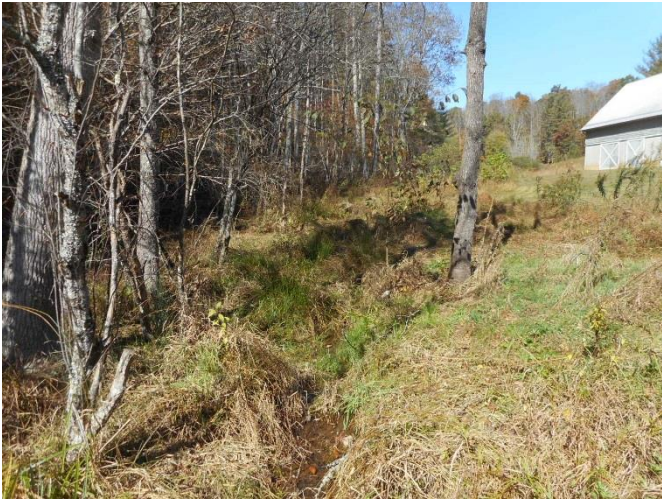
Photo Point 12: looking upstream

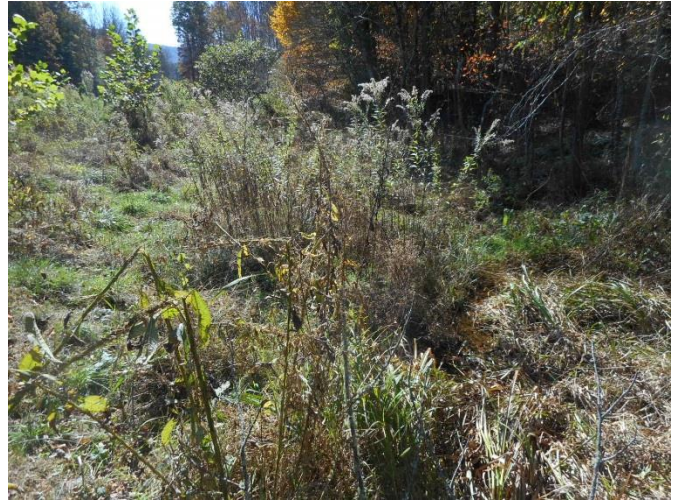
Photo Point 12: looking downstream

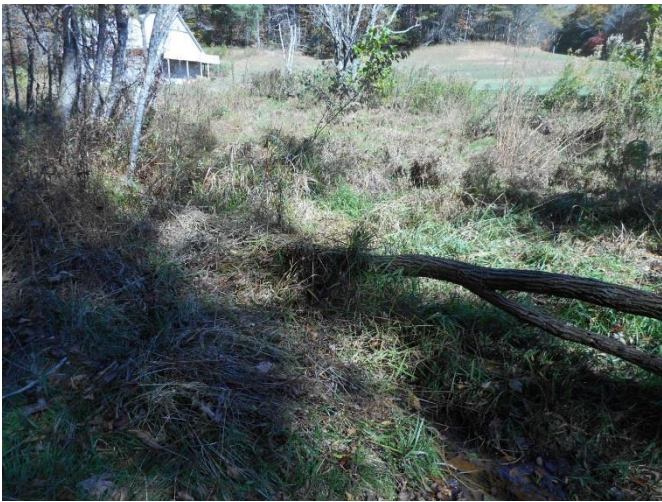
Photo Point 13: looking upstream

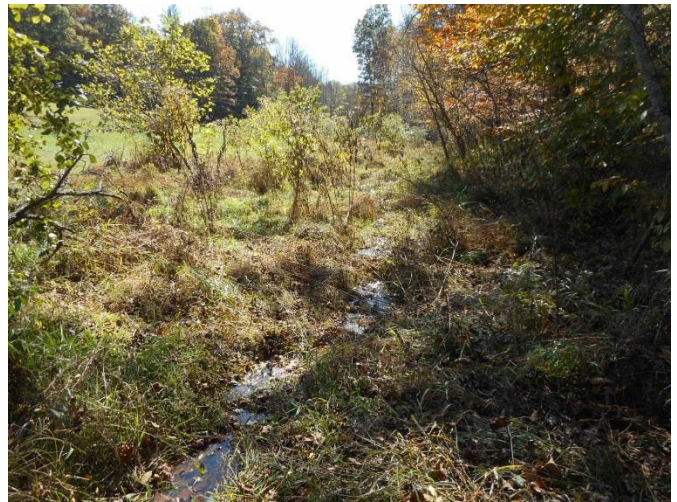
Photo Point 13: looking downstream

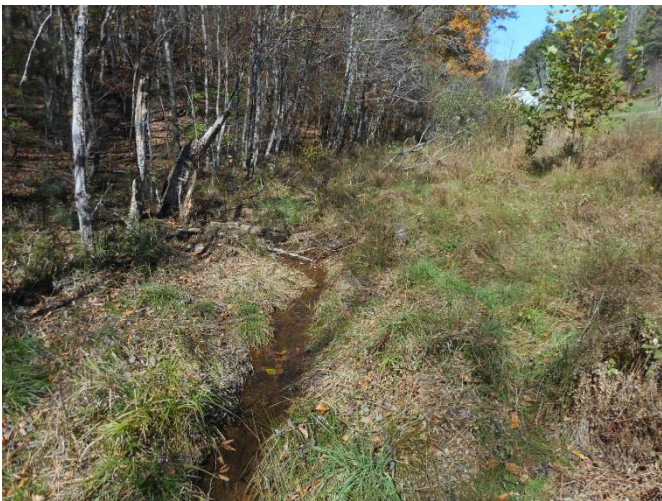
Photo Point 14: looking upstream

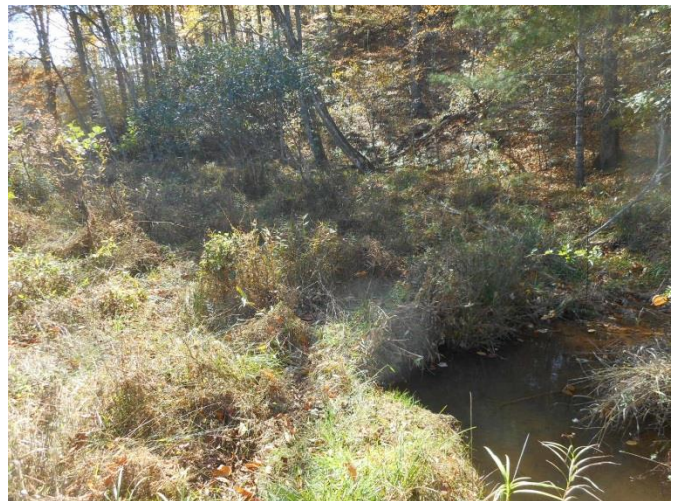
Photo Point 14: looking downstream

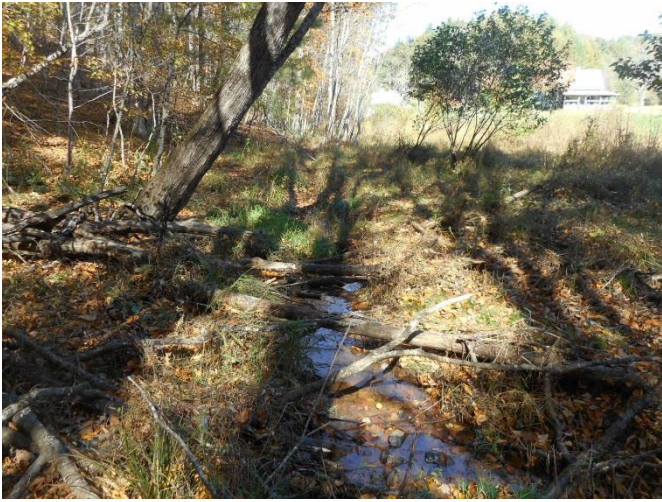
Photo Point 15: looking upstream
