**ELLERBE CREEK STREAM RESTORATION – Project #127
Third Annual Monitoring Report - February 2008 - FINAL**

Designed by:
Stantec Consulting Services, Inc.
Suite 300, 801 Jones Franklin Road
Raleigh, North Carolina 27606

North Carolina Department of Environment and
Natural Resources
Ecosystem Enhancement Program
1652 Mail Service Center
Raleigh, NC 27699-1652

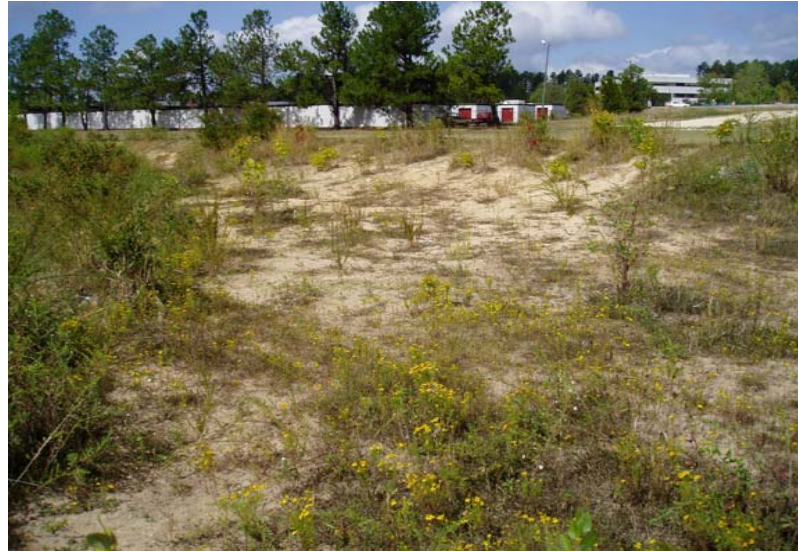
Exhibit Table 6. Vegetation Problem Areas – Ellerbe Creek Stream Restoration – Project #127			
Feature/Issue	Station/Range	Probable Cause	Photo #
Bare soil/eroded slopes	1140-1280	Compated soil/high runoff from golf course	VP1
Bare soil/eroded slopes	1840-2025	Compated soil/high runoff from golf course	VP1
Bare soil/eroded slopes, including floodplain	1890-2070	Compated soil/high runoff from golf course	VP1, VP2
Bare soil/eroded slopes	3540-3630	Compated soil/high runoff from golf course	VP1
Bare soil/eroded slopes, including floodplain	5555-5840	Compated soil/high runoff from golf course	VP1, VP2
Bare soil/eroded slopes, including floodplain	6315-6570	Compated soil/high runoff from golf course	VP1, VP2

VP2. Bare soil on floodplain

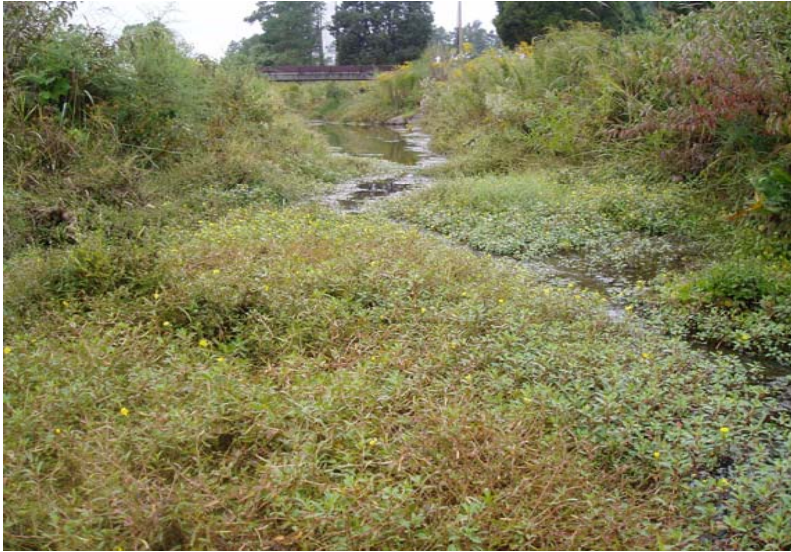
SP1. Aggradation (bar)

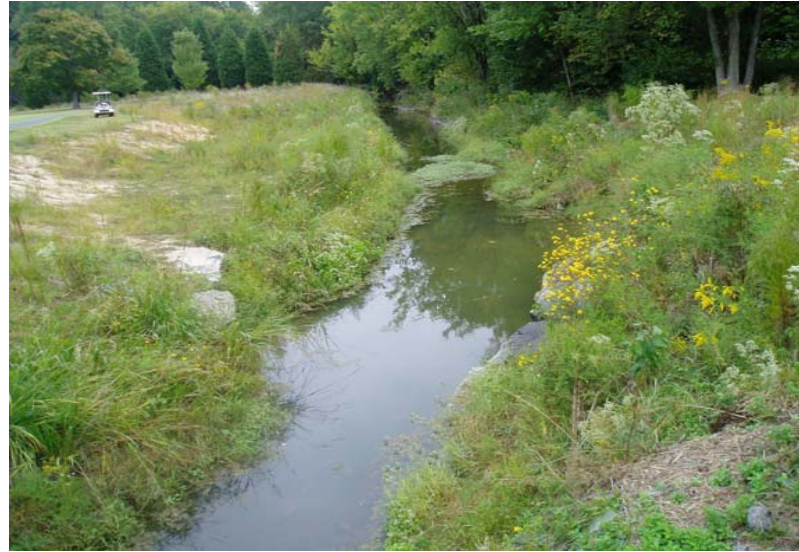
SP2. Aggradation (pool)

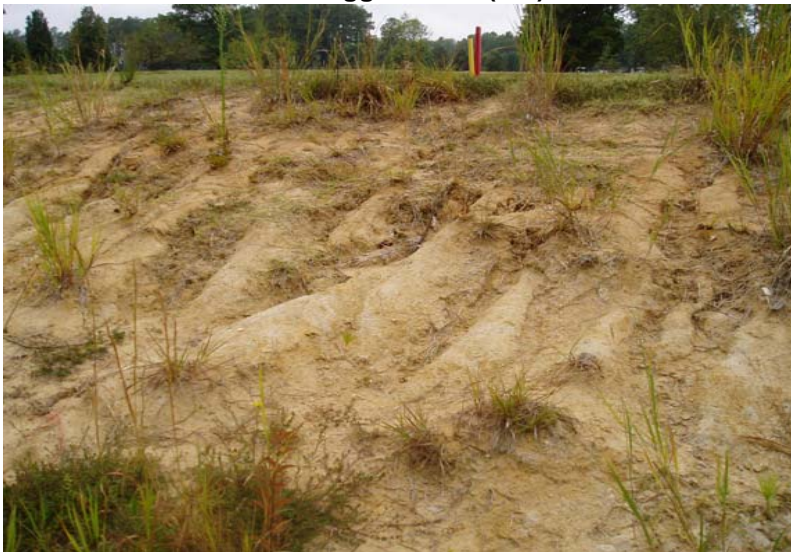
SP3. Rill and gully

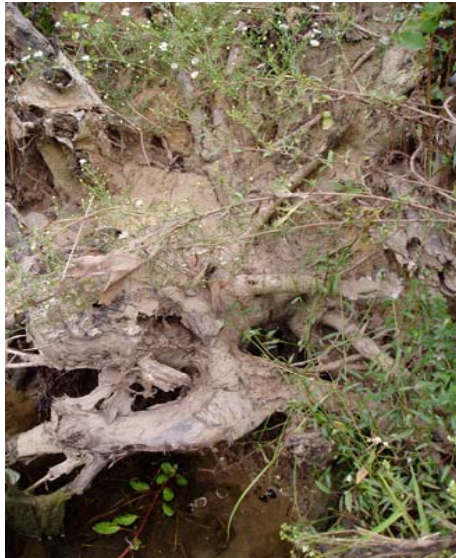
SP5. Root wad undercut
