**ELLERBE CREEK STREAM RESTORATION – Project #127
Fourth Annual Monitoring Report - 2008 - FINAL**

Submitted on January 30, 2009 to:

North Carolina Department of
Environment and Natural Resources
Ecosystem Enhancement Program
1652 Mail Service Center
Raleigh, NC 27699-1652

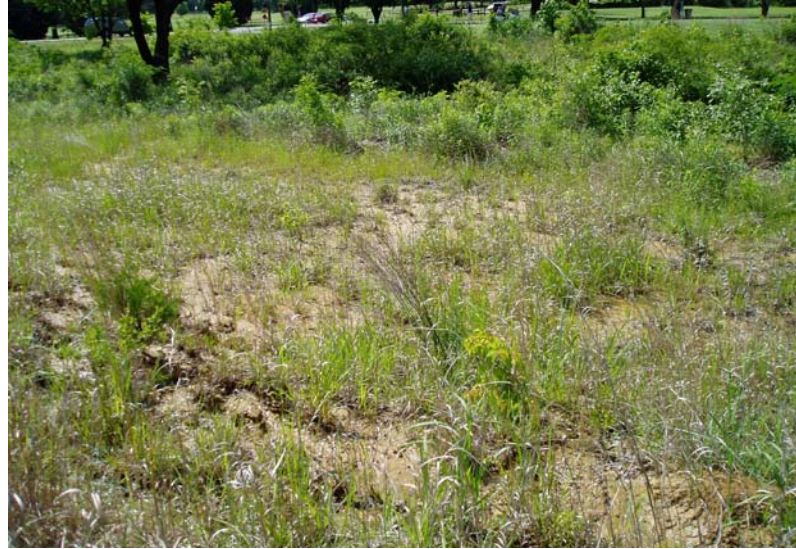
Two small rill and gully vegetation problem areas were observed in the Hillandale reach. One area on the left-bank slope from the terrace, immediately downstream from cross-section four, and the other on the right-bank slope beginning at station 3880. As described above, this vegetation problem area is likely to be the result of the lack of an adequate substrate and run-off from the golf course. The third problem area in the Hillandale reach involves bare floodplain soils at station 4450 (Vegetation problem Photo 2).

VP2. Bare soil on floodplain (9/18/08)

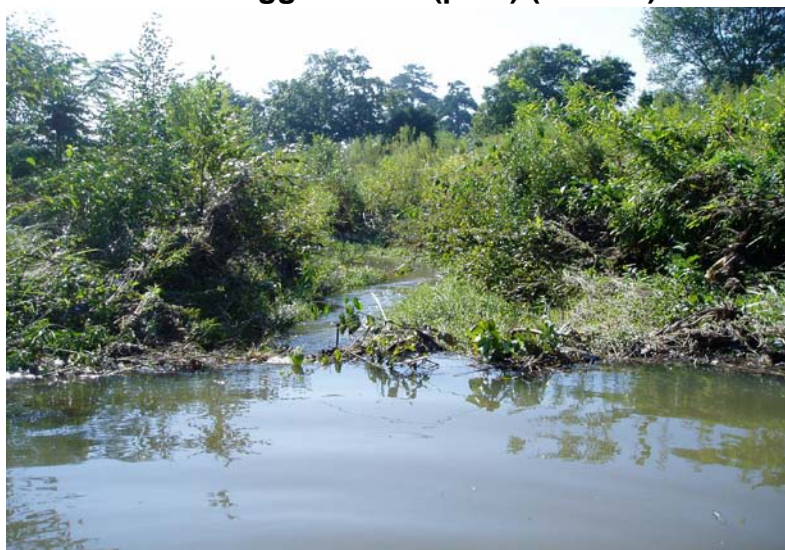
A total of three active beaverdams were observed throughout the restoration project, all of which located in the Hillsborough reach. Those three, along with three additional abandoned dams in this reach, are impounding water and sediments in the uppermost reach. All six are identified in the longitudinal profile (Appendix B).

SP4. Beaverdam looking downstream (9/15/08)

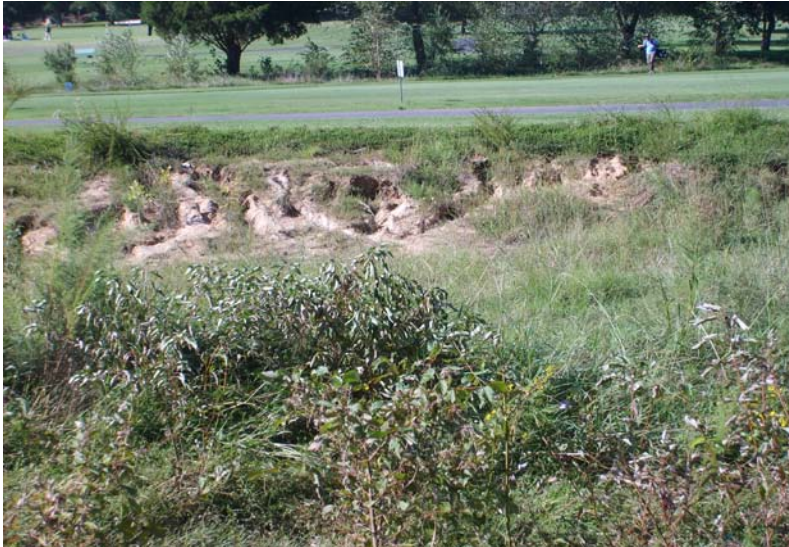
Aggradation (bar)	5265-5275	SP7	Sediment from stormwater/scour areas
Aggradation (bar)	5285	SP7	Sediment from stormwater/scour areas
Mid-channel bar	6075	SP8	Sediment from stormwater/scour areas
Mid-channel bar	6110	SP8	Sediment from stormwater/scour areas
Mid-channel bar	6160	SP8	Sediment from stormwater/scour areas
Bank slump/scour	6180-6270	SP7	Insufficient rootwad/armoring
Boulder failure	6330	SP7	Insufficient coarse backfill
Rill and gully	6350	SP5	Insufficient growth medium
Bank undercut/scour	6340-6360	SP7	Insufficient rootwad/armoring
Aggradation (bar)	6390	SP7	Sediment from stormwater/scour areas
Rill and gully	6425	SP5	Insufficient growth medium

SP5. Rill and gully (9/18/08)

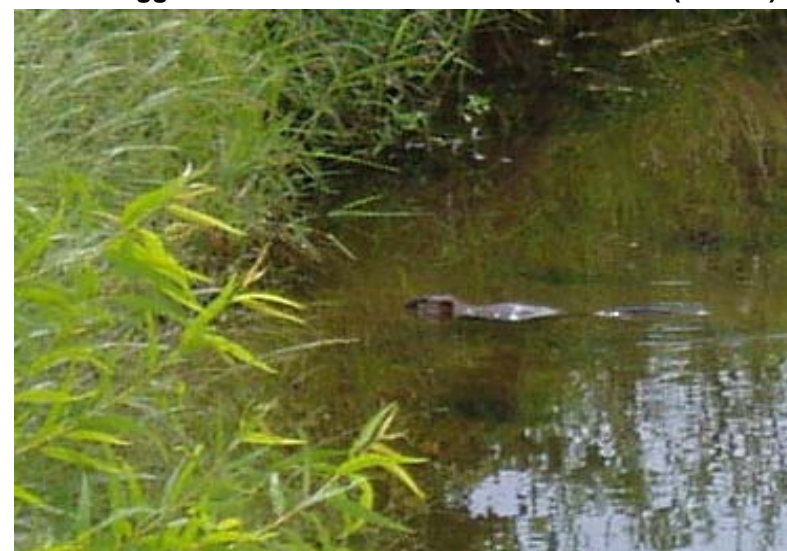
SP12. Beaver (4/16/08)
